BONNET CABLE DEFECT ANALYSIS USING SIX SIGMA DMAIC TECHNIQUES

Dina DIGA¹, Irina SEVERIN²

Study presents the implementation of Six-sigma techniques to identify the root cause of bonnet cable problem at the customer's request. The process was developed in detail, using five main (DMAIC) steps: Define, Measure, Analyze, Improve and Control. In this research, Quality Management tools such as SPD – Standard Problem Definition analysis, Data Analysis, Quality Assurance Part Inspection, Data Collection Plan, Process Capability Study - DPMO, Initial Verification Diagnosis, Visual and Control Charts etc. are used in defining the problems to find the root causes for the problem and carrying out experiments in order to suggest improvements, through which the company could bring in quality and reliability in their process.

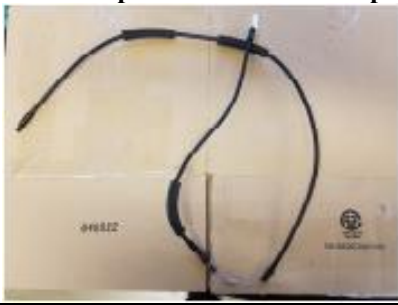
Project research no. & Title : P232813 Bonnet - Will not open	Problem investigator: Dina Diga / P. P.	Date: 07/02/2020
What/Why/Where/Who/When		
Part no.: (Eng. / Service)	Part description: Bonnet cable	Supplier, Code & Contact details
Visual Inspection evidences: i.e. photos etc.

Other supporting evidences: <ol style="list-style-type: none"> VIN (Vehicle Identification Number): SLRA2BV9HA022 TIS: 4 months / 1503 Km Customer Verbatim: Unable to open Bonnet Technician Verbatim: Customer concern confirmed. Bonnet opening lock cable failed renewed. Issue still the same. Bonnet right hand latch failed renewed. 		
Conclusion: There is evidence of a kink in the cable which may cause a tight spot. ABA – (Applied Behavior Analysis) test to vehicle to test operation.

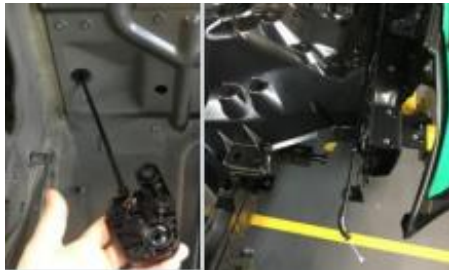
Validation/ Observation/ Conclusion - 1st Initial Verification Diagnosis - IVD		
IV&D What/Why/Where/Who/when		IVD evidence: Highlight any non-conformance found during verification There are no non-conformities to process found during inspection. However the fault is being reworked at early MiS but no recent repairs were highlighted by the rectification team. Additionally, operators at Zone 1 say grommet in vehicle1 is causing problems in comparison with vehicle2, where vehicle1 is "soft" and can pass the BIW- Body in White. To be followed up with PVT - Production Validation Test team. Conclusion Please highlight the major non-conformance i.e. Drawings, Control Plan, FMEA – failure mode and effect analysis etc. Although failure can be witnessed on plant, it is not understood at this stage what causes the fault. Parts required for measurements and further investigation on grommet material required.

Project research title	Cable - bonnet control	
IV&D scope & target:	To understand supply chain of parts assembly and detection points for low TiS in plant.	
Component description	Cable - bonnet control	
Supplier/Plant/ Dealership name	M. Cables	
Problem verifier/investigator	S. G.	
Date verification carried out	06/11/2019	
IVD evidence: i.e. Photos, documents etc.

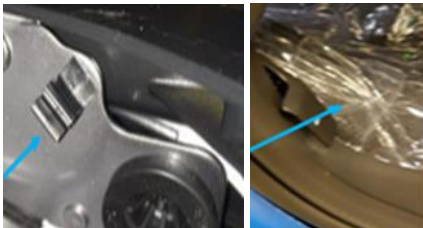
2nd Initial Verification Diagnosis

Conclusions from 2nd IVD: Correct routing and consistency of bonnet cables to be adhered in manufacturing. Some variation was noticed in routing of bonnet cable in a subsequent visit to Plant. Cable not clipped. Associates also stated lever does not always fully return on some vehicles [10, 11].

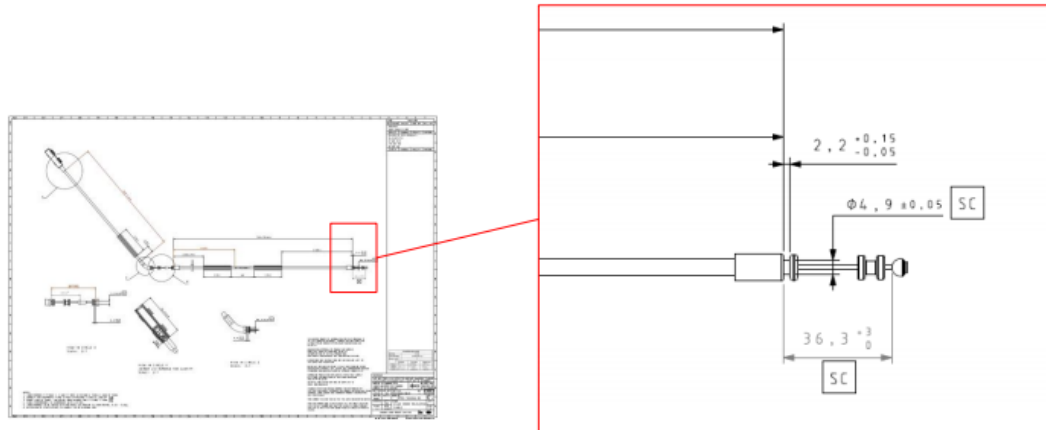
Fig. 2. Bonnet cable drawings

During the document inspection, it was noted: Drawings specify several SC - sharp corners. The length of cable exposed to the latch (relevant to the failure mode) is an SC. See drawings in Fig.2.

DFMEA - Design failure mode and effect analysis and PFMEA - Process Failure Mode Effects Analysis contain failure mode of cable being too long or short but no reference to quality inspection or prevention of failure mode.

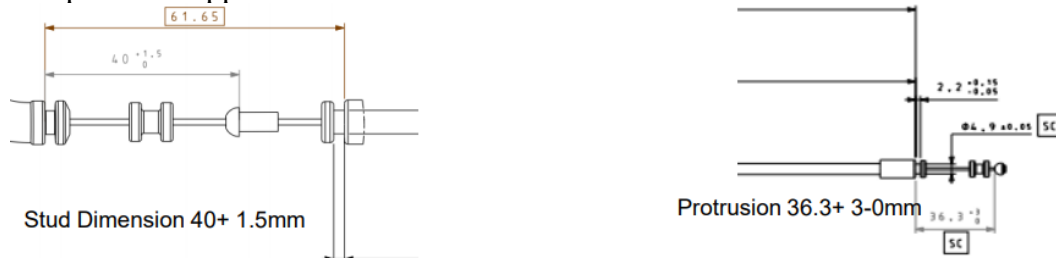
Fig. 3. Cable drawings

Five samples were measured, as presented in Table 3, in terms of cable length produced in the company's plant and it was concluded that the parts returned for measurement and new cables are out of tolerance. Similar measurements were performed at the supplier, as shown in Table 4.

The drawings in Fig. 3, shows the bonnet cable stud dimension and protrusion compared to supplier results.

Conclusion: following the measurements performed and the straightening of the cables, it was included in the specifications.

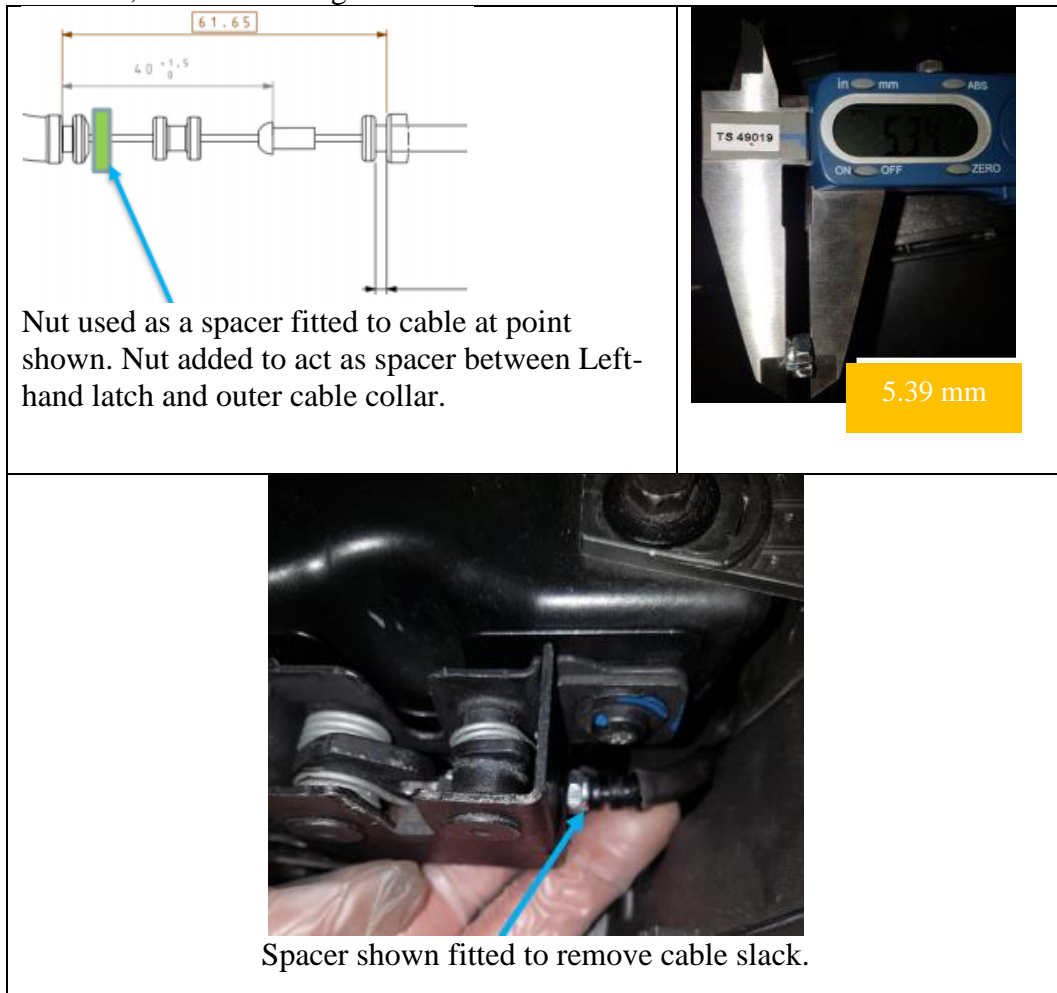
Fig.4. Bonnet cable modification test

The goal of the Six sigma improve phase is to identify a solution to the problem that the project research aims to address [12]. This involves brainstorming potential solutions, selection solutions to test and evaluating the results of the implemented solutions. Such a solution has been identified and implemented, after measurements showed that there is a difference in tolerances between the cables. The design of the system allows for excess free movement where the failure mode can be produced when coupled with other factors such as routing and bonnet alignment [13]. During the cable assembling process inspection, there were evidences wherein the cable was out of its position and not clipped at timing marks. Bonnet lever specification is from 10°C - 90°C which allows for considerable free play leading to the lever reaching its end of travel before enabling the bonnet to be

open. Following the final tests, the solution to reduce release lever free play was identified, as shown in Fig.4.

Conclusion: This reduced release lever free play and thus overall travel.

The solution found for the difference in tolerances between the cables is to add a nut to act as a spacer between the left-hand latch and the outer cable collar. The solution for improper cable assembly is to standardize the assembly method and perform operator training.

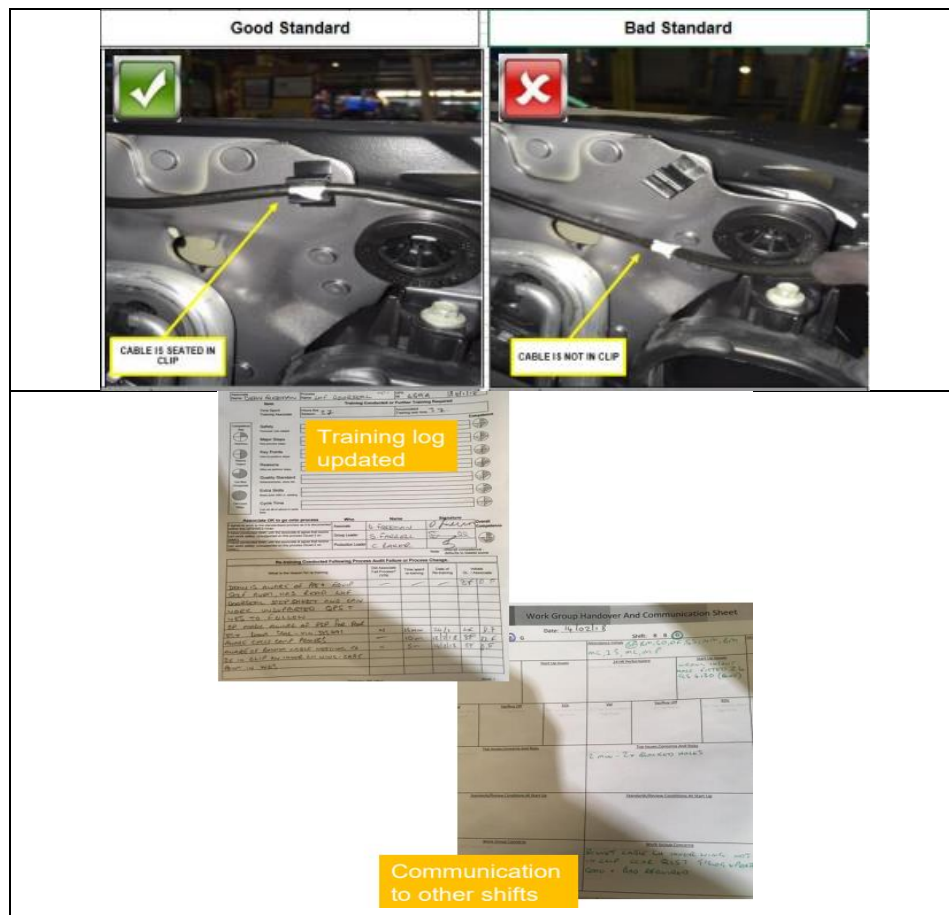
Fig.5. Standardization method of installation and training

In the control phase of the project research, the solution was developed and validated and the goal is to make sure that the problems have been eliminated and that the method is improving [14]. A training was performed on the correct mounting of the bonnet cable because the cable was out of its position and not clipped at timing marks, as shown in Fig. 5.
