## FAILURE ANALYSIS AND CORROSION MECHANISM INVESTIGATION OF HEAT EXCHANGER PLATES FROM AN OIL REFINERY

*This paper presents research conducted on four plates from a heat exchanger located in an oil refinery, aiming to identify the causes leading to their severe corrosion. The chemical composition, macro- and microstructural analysis, and hardness characteristics of the material were analyzed. Results obtained were compared with material standard specifications outlined in the equipment documentation. A separate chapter details optical and electron microscopy analyses of corrosion developed on plate surfaces. Finally, the probable causes of premature plate failure caused by severe corrosion are discussed.*

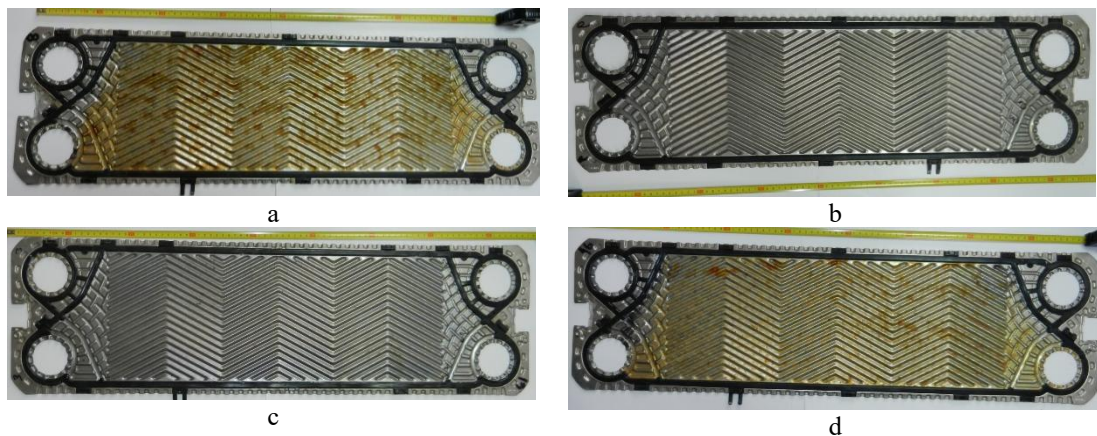
The heat exchanger consists of 20 stainless steel plates of grade 1.4404 EN 10028-7 (SS 316 L), with overall dimensions of approximately  $300 \times 850 \text{ mm}^2$ . Four of these plates were selected for analysis and are shown in Figure 1. All analyzed plates exhibit perforations with dimensions of up to 4 mm.

**Figure 1.** Plates for the analyzed heat exchanger

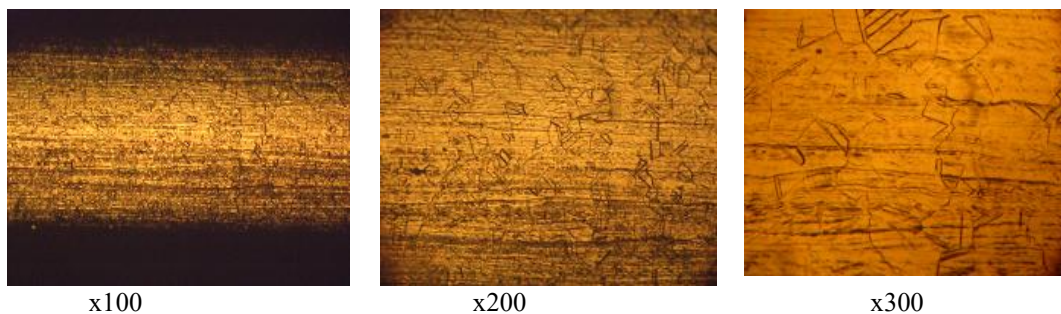
**Figure 2.** Microstructure of the material in the contour zones of the plates; etched with Marble's reagent

In the flat areas, the microstructure is  $\gamma$ -solid solution (austenitic), with maced polyedra. The grain size is very fine, corresponding to ASTM grain size score 8 (Figure 2).

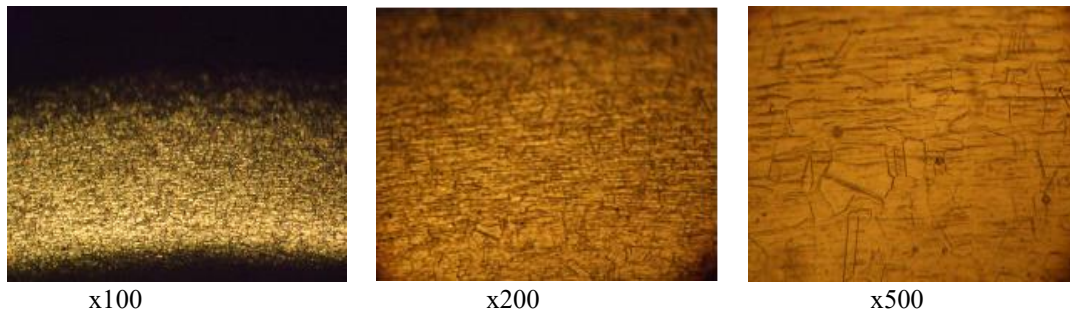
In areas profiled by embossing process (Figure 3), the microstructure is textured, typical of a cold plastically deformed material.

**Figure 3.** Material microstructure of cold-formed plate areas etched with Marble's reagent

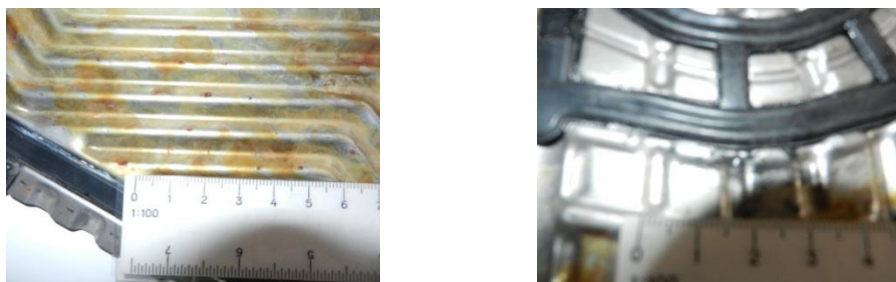
**Figure 4.** Macroscopic appearance of the mark 1 sample

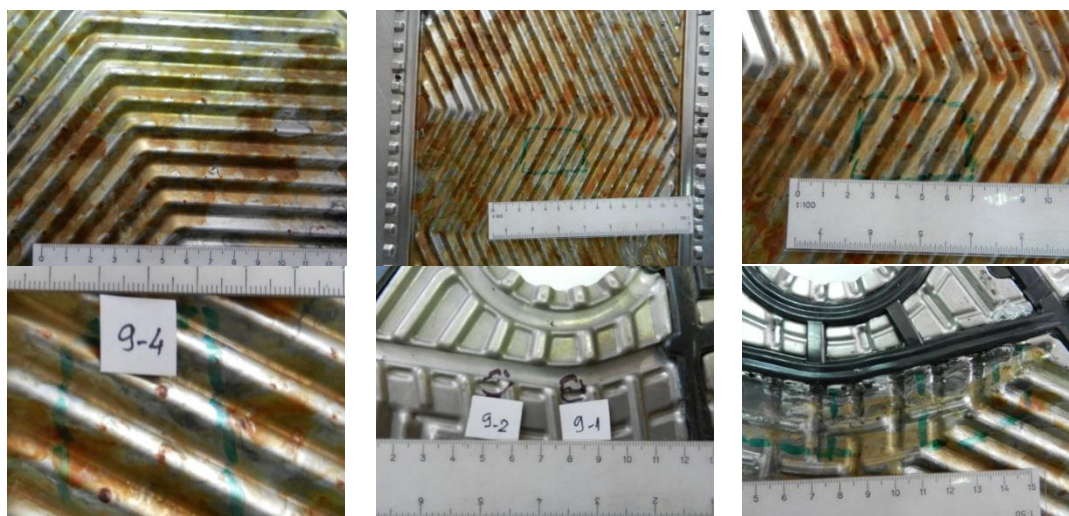
**Figure 5.** Macroscopic appearance of the mark 2 sample

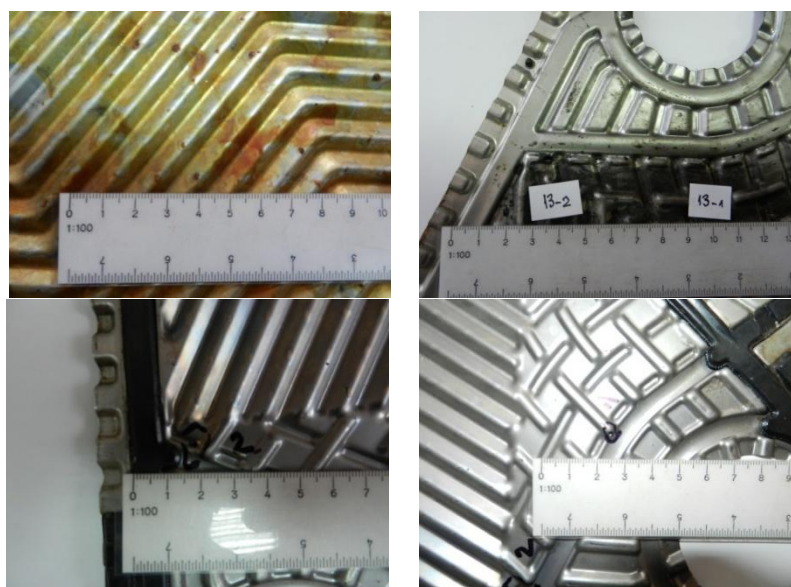
**Figure 6.** Macroscopic appearance of the mark 3 sample

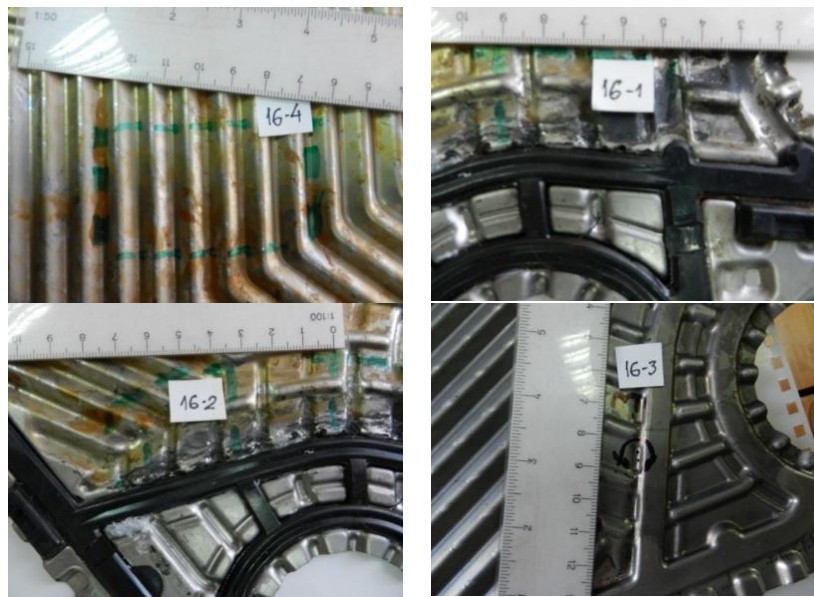
a) the two faces of each plate differ significantly in appearance; one of them is clean and with a metallic sheen, while the other shows an uneven appearance, with stains and deposits of a yellowish-brown color; thus, in the case of plates marked 1 and 4, the affected faces are those on which the contour gasket is fixed, while in the case of plates marked 2 and 3, the affected faces are the opposite faces to the face with the contour gasket; [8,9]

**Figure 7.** Macroscopic aspect of the mark 4 sample

b) the faces with yellowish-brown deposits show numerous points, randomly positioned on the face of the plate, in which local deterioration processes occur on the surface of the plate; in the vast majority of cases, these points are positioned on the tips of the protrusions that shape the plate;

c) the most affected areas, in which the deterioration process has caused the perforation of the material and the development of holes up to 5 mm in size, are located near the circular cutouts; in these areas, the material shows a strong local profiling; the thickness of the material decreases in these areas up to approx. 0,38 mm, compared to ca. 0.50 mm in the undeformed areas at the periphery of the plates.

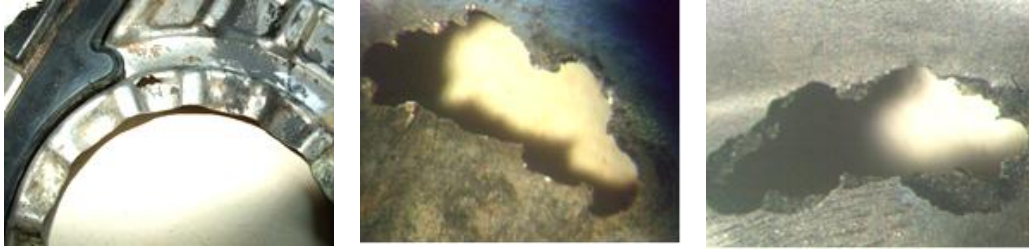
One of the perforations in the plate marked 4 is shown in Figure 8. It was located in the ambushed area at the contour of the circular cutout illustrated in Figure 7.

**Figure 8.** Corrosion in the crevice in the area of the circular cutout in the plate mark 4

The detail images showing the two faces of the material show that the tear-out was caused by localized corrosion. The edges are corroded, with undercuts towards the face with the gasket. We assess that this type of highly localized corrosion is “crevice” corrosion. Both faces of the analyzed area are in the proper face environment with yellow reddish deposits.

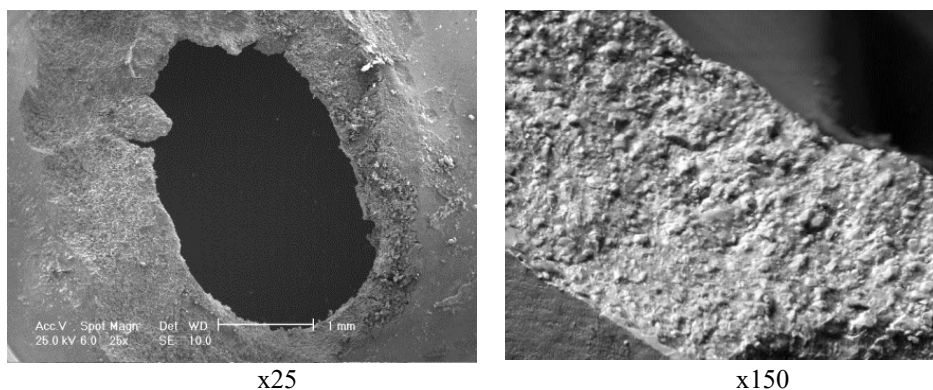
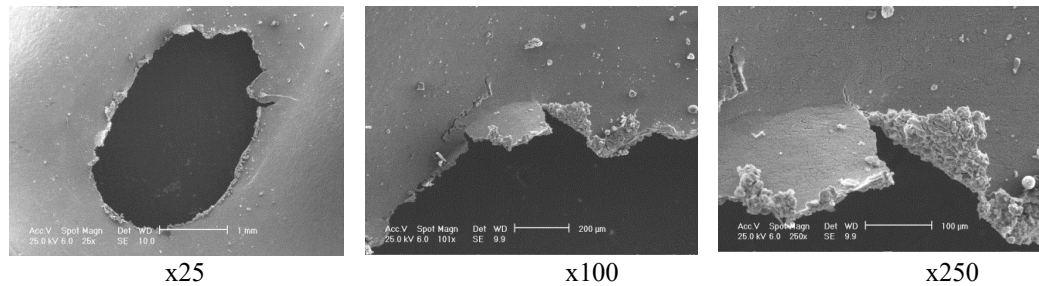
In the case of the plate mark 4 the top of a strongly deformed area was examined in which the plate presented a corrosion spot with wall perforation. The images included in Figure 9 illustrate the outline of the plate wall puncture point and the appearance of the corrosion surface at the edge of the hole.

**Figure 9.** Appearance of a pitting corrosion spot, present in the plate mark 4 a) face of the plate without gasket (with yellowish-brown spots) b) face of the plate with gasket (with clean surfaces, with metallic sheen)

It is evident that the corrosion process has penetrated the passivated layer on the surface of the material and has progressively expanded by increasing both the contour and the depth of the affected area. The corrosion initiating surface is the one corresponding to the face of the plate without gasket (yellowish-brown color).

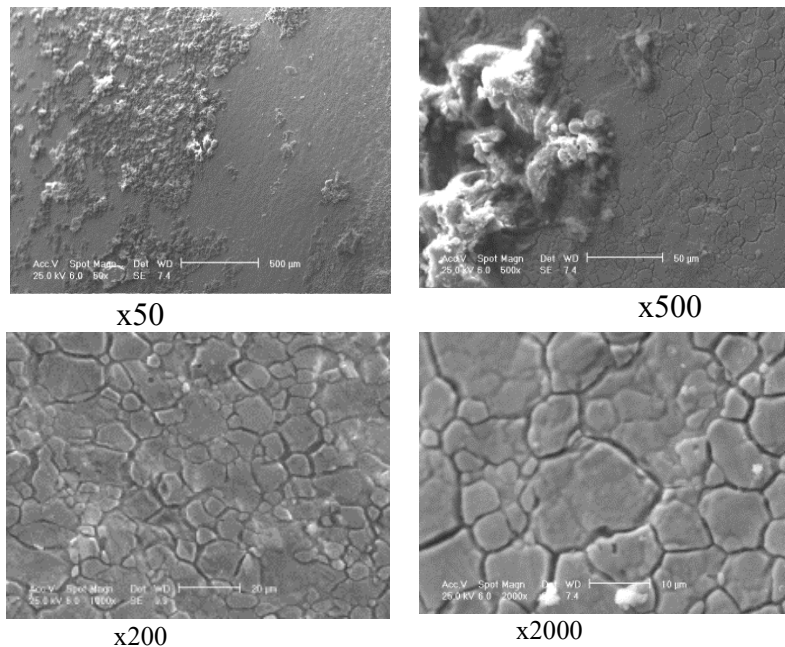
A separate analysis aimed to highlight the particularities of the yellowish-brown colored plate face in an uncorroded area, on which there is an adherent deposit. The appearance of such an area is shown in Figure 10. It shows the presence of a relatively uniform deposit, which after drying shows extensive cracking after drying, as well as an area with prominent formations in relation to the face of the plate, consisting of adherent deposits.

**Figure 10.** Deposits on the face of the plate marker 4 ; Qualitatively, the nature of the deposits is evidenced by the X-EDS emission spectra (Figure 11a). Quantitative data obtained after fluorescence correction are shown in Figure 11b

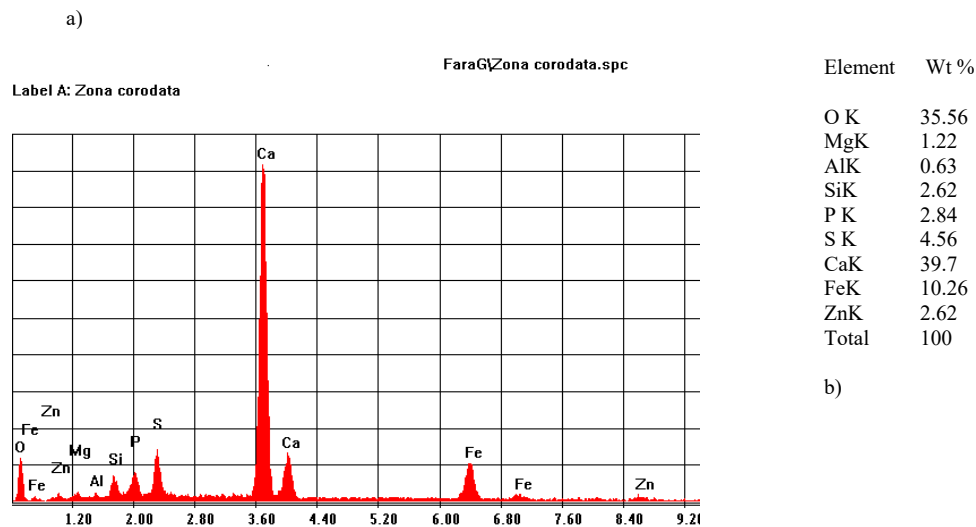
**Figure 11.** Analysis of the nature of the deposits on the yellowish-brown colored surface of the plate mark 4

The presented data reflect the nature and proportion of the products in the medium in contact with the respective face of the heat exchanger plate.
