## RESEARCH ON CORROSION DEGRADATION PROCESS OF SOME THERMAL POWER PLANTS STEAM BOILER PIPES

**Keywords:** degradation, corrosion, steam boiler pipe

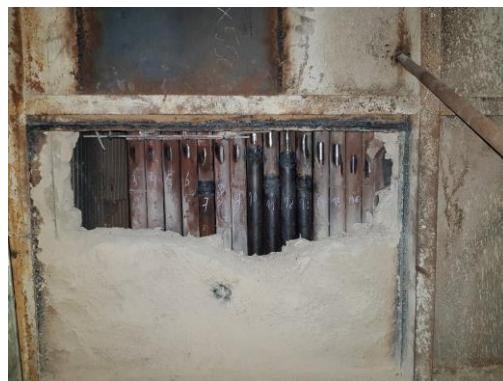
Fig. 1. Macroscopic overview of boiler pipes damaged in operation

Figures 1 – 4 show areas of typical degradation by oxidation: the regions surrounding the perforations are reddish-brick, specific color of the iron (II, III) oxide  $\text{Fe}_3\text{O}_4$ . The corroded area has a "stepped" surface, a specific detail of intercrysalline corrosion, this type of corrosion being commonly found in oxidation phenomena. Moreover, the areas surrounding the corroded regions have longitudinal streaks where the metallic material exfoliates. They are denser the more intense the oxidation phenomena were. The most relevant example is the case of pipe 13, Figure 4a, which is even deformed in the corroded area, where one can see deep streaks that mark the delamination of the metallic material, the corrosion advancing in an intercrysalline manner.

Observing the position of the pipe 13 in the boiler architecture (Fig. 1) one may see that it comes in almost direct contact with the burners flame, which explains the very high oxidation kinetics.

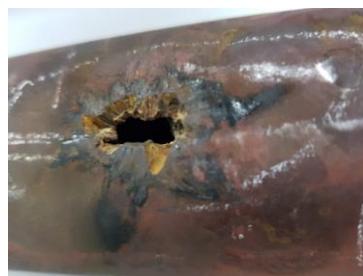
Fig. 2. Macroscopic image of damaged pipe 11 (a), detail of the sample inner surface (b)

Cross section analysis of pipe 11 (Fig. 2b) supports the statement that the pipes are strongly degraded by oxidation. Thus, inside (on the pipe inner walls) the corrosion area shows a very rough surface, with a reddish-brown shade, typical for  $\text{FeO}$  oxides. The oxygenated salts existing in the circulating water contributed also to the oxidation phenomena, which, amplified by temperature, led to the advanced chemical corrosion.

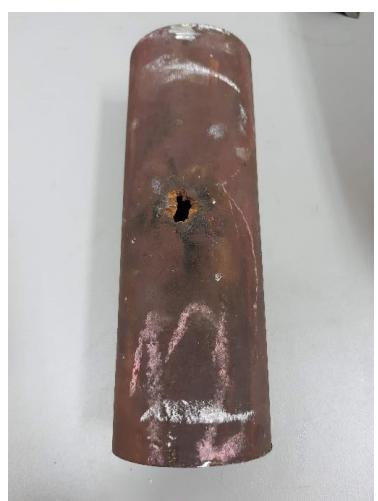
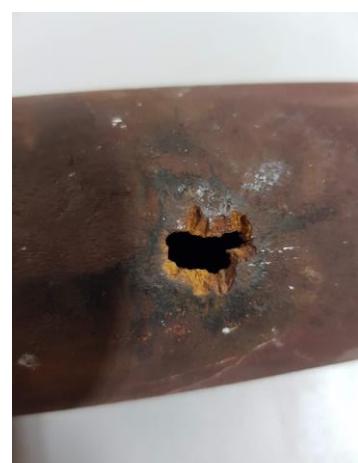
Fig. 3. Macroscopic image of damaged pipe 12 (a), detail of the sample front side (b)

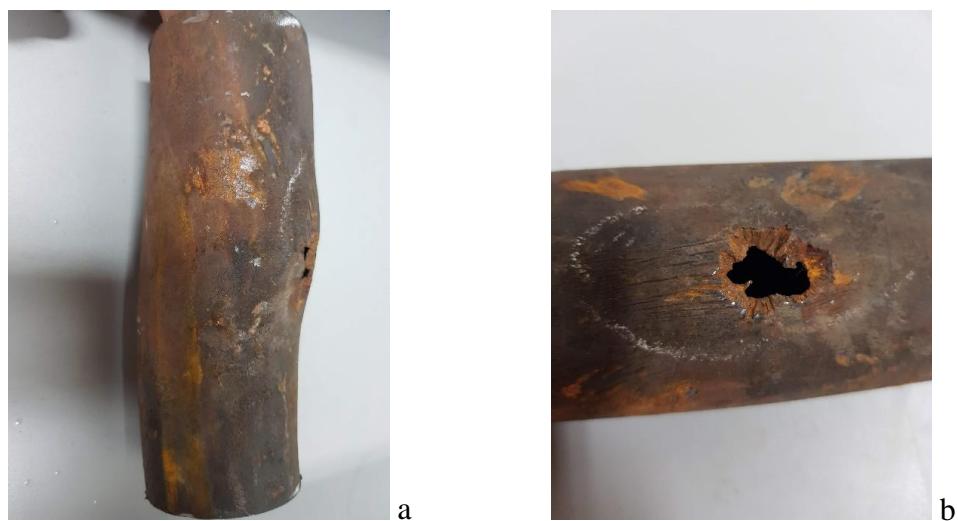
Fig. 4. Macroscopic image of damaged pipe 13 (a), detail of the sample right side (b)

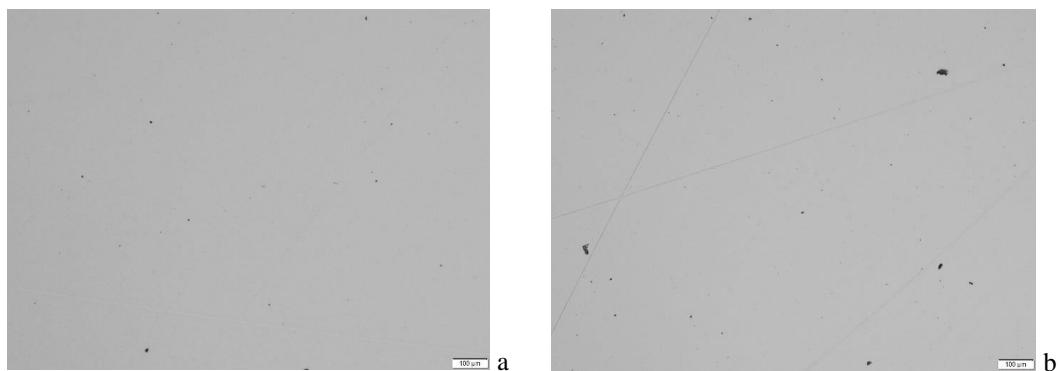
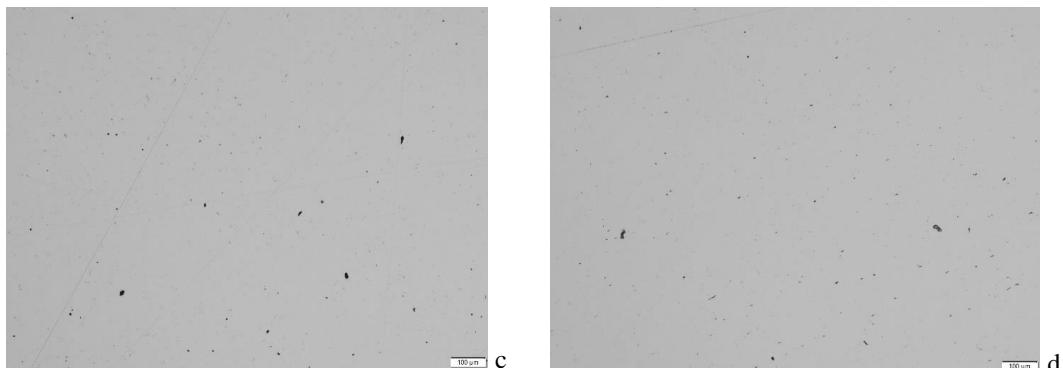
Fig. 6. Optical microscopy of the unetched samples surfaces (a-10, b-11, c-12, d-13)

The samples were studied only in cross section thus the inclusions orientation could not be followed. However, the images are relevant for assessing the inclusions state. Thus, in Figure 6 one can see large, dark brown inclusions, with angular edges specific to alumino-silicates, but also smaller, circular, gray-blue shaded inclusions, belonging to mixed manganese - iron sulfides. Both types of inclusions are endogenous, resulting from the specific smelting - deoxidation reactions that generates oxidic components, such as alumino-silicates and desulphurisation with the formation of mixed manganese - iron sulfides.

The inclusions state of all samples falls within the standardized norms, this being directly dependent on the chemical composition of all four samples, of OLT 45 steel.

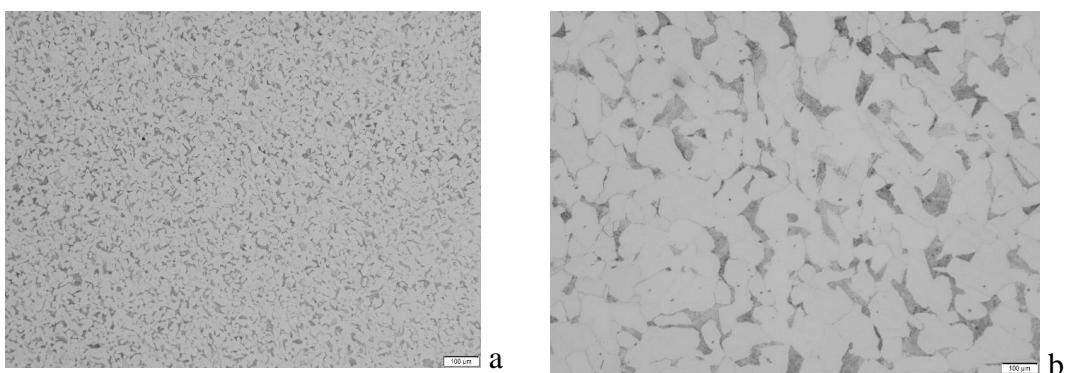
Fig. 7. Optical microscopy micrographs of sample 10, a) M=100x, b) M=500x, reagent Nital 2%

According to theoretical data, a non alloy steel, with a carbon content of about 0.25% as OLT 45 is, has a ferrite-pearlite structure, of about 65% ferrite and 35% lamellar pearlite. These structural details are visible in the four samples analyzed at 100:1 magnification. In addition, the structure is fine (grain size 6-7) which ensures the steel a proper operating behavior.

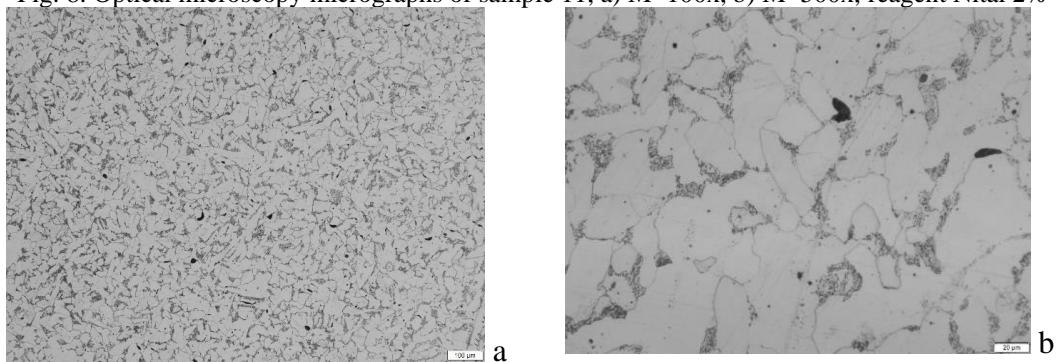
Fig. 9. Optical microscopy micrographs of sample 12, a) M=100x, b) M=500x, reagent Nital 2%

The metallographic analysis at 500:1 magnification comes with structural interesting informations: in sample 12, lamellar pearlite changes its morphology, acquiring a globular appearance. The spheroidization of pearlite is very evident in sample 13, which was the most strongly degraded by corrosion. One may mention that the spheroidization of pearlite (morphological changes from lamellar to globular) takes place at subcritical temperatures, lower than 728°C. The phenomenon starts at 350 - 400°C, becoming more pronounced as the temperature approaches the critical threshold (728°C). Being based on diffusion phenomena, the process essential parameters are temperature and time; the two are in inverse proportion relationship: the higher the temperature, the higher the transformation kinetics and the shorter the duration; the lower the temperature, the slower the kinetics and the longer the duration.

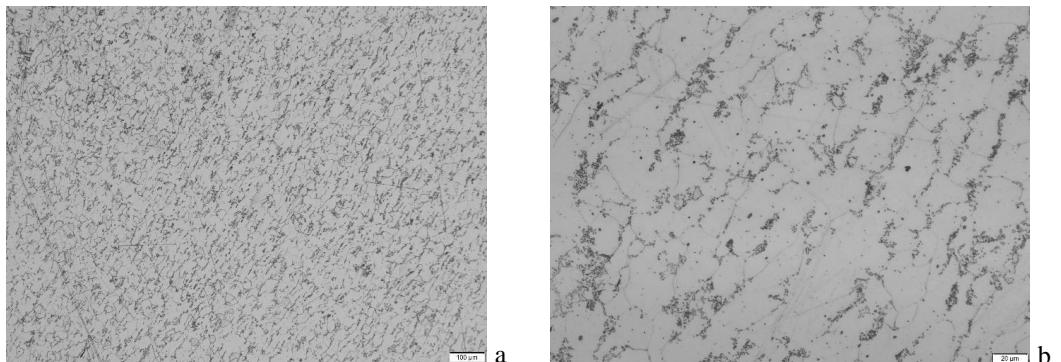
Fig. 10. Optical microscopy micrographs of sample 13, a) M=100x, b) M=500x, reagent Nital 2%

From a structural point of view, one may conclude that the pipes (especially pipe 13, the strongly affected by corrosion) have served far beyond their lifespan.

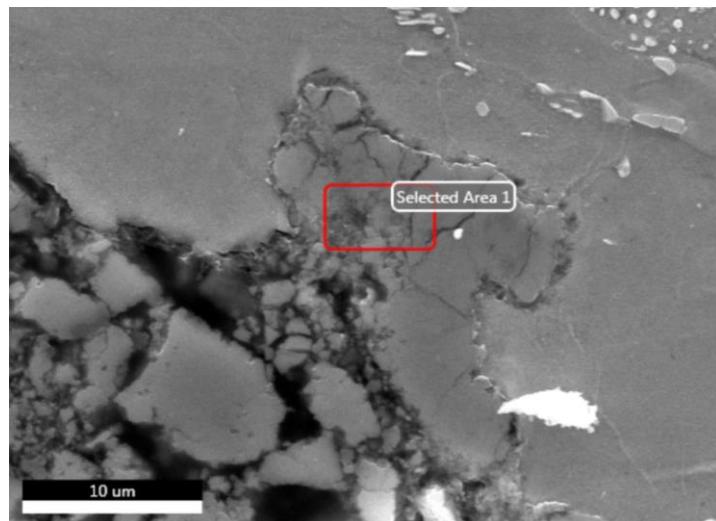
Fig. 11. Secondary electrons image of pipe 13 (Zone 2, Selected Area 1)

Fractured microzones are observed in both secondary electron images, their presence resulting in a strong discontinuity of the material. At the same time, the areas are characterized by a certain porosity, which suggests the existence of a high content of iron oxides. The local chemical analysis confirms, through the energy dispersion spectra, the existence of the atomic species Fe and O. In both areas, the local chemical composition is:

The atomic percentages of Fe compared to those of O are approximately equal (~ 1: 1) with a slight excess of iron. These data show that the type of iron oxide found is FeO.

According to chemical thermodynamic data [11], ferrous oxide FeO is stable at temperatures above 570°C, which shows that the operating temperature could have reached this much too high value. These results are perfectly in accordance with the optical microscopy studies that show, according to the structural changes, sufficiently long operating durations at temperatures over 350°C.
