EVALUATION AND CONTROL OF MICROBIOLOGICALLY INFLUENCED CORROSION (MIC) OF A PIPELINE USING A BIOFILM SAMPLING DEVICE

Mădălina ANDREI¹, Brândușa GHIBAN²

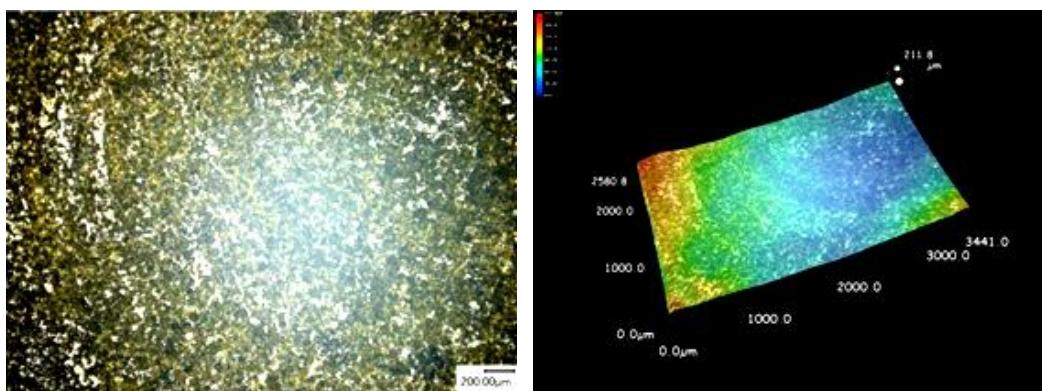
In monitoring campaign no.1, microscopic examination of the metal surface indicated general corrosion, the entire surface of the disk coupons being affected (Fig. 4).

Fig. 4. 2D (left) and 3D (right) micrographs of the metal surface showing general corrosion in monitoring campaign no.1, 100X

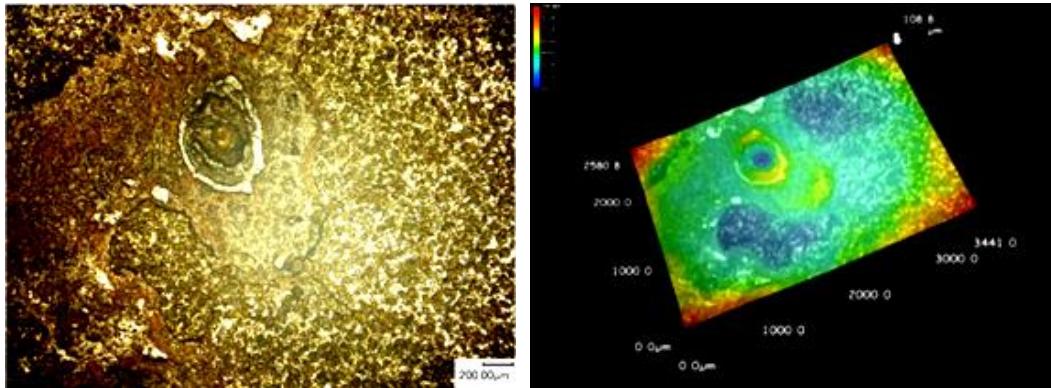
In monitoring campaign no.2, microscopic examination of the metal surface revealed the terraced pitting (Fig. 5), a morphological characteristic for MIC, consisting in a corroded area in terraced form, surrounded by general corrosion or non-corroded areas. The terraced pitting is usually attributed to SRB activity [14].

Fig. 5. 2D (left) and 3D (right) micrographs of the metal surface showing terraced pitting in monitoring campaign no.2, 100X

The morphologies specific of MIC on the surface of disk coupons were closely related to the diversity of bacterial population. In the case of a low bacterial activity, the effects of MIC were not identified by microscopic examination of the surface. After the number of bacteria increased, in monitoring campaign no.2, the appearance of terraced and localized shallow pitting, specific of MIC, was observed.

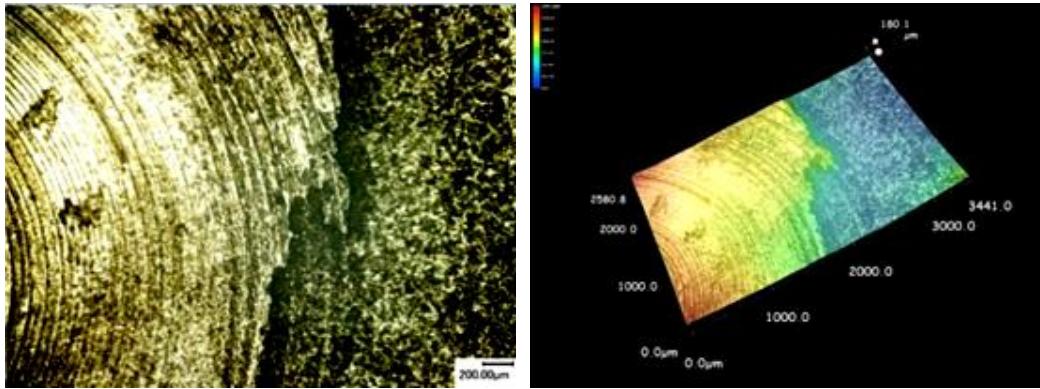
In monitoring campaign no.3, microscopic examination of the metal surface revealed corrosion under-deposit (Fig. 6), only a part of the surface was corroded, as the deposits accumulated. This corrosion type cannot be attributed directly to MIC.

Fig. 6. 2D (left) and 3D (right) micrographs of the metal surface showing corrosion under-deposit in monitoring campaign no. 3, 100X

Characterization of the metal surface revealed different corrosion morphologies, caused by the complexity of the deposits which accompany the biofilm. Therefore, corrosion control program should continue, in addition to biocide treatment, with the scale inhibitor treatment, depending on the results of chemical analysis of the deposits.

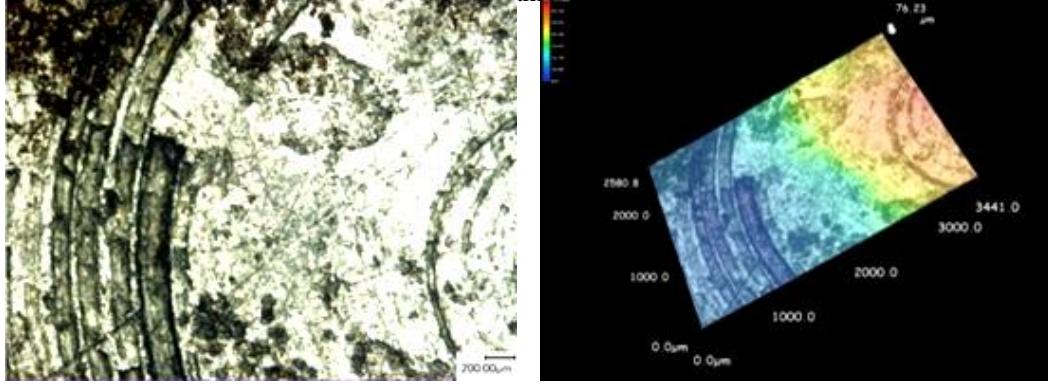
Fig. 7. 2D (left) and 3D (right) micrographs of the metal surface showing localized pitting and tunnelling effect in monitoring campaign no.4, 100X

In monitoring campaign no.4, microscopic examination of the metal surface revealed localized pitting and tunnelling effect (Fig. 7), another morphological characteristic for MIC, considered a sign of APB activity [14].

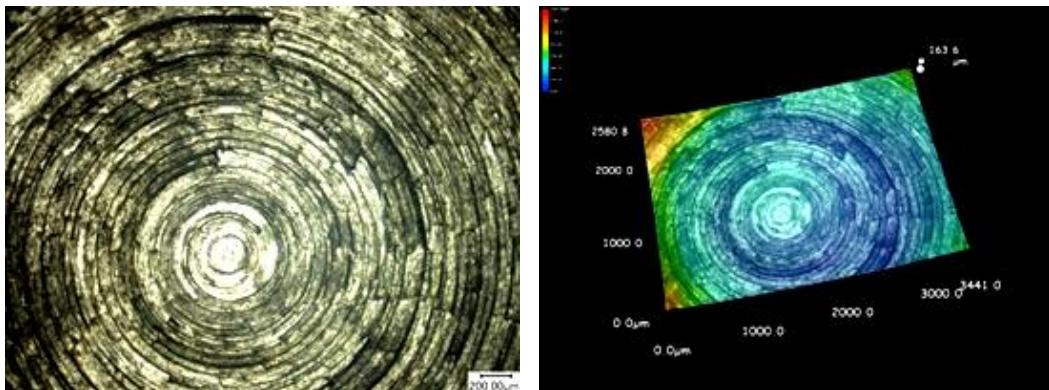
In monitoring campaign no.5, microscopic examination of the metal surface revealed low corrosion (Fig. 8), which can be correlated with reduced number of bacteria in biofilm.

Fig. 8. 2D (left) and 3D (right) micrographs of the metal surface showing low corrosion in monitoring campaign no.5, 100X

The general bacteria population progressively decreased during biocide treatment. The population of sulfate reducing bacteria decreased from a high number to a moderate population in the last monitoring campaign. Also, the number of acid producing bacteria in biofilm samples was low in the last monitoring campaign.

For prevention of the growth of bacterial population and the associated problems, such as MIC appearance and, respectively, the formation of iron sulphide, it is necessary to continue the alternatively treatment with the 2 biocides and to optimize the treatment concentration.

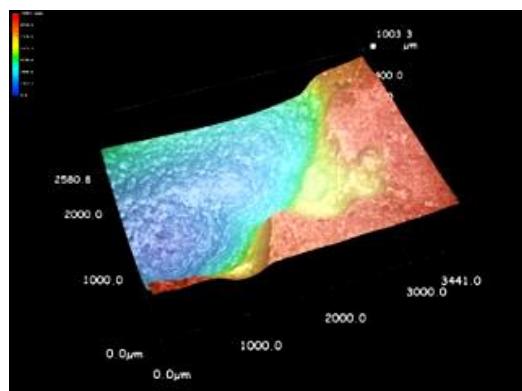
The corrosion type identified on the surface of corrosion coupons was severe and moderate, according to corrosion rate values. Also, the specific morphology of MIC, terraced pitting (Fig. 9), was observed in monitoring campaign no.4.

Fig. 9. 3D micrograph of the metal surface showing terraced pitting in monitoring campaign no.4, 100X

The efficiency of biocide treatment was also demonstrated by corrosion monitoring using corrosion coupons. There was a significant decrease of the corrosion rate, from 1.050 mm/year to 0.042 mm/year, after 6 months of treatment. The increase of the corrosion rate in monitoring campaign no.4 was caused by the higher concentration of suspended solids in the injection water and acidification of the oilfield.

More than that, in order to control the aggressiveness of the environment, filtration and separation of suspended particles are necessary along with corrosion inhibitor treatment, especially during acidifications.
