## ASSESSMENT OF PREMATURE DEGRADATION OF A GAS INJECTION PIPELINE DUE TO HYDROGEN RELEASED BY THE BENZENE HYDROFINING EQUIPMENT

*The present research aimed to identify the causes that led to the deterioration of a pipeline comprised in the benzene hydrofining equipment of a refinery. The pipeline ascending branch was perforated, therefore the installation was stopped in order to remove it and replace it.*

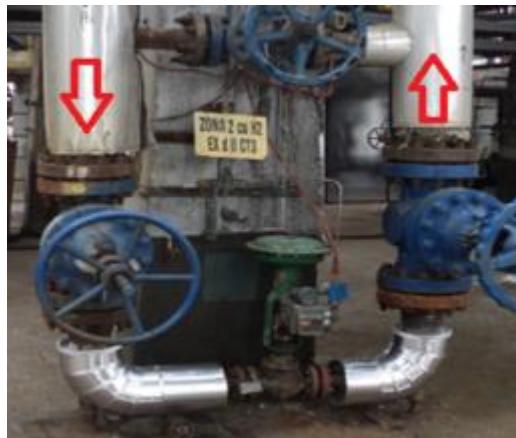
Fig. 1. The aspect of the pipe in the installation

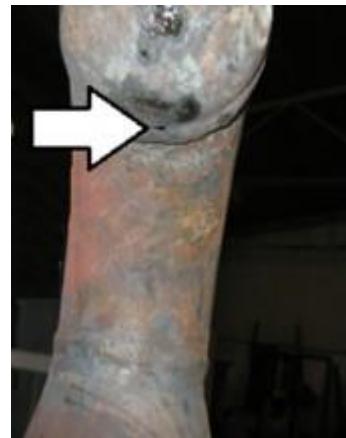
Fig. 2. Aspect of the area where the crack occurred

For the present study samples were taken in order to perform material analyses and also those made in order to establish the corrosion type. For this purpose, a section comprising the damaged area was extracted from the pipeline. The aspect of the pipe zone where the porosity responsible for the incident was located is shown in Fig. 2.

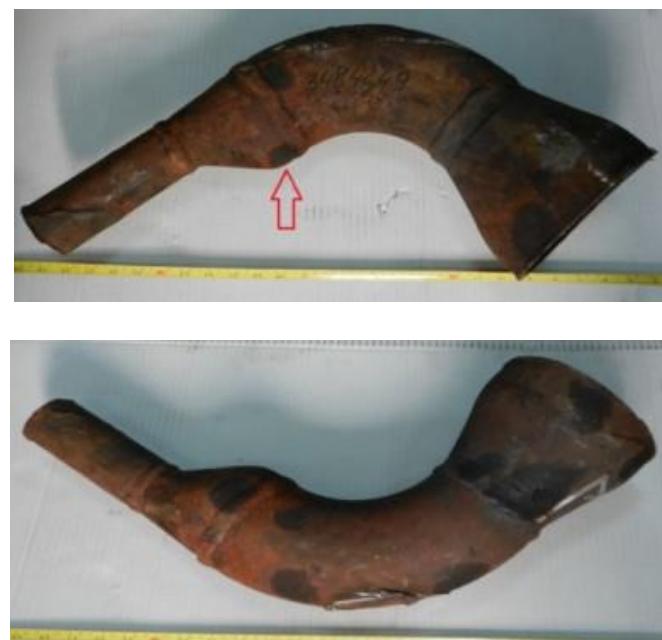
**Aspect.** The analyzed section of the pipeline, representing its ascending branch, is shown in Fig. 3 and contains the welded subassembly consisting of DN50 pipe, DN100 / DN50 eccentric reducer, DN100 pipe elbow and DN150 / DN100 eccentric reducer. One may observe that a different constructive solution was

applied to the execution of the subassembly than the one shown in Fig. 2, namely hot formed reducers were used instead of cone - cylinder welded reducers. The porosity indicated in Fig. 3 is located in the welded joint between the eccentric reducer DN100 / DN50 and the pipe elbow DN100.

Fig. 3. Locating the pipeline fault, face 1 and face 2

- the high values of the DN50 / DN100 reducer thickness of up to 14.5 mm as against to nominal 6.0 mm in the area of the DN50 pipe joint are noticeable; these were related to the unusual shape of the reducer (see Fig. 3) and the production technology of this part; in the area corresponding to the pipe GH-120-201 minimum radius, where the damage occurred, it is assumed that the eccentric deformation of the semi-finished product and the curvature made in order to bring its diameter to 114 mm were made with difficulty and could generate from the start an insufficient wall thickness of the semi-finished product; these issues raise concerns about the initial dimensions of the DN50 / DN100 eccentric reducer.

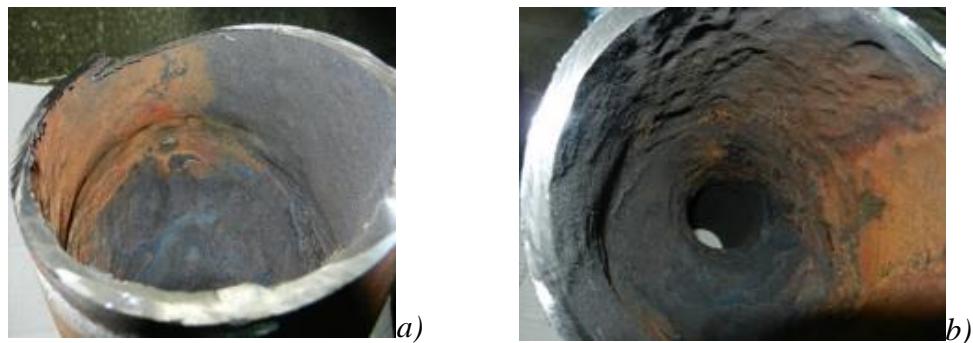
Inside the pipe the metal surface shows pronounced signs of general and pitting corrosion [2], including the welded seams areas, as seen in Fig. 4. The surface of the metal is mostly covered with dark deposits. The exception is the DN100 / DN150 reducer area, which, in the part corresponding to the large radius of curvature, shows deposits in the form of thin, reddish crusts. Samples were taken from each differently coloured deposition for analysis.

Fig. 4. Aspect of the pipeline coupon inner surface, with views in the low radius of curvature direction (a) and in the high radius of curvature direction (b)

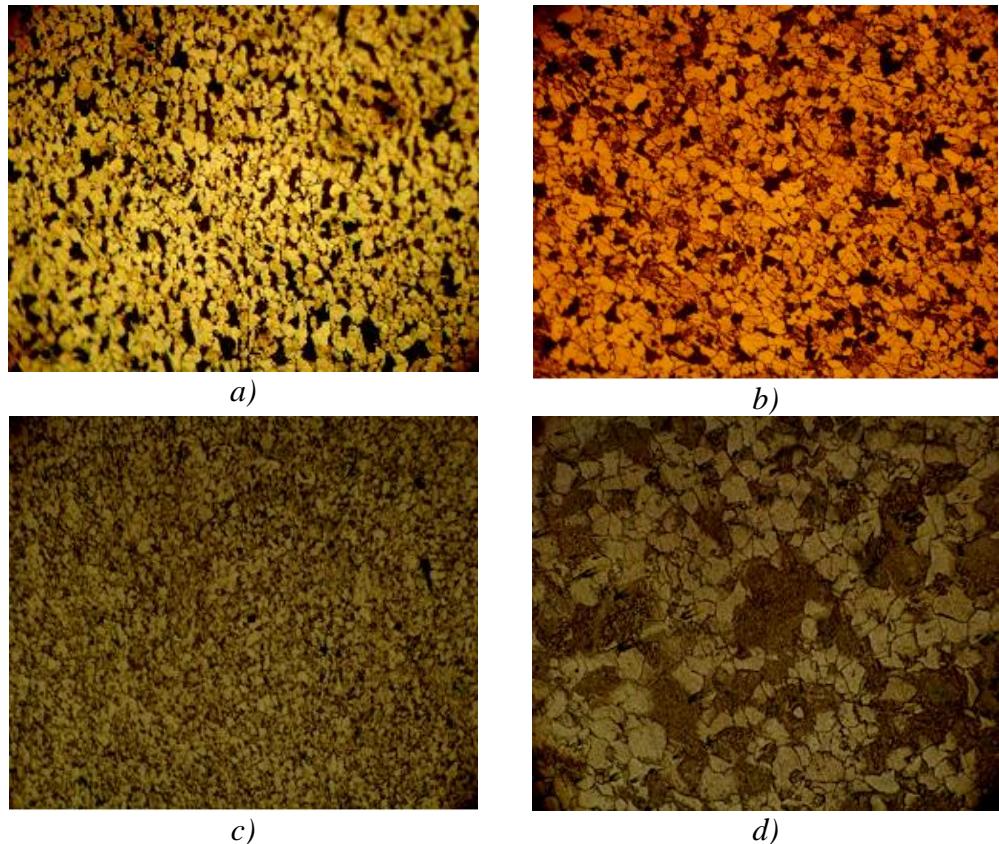
Optical microscopy investigations have shown that the DN50 pipe (Fig. 5a) and the DN50 / DN100 eccentric reducer (Fig. 5b) are not compatible with the prescribed treatment, being structures corresponding to normalizing only. However, the DN100 pipe elbow (Fig. 5c) as well as the DN100 / DN150 eccentric reducer (Fig. 5d) have structures in accordance with the indicated heat treatment. Concerning the eccentric reducer in Fig. 5d, an increased grain size is noticed, which suggests that the normalizing heat treatment (prior to subcritical annealing) did not strictly keep to the working parameters, which did not generate a proper grain size fineness, in accordance with the required norms.

Fig. 5. Optical microstructures of the pipeline components (Nital reagent,  $\times 100$ ): a) DN50 pipe, ferrite and pearlite, structure with fine grain size, score 8 according to SR ISO 643, corresponding to a normalizing heat treatment; b) eccentric reducer DN50 / DN100, ferrite and pearlite, structure with fine grain size, score 7-8 according to SR ISO 643, corresponding to a normalizing heat treatment; c) pipe elbow DN 100, ferrite and pearlite with a medium globulization tendency, structure with fine grain size, score 8 - 8.5 according to SR ISO 643, corresponding to a normalizing and sub-critical annealing heat treatment; d) reducer DN100 / DN150, structure consisting of ferrite and pearlite with a slight globulization tendency, but with a medium grain size, score 5 according to SR ISO 643: the structure corresponds to a normalizing and subcritical annealing heat treatment, but the normalizing exceeded either heat treatment temperature, or the holding time.

As a general observation, the four components' microstructures are different in terms of structure, but also in terms of grain size, which may be due to the microstructural features of the used products, as well as to the applied manufacturing technologies. It is assumed that the DN50 pipe and the DN100 pipe elbow were made of hot rolled pipe, because the configuration with an angle of 90° cannot be achieved by another technology, while the DN50 / DN100 and DN100 / DN150 eccentric reducers were made by a hot deformation technique involving changes in the walls thickness.

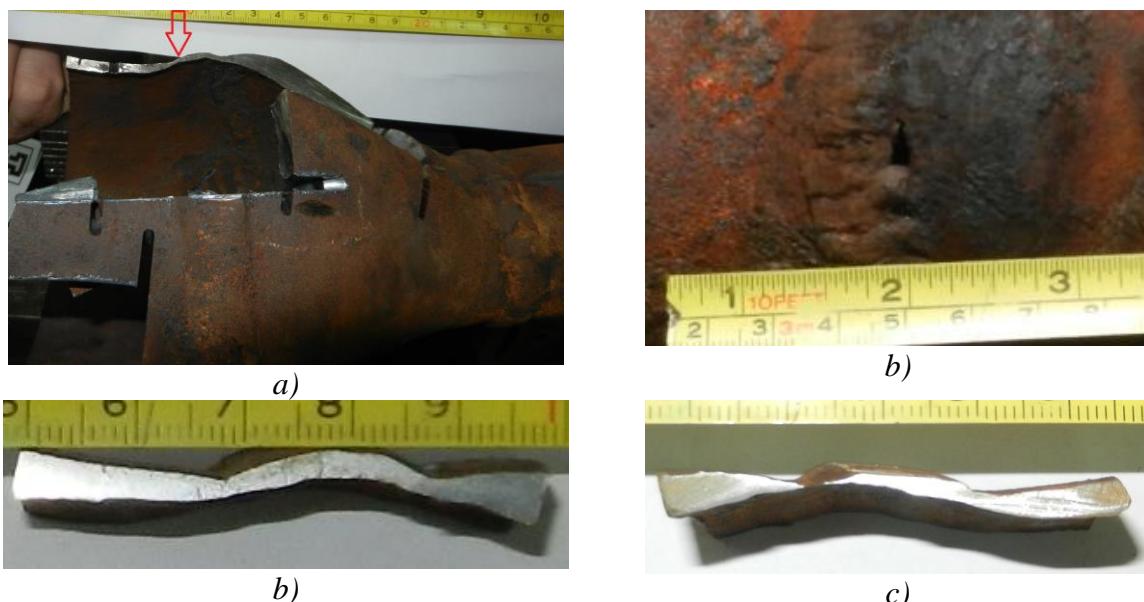
Fig. 6. The macroscopic aspect of the eccentric reducer DN50 / DN100 welded joint with the pipe elbow DN100 in the porosity zone. a) joint overview after sectioning; b) detail of the joint surface in the porosity zone; c) section in the pipe wall at 30 mm distance from the porosity; d) section in the pipe wall where the porosity is located.

The images show that the wall thicknesses are significantly smaller in the welded joint zone, when compared to those at distances of more than 10 mm from the joint. One may also note that the penetration of the wall took place in the welded seam.

- on the outer surface of the joint, the edges of the reducer and pipe elbow appear curved inwards, an unfavorable situation for the stress level of the joint;
- the width of the welded seam is large, with values up to 19 mm on the joint circumference, namely up to 2.4 times greater than the nominal wall thickness;
- the height of the welded seam is approximately 4 mm as compared to maximum 2.2 mm for the intermediate acceptance level corresponding to the base material thickness of 8 mm [5].

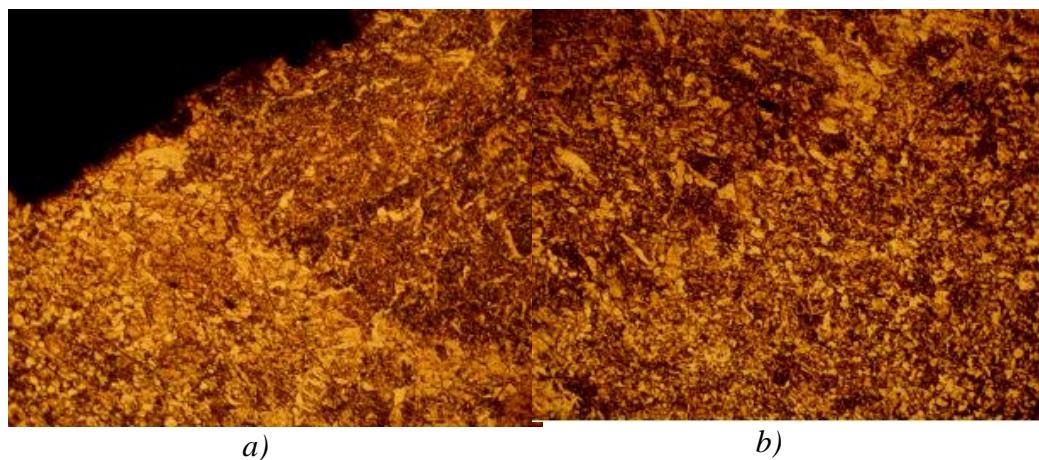
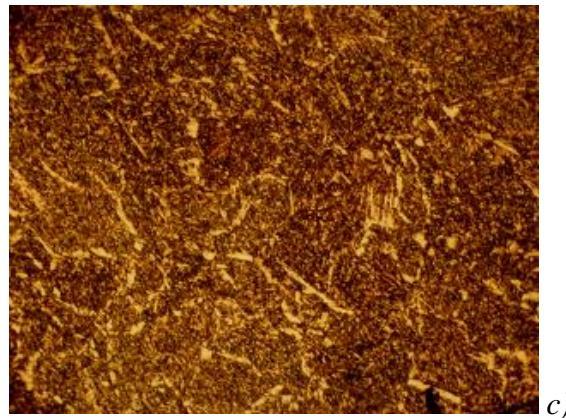
Optical microscopy examination of the welded joint was performed in cross sections, placed at the limit of the position where the porosity was identified. Fig. 7 shows micrographs of the heat - affected zones of the DN50 / DN100 eccentric reducer, respectively of the DN100 pipe elbow, as well as of the welded seam [2].

Fig. 7. Microstructure of the eccentric reducer DN50 / DN100 with pipe elbow DN100 welded joint, in sections near the porosity (Nital etching,  $\times 100$ ); a) heat - affected zone towards the DN50 / DN100 reducer, mixed structure formed by bainite, fine pearlite and ferrite; b) heat - affected zone towards the DN100 pipe elbow, mixed structure formed by bainite, fine pearlite and ferrite; c) welded seam, structure formed by networks of ferrite, fine pearlite and traces of bainite. The structure preserves the disturbed character of a non-homogeneous, dendritic austenite from whence it derives.

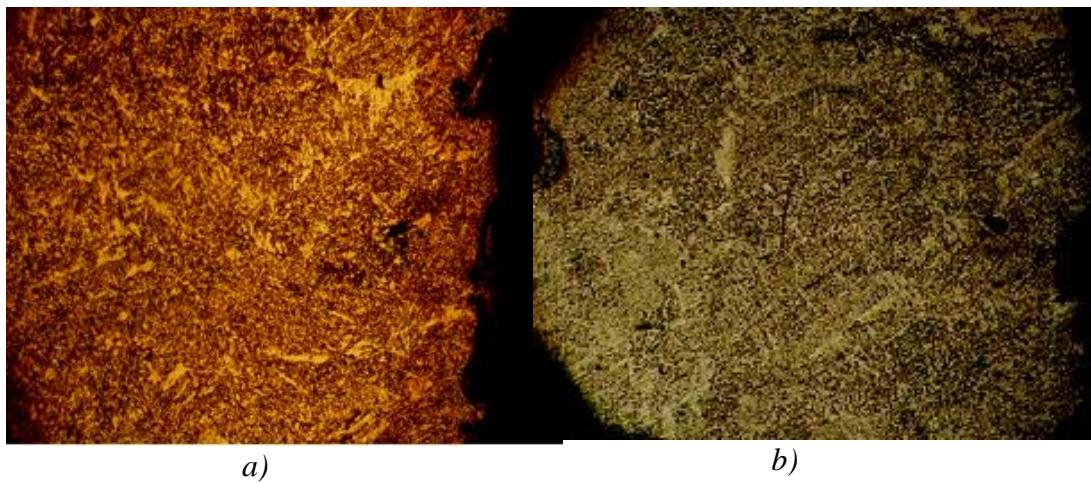
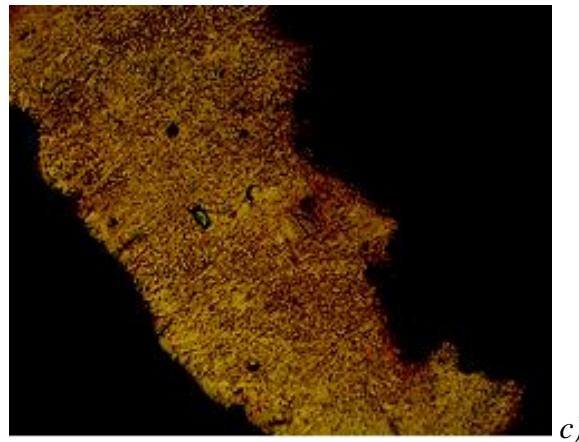
Fig. 8. Microstructure of the welded joint at the porosity boundary (Nital etching,  $\times 100$ ); a) traces of the welded seam at the joint boundary with the DN50 / DN100 reducer; b) welded seam thinned (damaged) by corrosion; c) continuation of the welded seam thinned (damaged) strongly by corrosion until piercing.

One may observe that the failure resulted from the metallic wall advanced degradation by general and pitting corrosion. No structural effects have been reported to justify any other type of failure in operation than those specific to corrosion [2].

**3.** It is recommended to revise the execution design for the DN50 / DN100 and DN100 / DN150 reducers, to re - manufacture the entire pipeline ascending

branch as a spare part, paying attention to a careful execution, applying the appropriate heat treatments for all hot formed parts, including the post - welding heat treatment, which is to be applied only once, after making all of the welded joints.

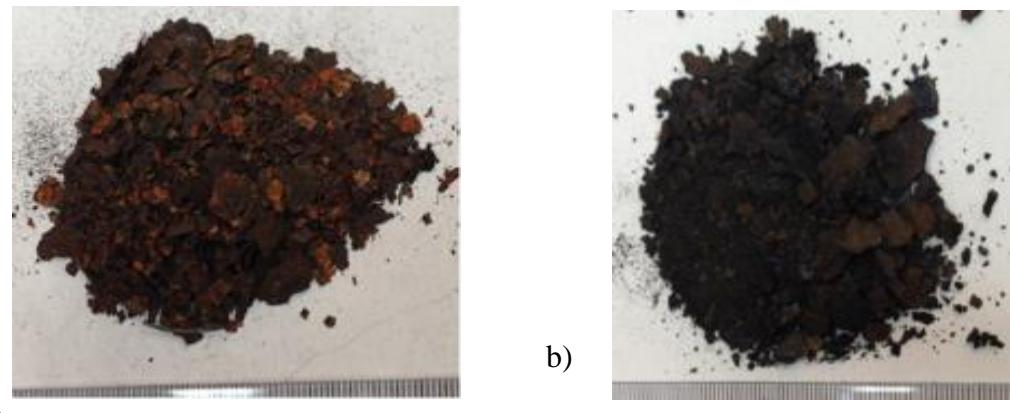
Fig. 9. Macroscopic aspect of deposit samples extracted from inside the pipeline; a) the reddish coloured sample taken from the DN100 / DN150 reducer area; b) the dark coloured sample taken from the DN100 pipe elbow area.

The results of X-ray fluorescence analyses are given in Table 6, in which the sulphur and chlorine contents are to be noted.

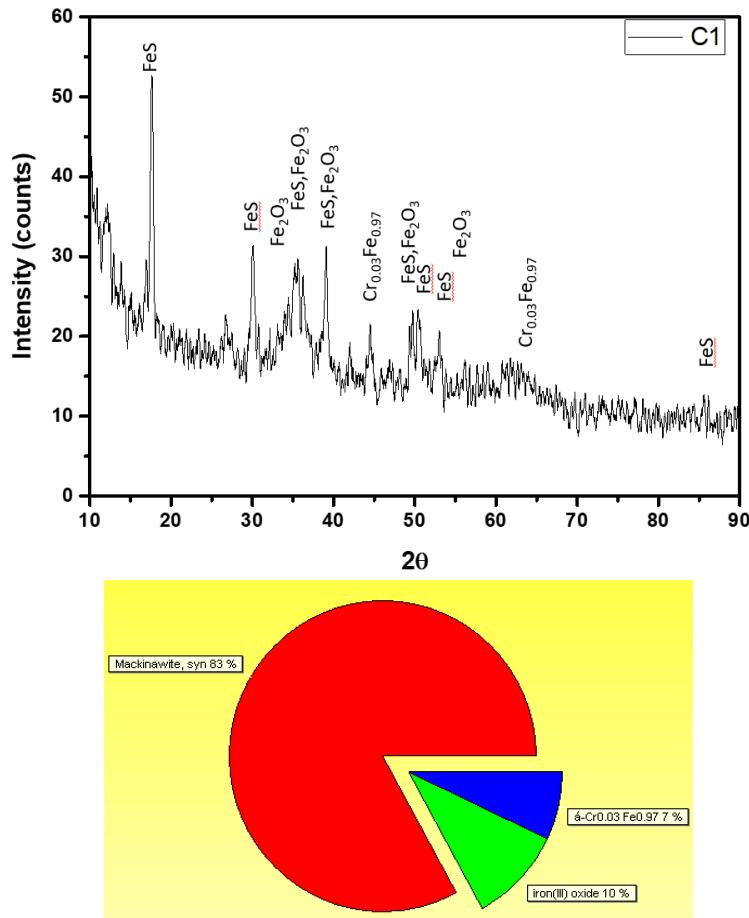
Fig. 10. X-ray diffraction analysis of the reddish compounds sample taken from the DN100 / DN150 reducer zone.

It is observed that, in addition to iron sulphide, both samples contain in various forms iron oxides, an aspect which indicates the presence of water in the hydrogen-rich gases of the recirculation system.

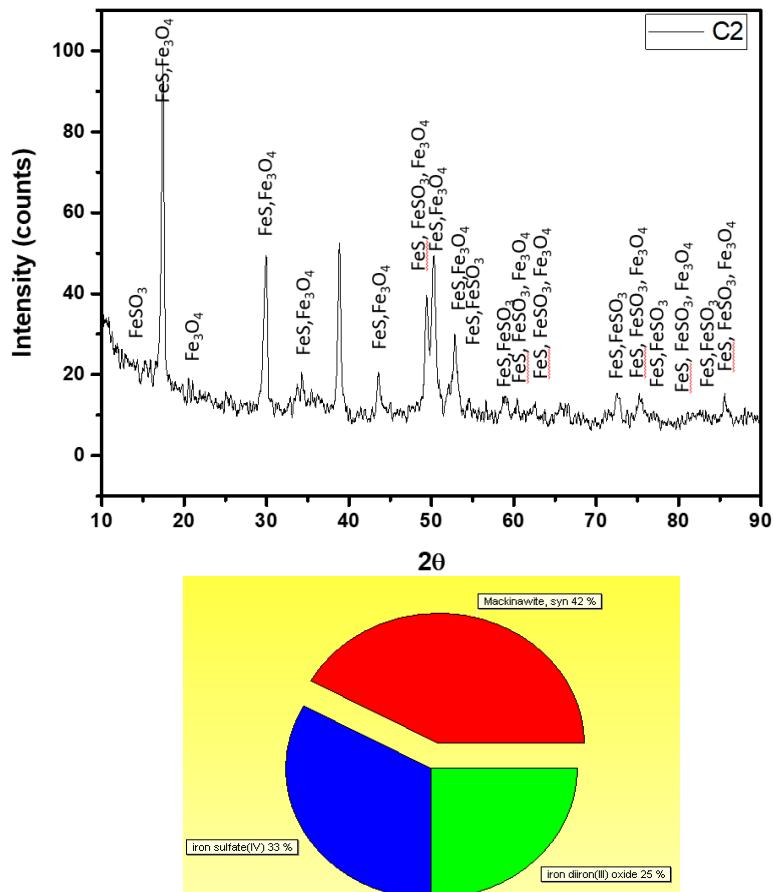
Fig. 11. X-ray diffraction analysis of the dark coloured compounds sample taken from the DN100 pipe elbow zone
