EVALUATION OF THE CONSERVATION STATUS OF THE FOUNTAIN ENSEMBLE FROM BRĂILA'S TRAJAN SQUARE, USING LASER INDUCED BREAKDOWN SPECTROSCOPY

Monica SIMILEANU¹, Roxana RADVAN², Dumitrel PANDREA³

Keywords: LIBS, stratigraphy, corrosion, cast iron

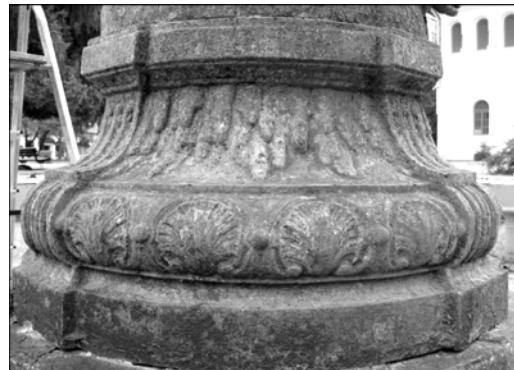
Fig.3. Detailed view of the metal base

From the visual investigation of the statue ensemble, it was clear that numerous layers of primer and paint brush were applied over time, a more thorough investigation being necessary in order to identify exactly the elemental composition of the layers applied on the original surface, without sampling.

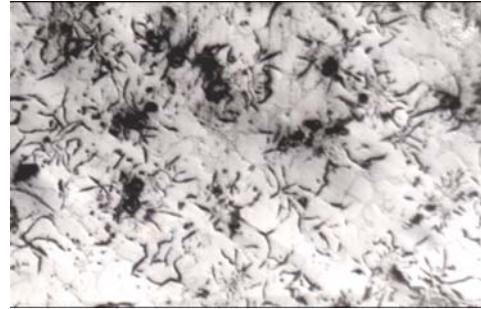
Fig. 5. After Nital 2%, 150x magnification

Based on the investigations made on the original sample, the structure of the metal was identified as soft cast iron with vermicular graphite at the limit of ferrite grain and interstitial graphite nests (see Figure 5). This alloy presents a high structural content of phosphorous eutectic (P between 0.9% - 1.2%) characteristic to the casting of thin pieces and decorations due to its high fluidity.

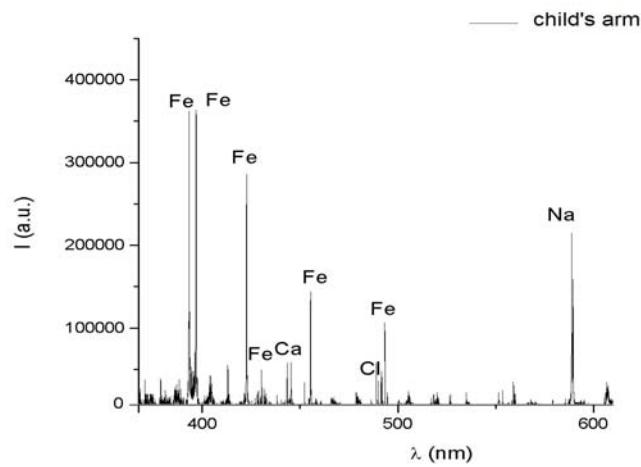
Fig.7. double pulse LIBS spectra acquired on the arm of one of the child statues

The major chemical elemental lines present in the spectra are: Fe - as expected, but also Ca, Mn, Na and Cl lines.

From the visual and microscopically examination there were noticed layers of rust, but the Cl lines are the ones that may indicate problems.

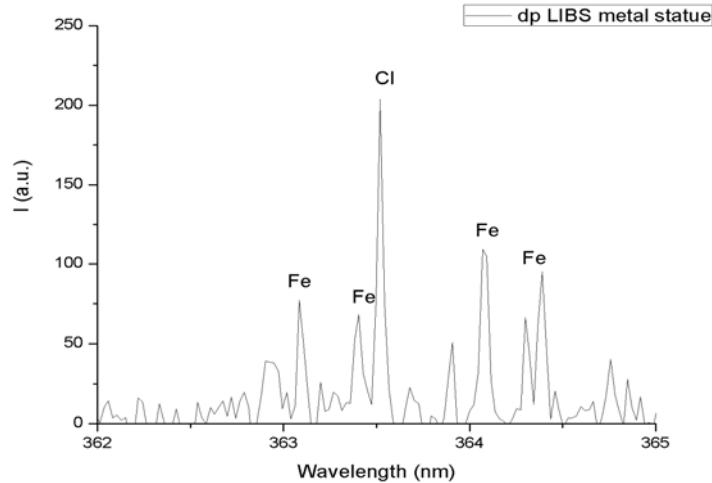
Fig.8. double pulse LIBS spectra selection for Fe and Cl lines visualization

But in the case of the fountain metal surfaces the situation is critical, as proved by the following LIBS spectrum.

The protective rust layer is clearly deteriorated and most probably presents fissures that allow water to infiltrate between it and the original layer, where FeCl_2 is formed, that is shortly followed by the incidence of acidic corrosion. Taking into consideration the permanent flux of water, this process will go on and on, further affecting the original layer.

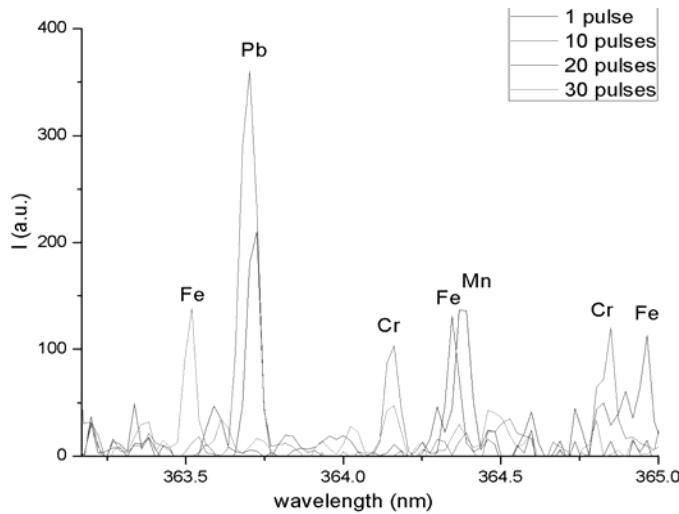
Fig. 9. Stratigraphy investigations: 1 to 30 pulses

In Fig. 9. there is presented a selection of the LIBS stratigraphy spectra acquired using a delay of 2 μs , gatewidth = 6 μs , gain = 220. From the spectrum, Pb lines were identified by the middle pulse, proving that lead based paint was once applied on the metal surface. Some Cr lines appear in the stratigraphy layers above the lead, fact which implies that the casted iron statue underwent chromium based treatment, also. We can observe that as we go deeper in the stratigraphy with the number of pulses, Fe lines come into sight.

From the stratigraphy investigations undertaken with the help of LIBS technique, the presence of several distinct paint layers were noticed (based on lead or manganese). Also, the pulse by pulse investigation had as a result an elemental map that will be used for the restoration procedure that will follow soon.

As was described before, LIBS stratigraphy investigations are very useful for laser cleaning monitoring. The evaluation of the cleaning depth can easily be made using this technique that generates pulse with pulse a chart of the elements present in the investigated micro-layer. Therefore, in the case of laser cleaning of thick layers of adherent deposits interposed between different levels of paints, we can have an accurate map that can guide us through the right steps.
