# EXPERIMENTAL ANALYSIS AND CONTROL OF WHITISH INDUCEMENT AT CORNER OF BLUNT TRAILING EDGE OF FAN BLADE

*It is a difficult problem to study the cause of whitening of the corner of blunt trailing edge of fan blade after vacuum perfusion molding. The causality analysis method is used to summarize and analyze the causes of the whitening of the corner of blunt trailing edge of fan blade and determine the main factors affecting it. Through in-depth analysis and experimental demonstration of raw materials (pouring resin, core material, etc.) and layering structure design used in the process of making fan blades, the measures to effectively control the blanking at the corner of blunt trailing edge of fan blades are put forward. The results show that all the influencing factors can have certain influence on the corner whitening of the blunt trailing edge of the fan blade. This study can provide reliable basis and theoretical basis for the study of product quality and blunt trailing edge of fan blade.*

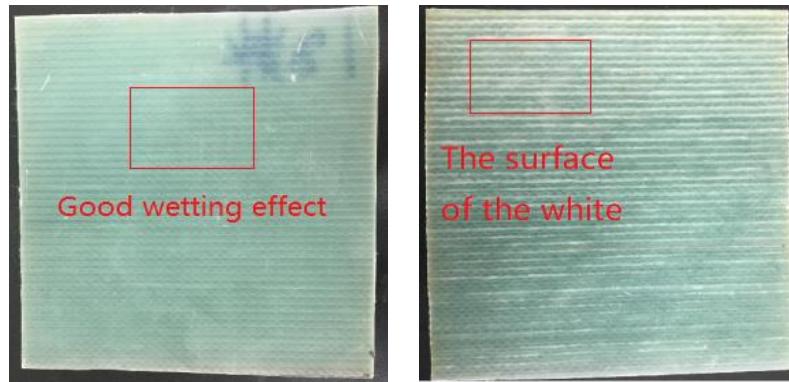
By comparing and analyzing the trial production sample 1 (as shown in Fig. 3) and trial production sample 2 (as shown in Fig. 4), the trial production sample 1 (using resin after defoaming treatment) has a good molding effect, and no related infiltration defects occur on its surface. Trial production sample 2 (using undefoamed resin) has a poor molding effect, with more white streaks on its surface.

Fig. 3 Trial-produced sample I

Fig. 4 Trial-produced sample II

The resin bubble perfusion on leaves has a great influence on the forming of leaves, especially the corner area of blunt trailing edge. The resin with good defoaming effect has a good curing effect on the surface after the resin is perfused and formed, and there is no whitening and other infiltration defects. The effect of defoaming is poor or the resin without defoaming is poor after perfusion molding. The corner area in the blunt trailing edge of leaves is more likely to produce white, bubble aggregation and other infiltrating defects. It is suggested that epoxy resin should be treated with single-component or two-component defoaming respectively in the process of leaf production. If production conditions permit, it is recommended to use the online all-in-one machine for perfusion of all blade components. The online all-in-one machine has the advantages of good defoaming effect and automatic control of resin flow. The resin flows directly into each blade component through the pipe from the online all-in-one machine, preventing the resin from contacting the air.

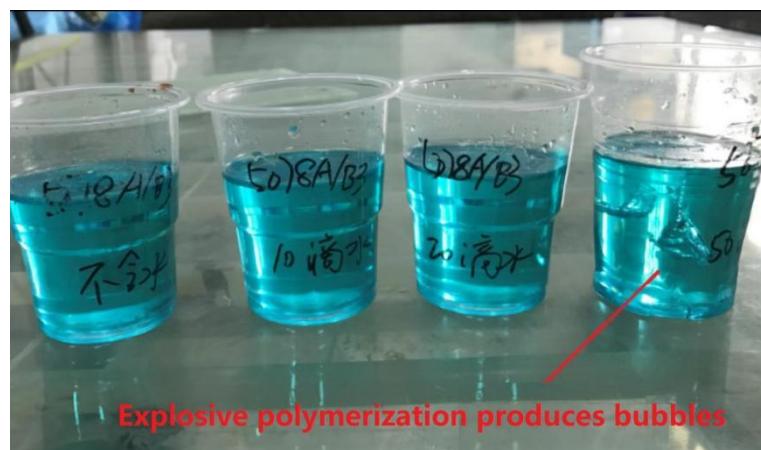
Fig. 5 Morphology of cured resin at room temperature

Through the experimental analysis and theoretical calculation, in a certain range, moisture can effectively promote the curing reaction of resin, shorten the curing time; When the moisture content in the resin is 1.3%~1.5%, the resin will produce bubbles in the curing process because of the explosive polymerization, resulting in the curing of the leaf white phenomenon.

When the moisture content of the core material reaches 1.3%~1.5%, the water and the resin combine and react during the curing process of the leaf, leading to the occurrence of the resin explosion and whitening defect. Therefore, when laying Balsa wood core material in the process of making leaves, the moisture content of Balsa wood in the corner area of blunt trailing edge should be controlled, which can effectively reduce the whitening defect in the corner area of blunt trailing edge of leaves and improve the quality of leaf products.

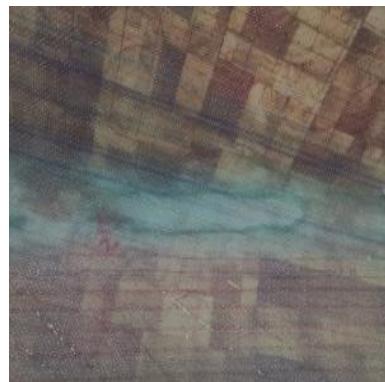
Fig. 12 No cooling, corner gap

a. As shown in Fig. 12, there is a gap in the corner area, and the highest curing temperature of the blade without cooling measures is between 99°C and 115°C, and the corner area is seriously white. After polishing the white area, it is found that there is a certain resin rich phenomenon.

By comparing and testing 76A(LZ) and 76(LZ) bladed trailing edge structures, it is concluded that if the corner structure layer of blunt tail edge is all covered with glass fiber cloth layer, when cooling measures are taken during the vacuum perfusion process, there will be no whitening defects in the corner area. If the corner structure layer of the blunt tail edge is laid with an inner and outer glass fiber cloth layer, and the core material structure is contained in the middle, the gap between the cloth layer and the core material and the high temperature of curing occur in the production process, which will lead to white defects in the corner of the blunt tail edge. By refining the operation instructions of the corner area, standardize the operation mode of employees, ensure that there is no gap in the corner area, and effectively reduce the white defect of the blunt tail edge corner caused by the gap of the layer; At the same time, in the curing process, cooling measures are taken to avoid high temperature in the corner, which can effectively reduce the white defect of the blunt end edge corner caused by high temperature.

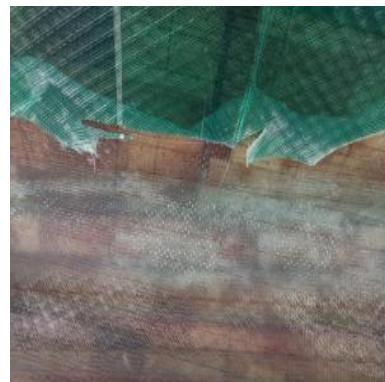
Fig. 13 No cooling, no clearance in corner

c. As shown in Fig. 13: there is no gap in the corner area, and the highest curing temperature of the blade without cooling measures is between 84°C and 93°C, and the corner area is slightly white. After polishing the white area, it is found that there is no resin rich phenomenon.

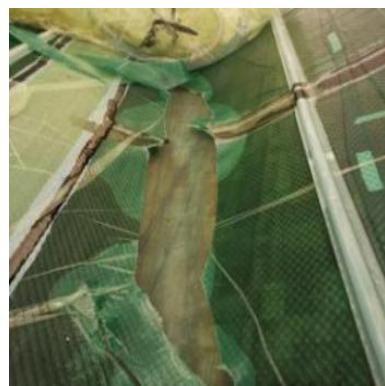
Fig. 14 Cooling, corner gap

b. As shown in Fig. 14, there is a gap in the corner area, and the highest curing temperature of the blades that take cooling measures during curing is between 75°C and 86°C, and the corner area is slightly white. After polishing the white area, it is found that there is a certain phenomenon of rich resin

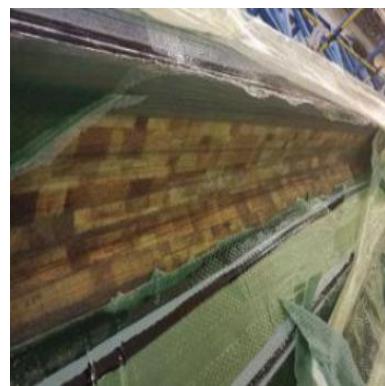
Fig. 15 Cooling, no clearance in corner

d. As shown in Fig. 15, there is no gap in the corner area, and the highest curing temperature of the leaves that take cooling measures in the curing process is between 65°C and 72°C. There is no whitening in the corner area, and there is no resin rich phenomenon.
