INFLUENCE OF MECHANICAL CHARACTERISTICS ON THE OPERATING BEHAVIOR OF COMPRESSORS INTAKE AND EXHAUST VALVES MADE OF INCONEL X750 SUPERALLOY

Andrei GRECU¹, George COMAN^{1*}, Andrei BERBECARU¹, Ecaterina MATEI¹, Ioana GHERGHEȘCU¹, Andra PREDESCU¹, Sorin CIUCĂ¹, Cristian PREDESCU¹

The objective of the research is to establish the causes that led to the shutdown of a recirculation compressor following the failure of several springs in the intake and exhaust valve system. The Inconel X750 superalloy is known as a material with excellent corrosion and mechanical performance in a wide range of temperatures and working environments, being used for highly stressed components in steam turbines, gas turbines, petrochemical equipment or nuclear energy. The choice of Inconel X750 superalloy for the execution of valve springs of compressors is correct, it has mechanical characteristics in a relatively wide band, depending on the applied heat treatment.

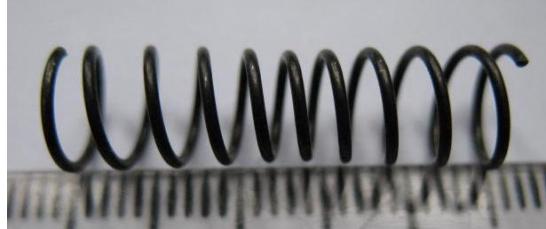
29 valve springs made of 0.7 mm wire, with different features, were analyzed. 13 springs, 9 unbroken and 4 broken, are of a darker colour (Fig. 1), while 16 other springs, all broken, are light coloured (Fig. 2), suggesting easier working conditions or shorter working times when compared to the dark colored ones.[2]

Fig. 1. Full spring with 10 coils, dark coloured.

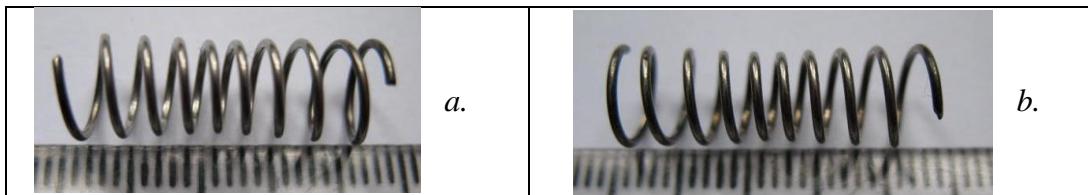
Fig. 2. Light - colored spring fragments
a) fragment with 9 coils; b) fragment with 9 and 1/4 coils.

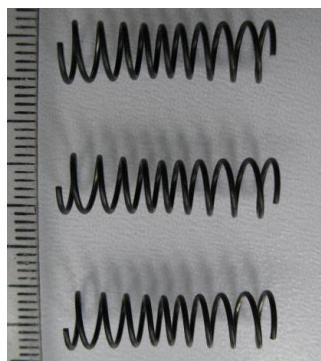
The typical aspect of the unbroken springs end zones is illustrated in Fig.. 3. One may see that, at both ends of the spring, the last coil is slightly bent over a length equal to approximately $\frac{1}{4}$ of the circumference. In fact, the springs do not have the ends formed in such a way as to present parallel seating surfaces on the entire circumference, which would be the needed geometry in order to ensure a correctly submitted stress during axial compression.[3],[4],[5],[12]

Fig. 3. Typical aspect of unbroken springs end zones

The last coil at each spring extremity is slightly bent over a length that covers approximately $\frac{1}{4}$ of the circumference, but none of the examined springs had the ends shaped in such a way as to present parallel seating surfaces on the entire circumference, specific to the geometry needed to ensure a correct stress applied on the spring in axial compression.

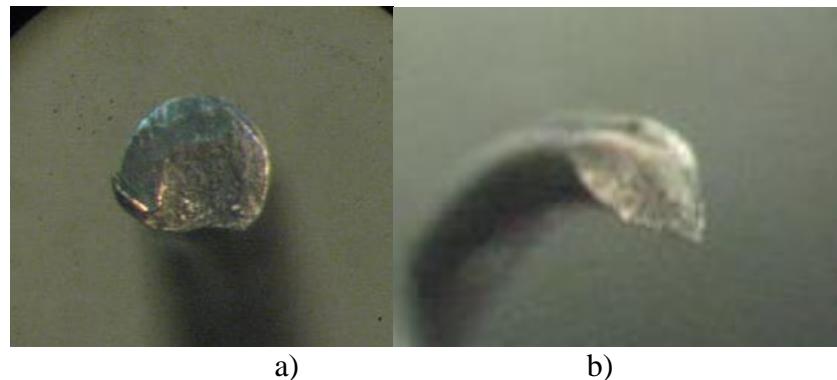
some springs show traces of friction, both on the inner and outer diameter [6]. Observed under the optical microscope, the ends of the unbroken springs (Fig. 4a) can be easily differentiated from those of the springs that failed in service (Fig. 4b).

Fig. 4. Spring end profile view: a) unbroken spring; b) broken spring

- the springs broke as a result of combined torsional and bending stresses, which is why the breaking surfaces are relatively flat and have a 45° axial tilt (Fig. 4.b);

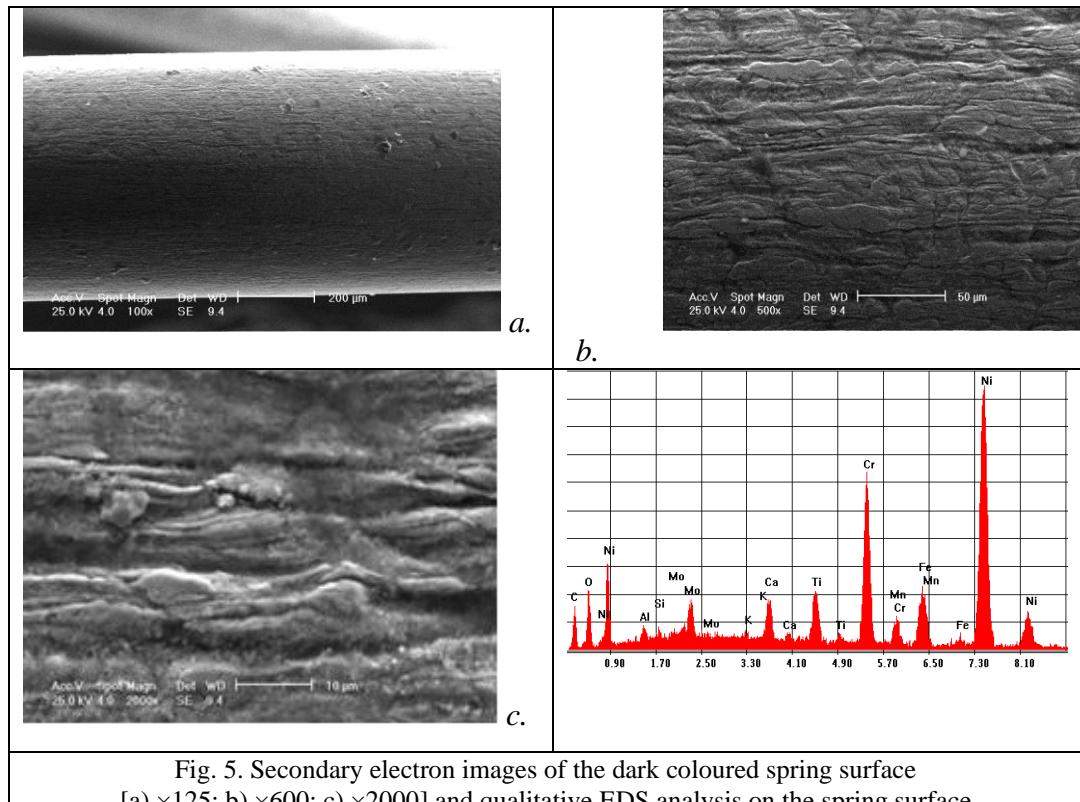
The surfaces of the dark-coloured springs appear relatively uneven along the wire pulling direction. Obviously, the morphology change resulted from the metal interaction with the technological medium. The examination also identified the presence of compounds containing carbon and oxygen on the surfaces, elements that are not present on the light-coloured surfaces. However, a connection between the darker coloured springs surfaces unevennesses and the operating behavior of the respective springs could not be highlighted.

Fig. 5. Secondary electron images of the dark coloured spring surface [a) $\times 125$; b) $\times 600$; c) $\times 2000$] and qualitative EDS analysis on the spring surface

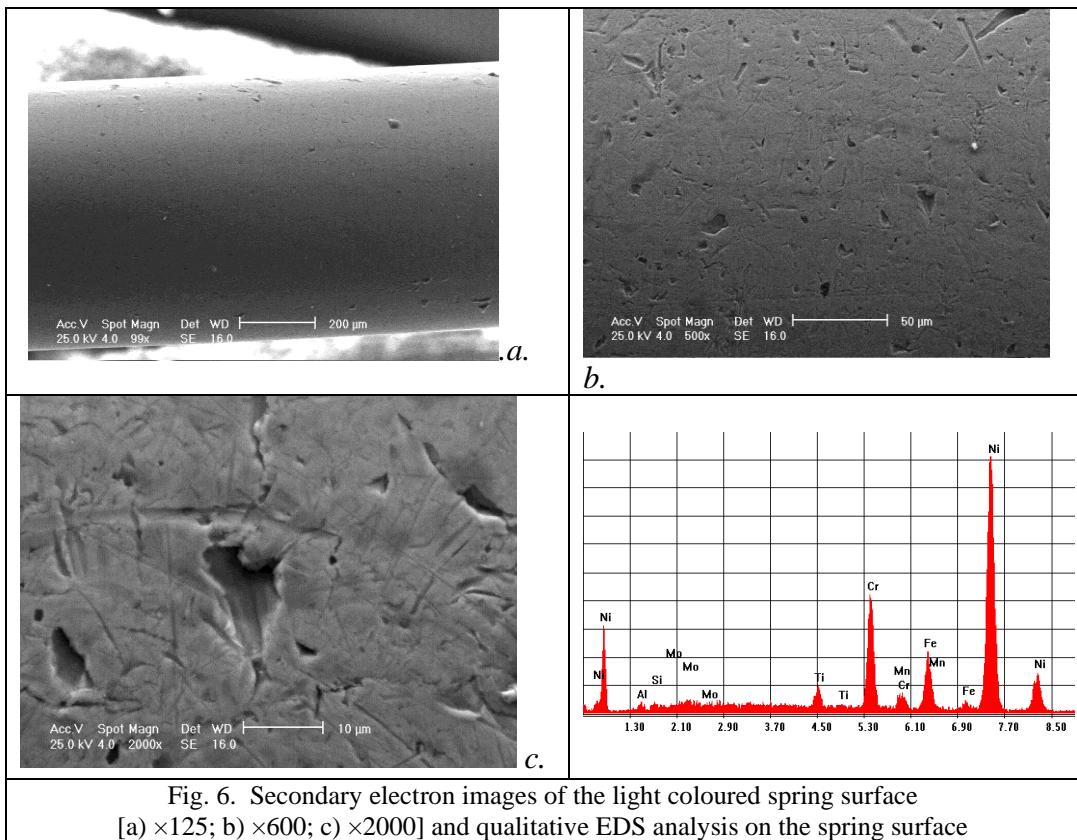
Light-coloured spring surfaces appear relatively clean up to high magnifications. Hard (undeformed) precipitates representing carbides of Nb, Ti and Cr can be observed in the matrix as well as small voids probably resulted from precipitates tearing from the same matrix. [7] [11]

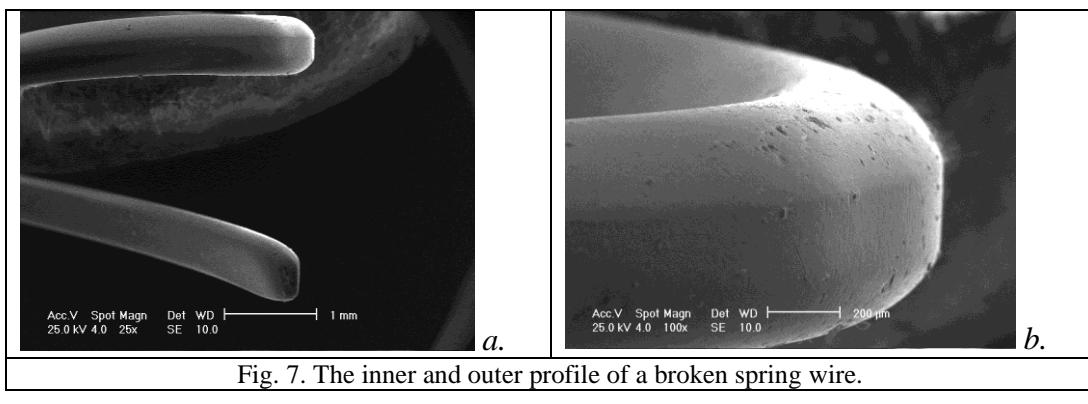
Further on the spring wire profiles near the breaking surfaces were analyzed. Fig. 7 shows a spring coil inner and outer surface close to the spring extremity and Fig. 8 shows the inner surfaces of some broken springs. The images reveal traces of wear processes that affected the spring wires circular profile. These effects can be considered as resulting from two probably interdependent actions: a) spring incorrect displacement under load as a result of the end zone defective profile; b) large spring deflections that determined contact and overlapping of adjacent coils of the springs extremities.[8] [11]

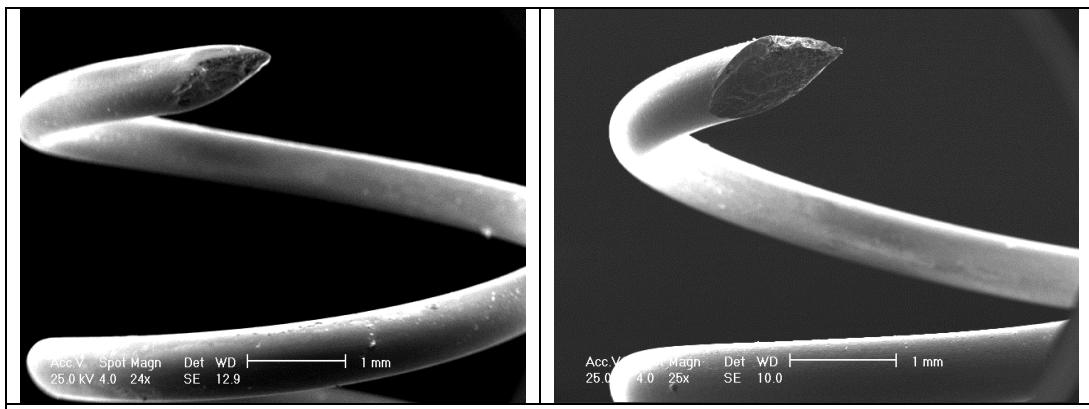
Fig. 8. The wire aspect inside some broken springs.

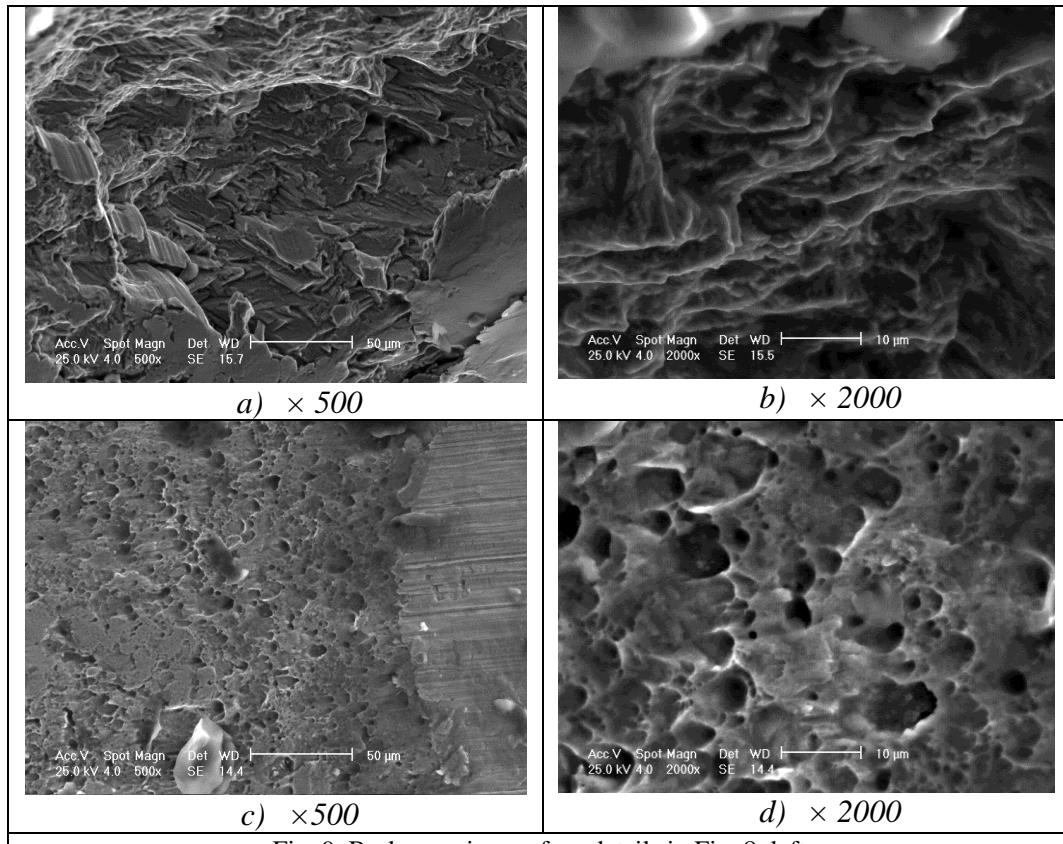
Fig. 9. Broken spring surface details in Fig. 8, left.

- after a progressive evolution of the crack front, failure occurred suddenly due to overloading of the remaining section (Fig. 9 c, d). Kink bands seen in Fig. 10 b are structures common in metals plastic deformation, fracture being the final effect of it.

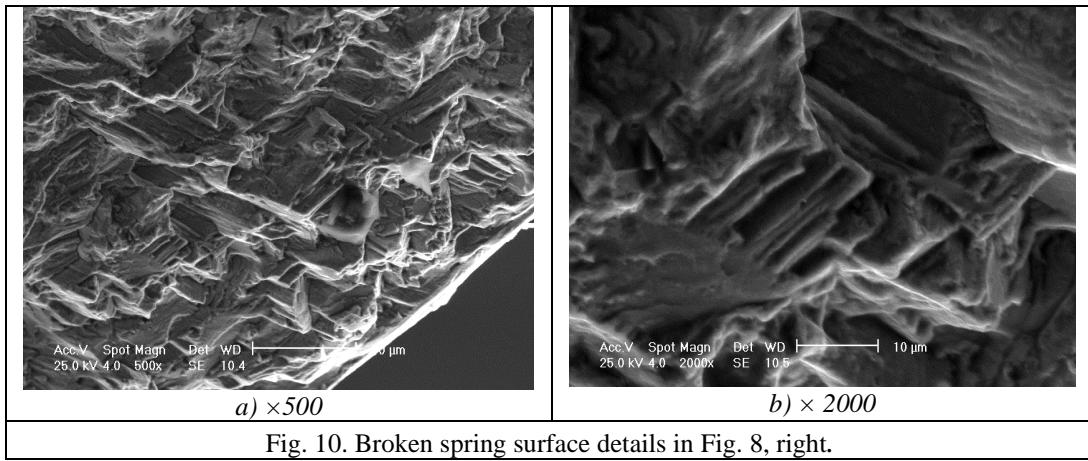
Fig. 10. Broken spring surface details in Fig. 8, right.

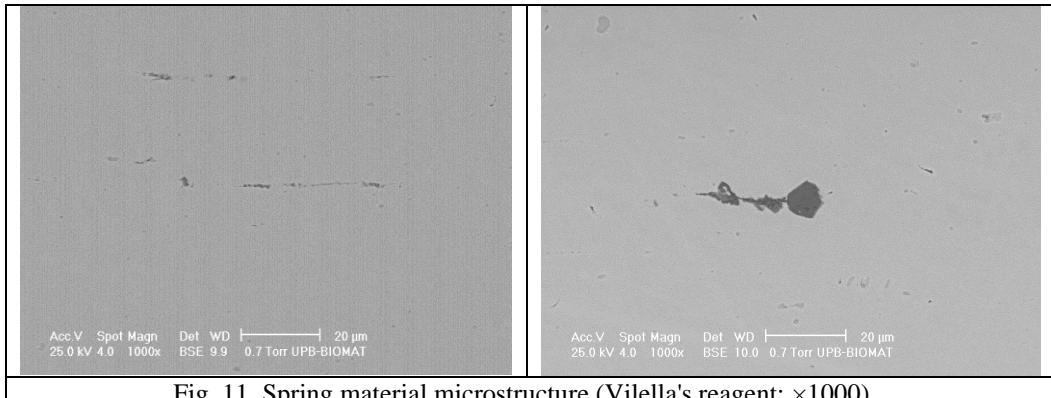
Fig. 11. Spring material microstructure (Vilella's reagent; $\times 1000$)

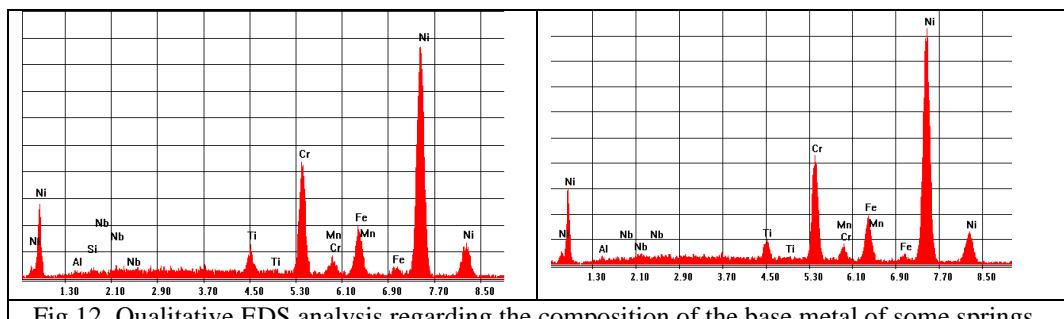
The X-ray emission spectra obtained in various areas of the austenitic matrix are given in Fig. 12. Quantitatively, the main atomic elements contents of the alloy are given in Table 2.

Fig.12. Qualitative EDS analysis regarding the composition of the base metal of some springs.

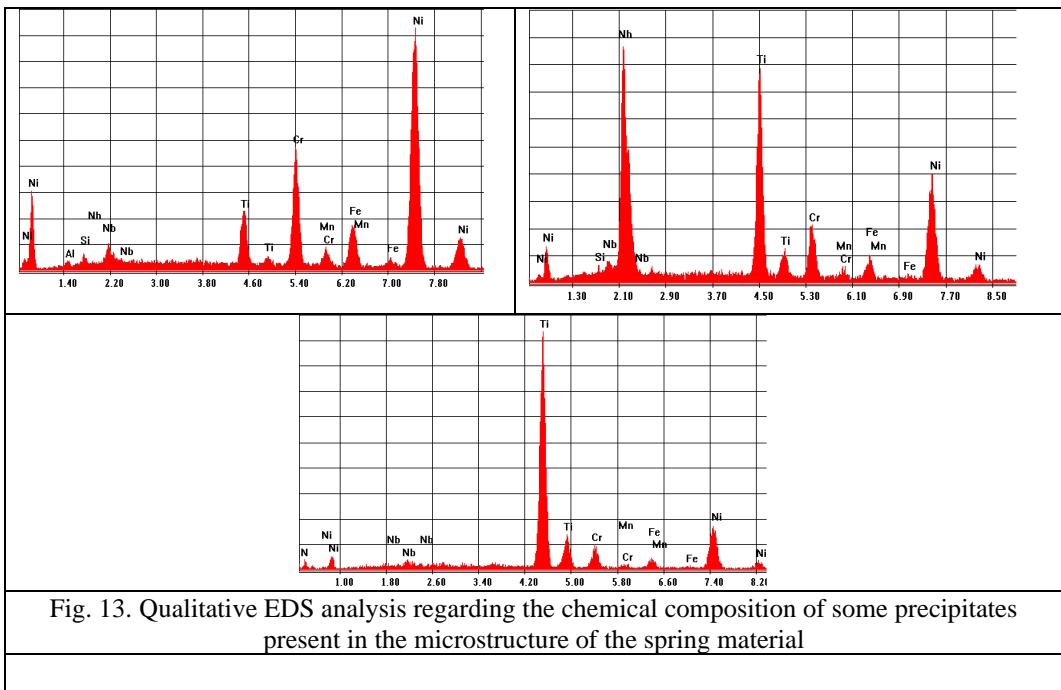
Using the same technique, the precipitates found in the alloy structure were analyzed. Part of the analysis images are given in Fig. 13. These are carbides and carbonitrides of Ti, Nb and Cr.

Fig. 13. Qualitative EDS analysis regarding the chemical composition of some precipitates present in the microstructure of the spring material
