RING TESTS ON CANDU FUEL ELEMENTS SHEATH SAMPLES

Silviu IONESCU¹, Octavian UTA², Marin MINCU³, Gabriel GHITA⁴,
Ilie PRISECARU⁵

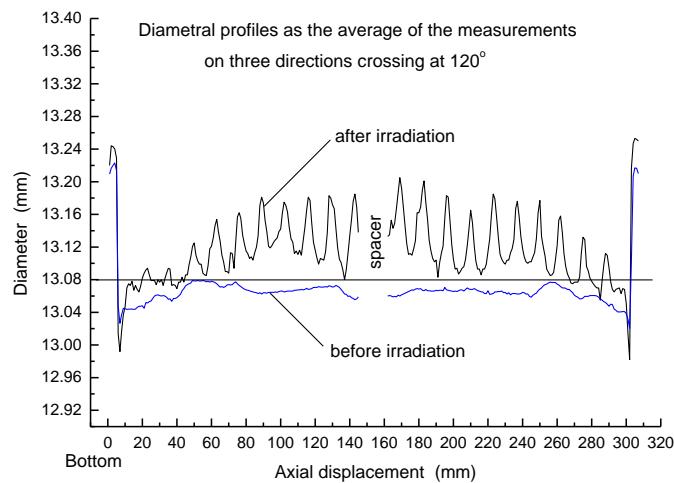
Fig. 2: Average diameter profile after irradiation

The diametrical profile, diametrical increasing, ovality and the arrow of fuel element were determined. In Fig. 2 is presented the average diameter profile of the fuel element. The average diameter is 13.149 mm. The average diametrical increasing is 0.087 mm (0.67 %), with respect to the diameter before irradiation.

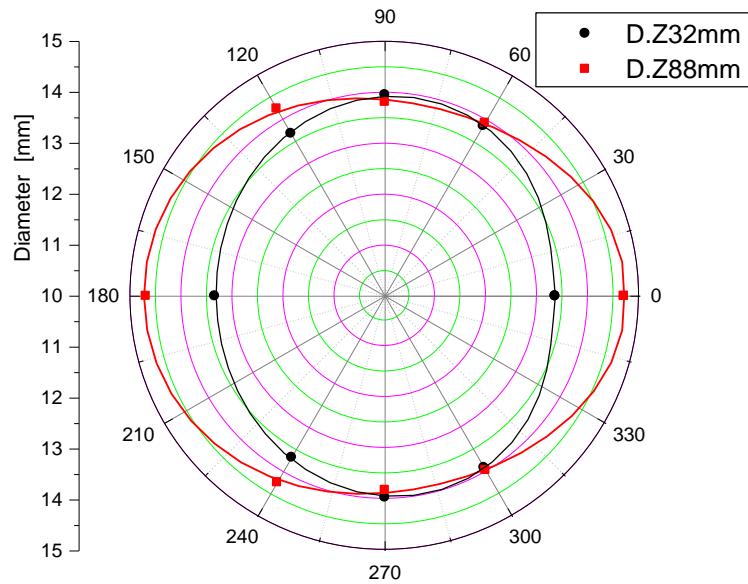
Fig. 3: Ovality profiles for $Z = 32$ mm and $Z = 88$ mm

After visual examination of the fuel rod we choose the zone with the greatest ovality for detailed analyse of diameter. Ovality profiles of the fuel element for two different positions on the vertical axis, $Z = 32$ mm and $Z = 88$ mm, are presented in Fig. 3.

The graphic representation was made based on the measurements performed at these positions in three directions (0° , 120° and 240°). The profiles of bending are presented in Fig. 4 which shows the profilometry results obtained from the experimental CANDU fuel element shown in Fig. 3 which has been irradiated in the TRIGA pulse reactor in a simulated RIA test. It is observed the prominent sheath swelling due to fuel swelling and a violent fission gas release which have determined sheath cracking. The sheath ovalization profile has been obtained by circumferential diameter measurements.

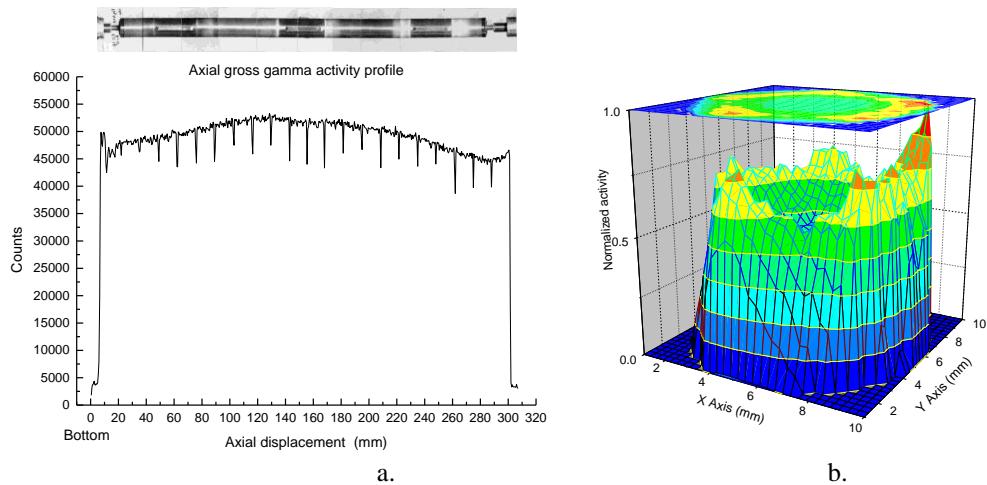
Fig. 5: Axial gamma scanning (a) and tomography (b) on a CANDU fuel rod irradiated in the INR TRIGA reactor in a power ramping test

For axial gamma scanning, the slit of the collimator was horizontal, having an aperture of 0.5 mm. The gamma acquisition along the fuel rod was performed at regular intervals of 0.5 mm; the acquisition time per step was 200 s. Fig. 5a shows the fuel rod axial gross gamma activity profile. A prominent depression of count rate at fuel pellet interfaces is observed, which means there is no interaction between the pellets. This gamma activity profile highlights practically a symmetric loading of the fuel rod.

A method of tomographic reconstruction based on a maximum entropy algorithm has been developed as described in ref. [5], [6]. The data acquisition was done while the fuel rod was moved transversally step-by-step at regular intervals of 0.25 mm after every 72° rotation in front of a vertical collimator slit (which is 50 mm high and has a 0.25 mm aperture). Fig. 5b shows, qualitatively, the tomographic image of the radial distribution of ^{137}Cs gamma activity in the cross section of the fuel rod, in the flux peaking area. This tomography indicates that the ^{137}Cs isotope migrated from the middle to the periphery of the fuel rod and was redistributed according to the temperature. The temperature is higher in the center and falls outward up to 300 °C, where the fuel element is in contact with the coolant.

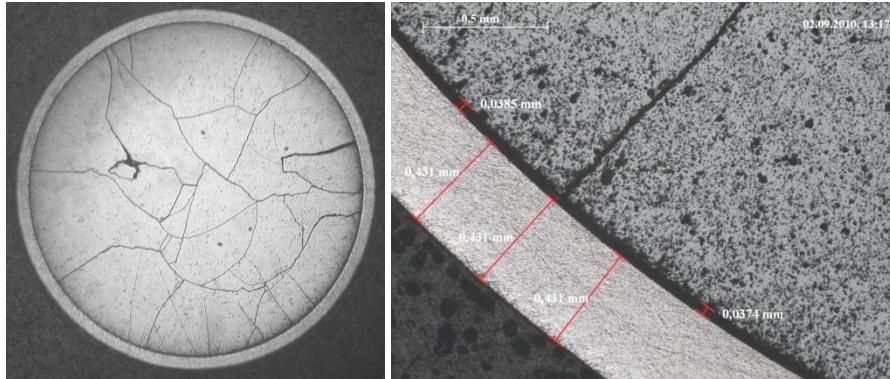
Fig. 6: The cross section of the fuel pellet

The cross section of the fuel pellet ($\times 8$) presents radial and circular fissures on the whole section. The cladding doesn't present nonconformities, the thickness of this being 0.431 mm. There are no visible effects on fuel sheath, due to mechanical or chemical interactions.

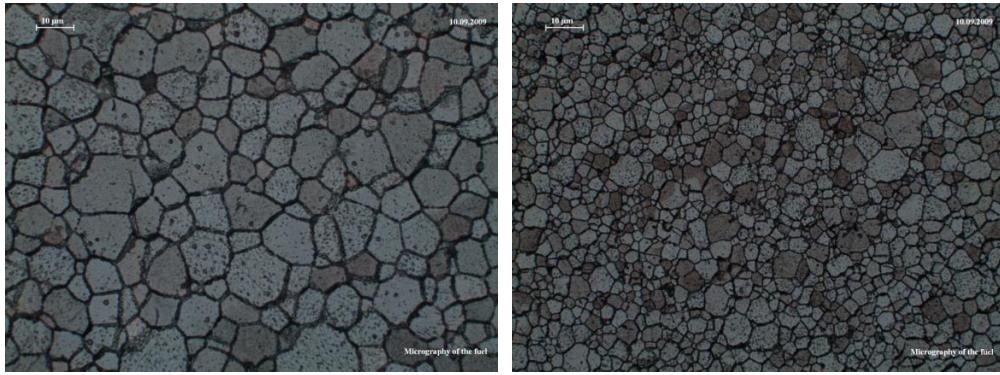
Fig. 7: The structural modifications in the fuel pellet

a) Equiaxial grains

b) Unaffected grains

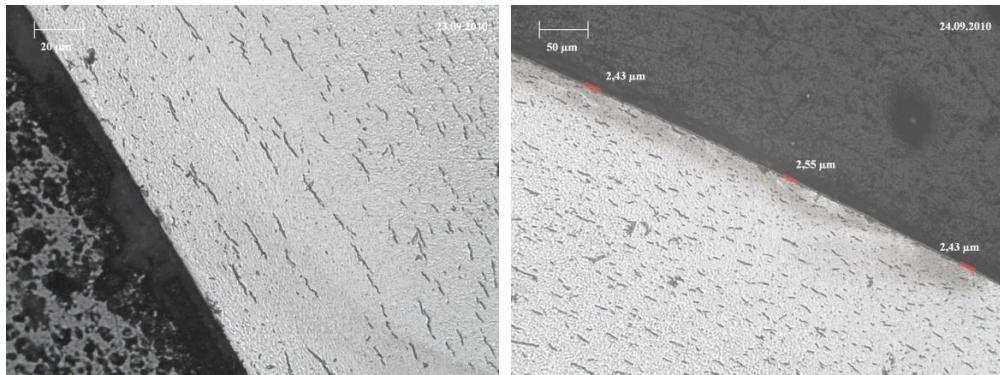
Fig. 8: Cladding aspect

a) Cladding hydriding

b) Outer oxide layer on cladding

The hydride precipitates are orientated parallel to the cladding surface. A content of hydrogen of about 120 ppm was estimated by means of hydriding charts ref. [8]. The fuel element presents on the outer side of the cladding a continuous and uniform zirconium oxide layer (Fig. 8). The thickness of the cladding oxide layer is 2.5 μm .

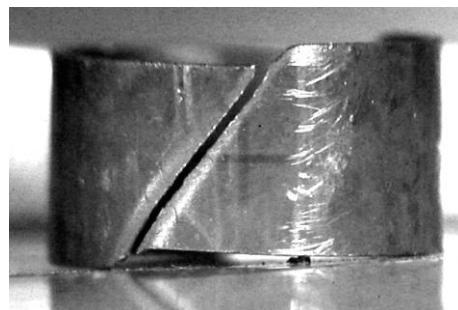
Fig. 12: Ring sample after test

The tests were done according to the procedures and standards are given in ref. [9], [10] and [11]. The aspect of the rupture and the relevant mechanical properties reveal the effect of irradiation on cladding material. It could be observed the increase of yield strengths and ultimate tensile strength with around 50% and the decrease of elasticity properties with the same value as effect of irradiation.

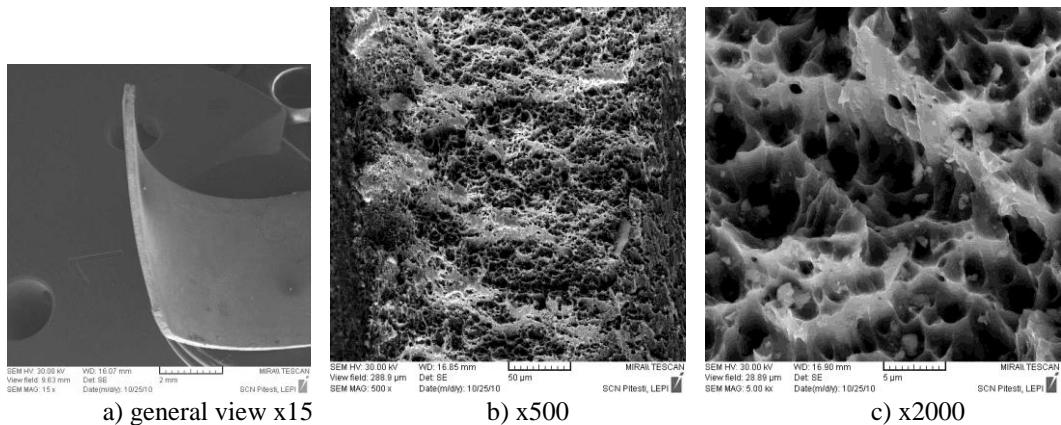
Fig. 14 The aspect of the central zone of the fracture

Both sides of the tensile fracture were analyzed on each half of the ring. The dimples from the central zone are rather deep, whereas the ones on the outer side are tilted and smaller.

The central zone of the fracture presents equiaxial dimples (Fig. 14).
