EXPERIMENTAL RESEARCH ON THE METALLIC MATERIAL DEFECTS APPEARED AT THE OPERATION OF PUMPING AGGREGATES

Cristian PANDELESCU¹, Nicolae CONSTANTIN^{*2}, Dan GHEORGHE³, Elisa-Florina PLOPEANU⁴

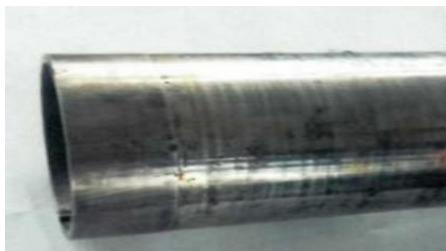
Fig..1 Adhesion wear - exfoliated mouth

The metal parts investigated show physical surface wear (exfoliation of the bushes, corrosion of the discharge discs), as well as breakages of the rotor blades as a result of chemical but also physical actions (water with harsh impurities).

The remediation of the surface wear caused can be done by making the parts of a pump made of metallic materials that will accept the reconditioning by applying successive layers of metal and that after the machining by cutting will return to the original dimensions of the project [6, 10].

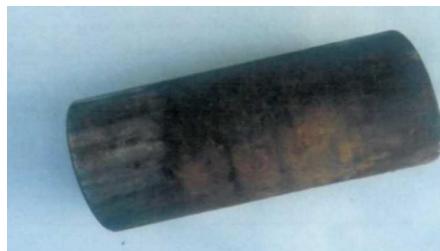
Fig..2- Brateş pump wear bush, corroded

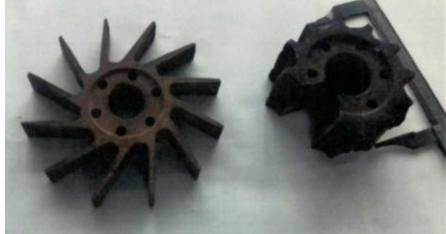
Fig..3 Pump rotors with broken blades

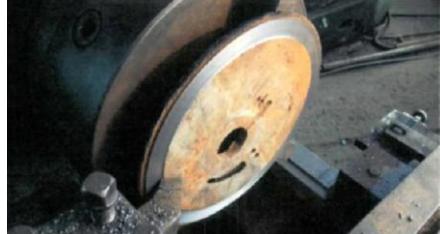
Fig..4 Disc discharge pump with surface wear

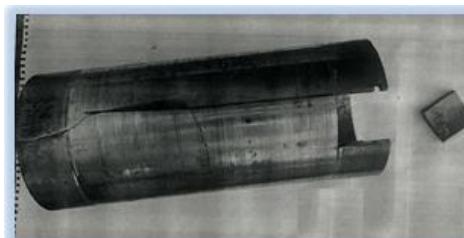
Fig. 5 Sample 1. Pump bushing wear DV 2-87

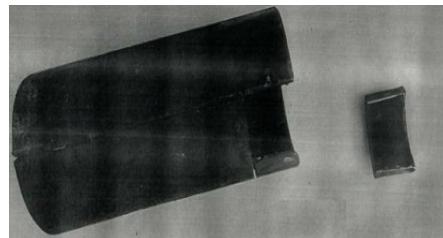
Fig. 6 Sample 2. Pump bushing wear Brates 400

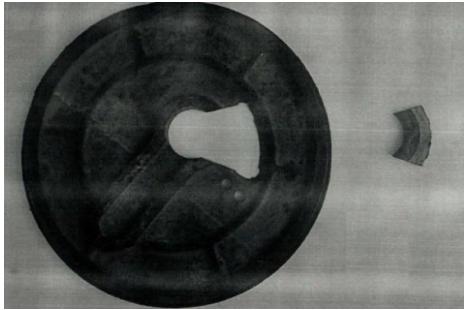
Fig. 7 Sample 3. Suction pump suction disc MIL

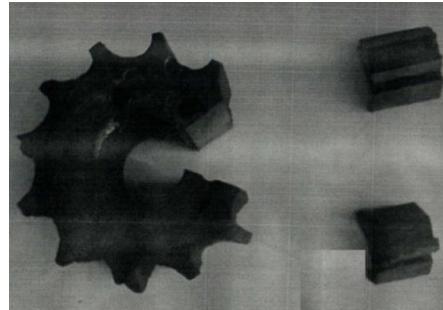
Fig. 8 Sample 4. Pump rotor blade MIL

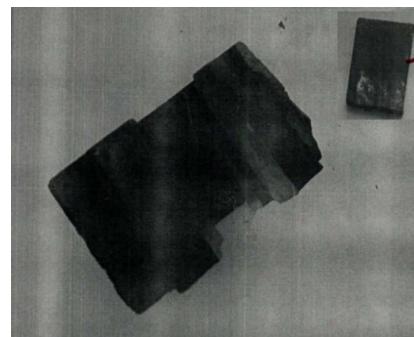
Fig. 9 Sample 5. Pump rotor blade MIL

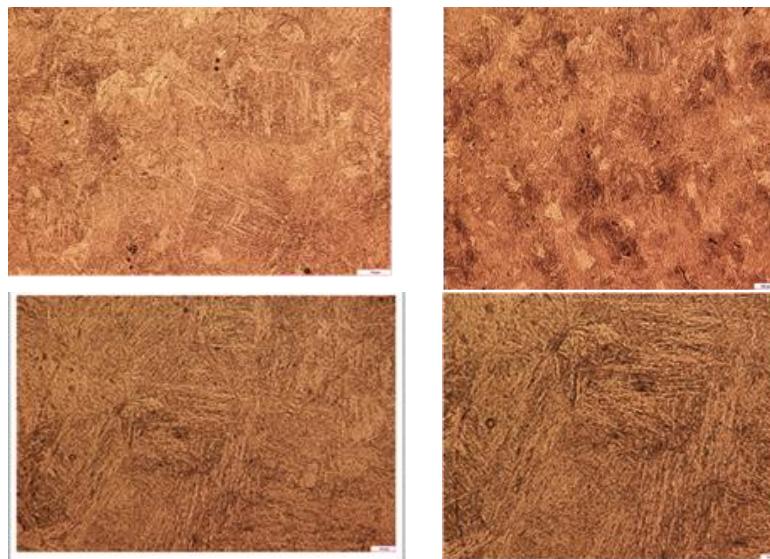
Fig.. 10-Sample 1

The observed structure is composed of fine martensite of recurrence with traces of residual austenite.

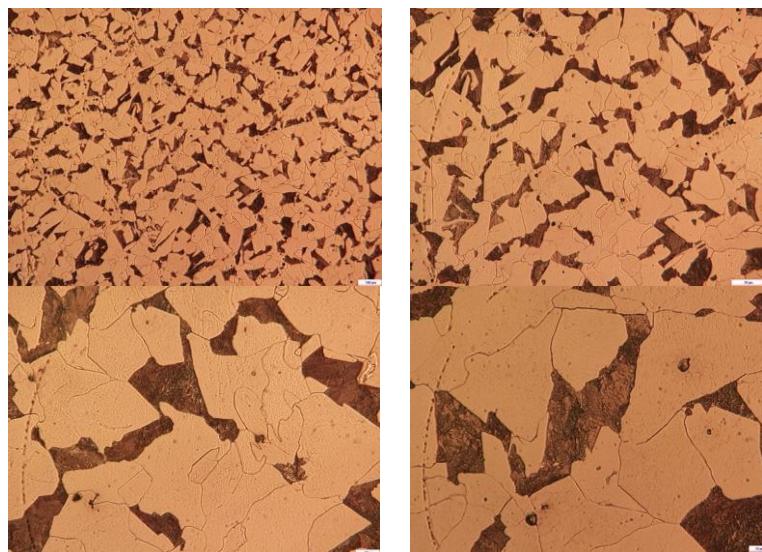
Fig.. 11-Sample 2

The structure of the material is a structure of equilibrium, relatively uniform and composed of ferrite grains and degenerate (ally) perlite grains.

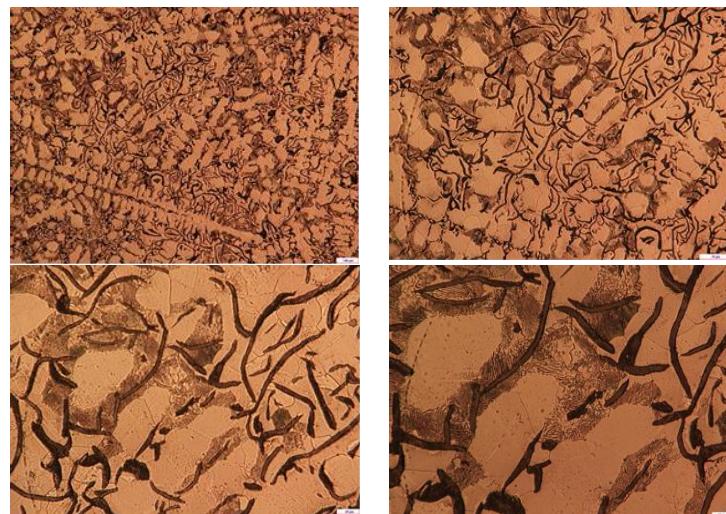
Fig.. 12-Sample 3

The micrographs of Fig.. 3 show a gray cast iron structure with lamellar graphite and a ferrite-pearlite base mass.

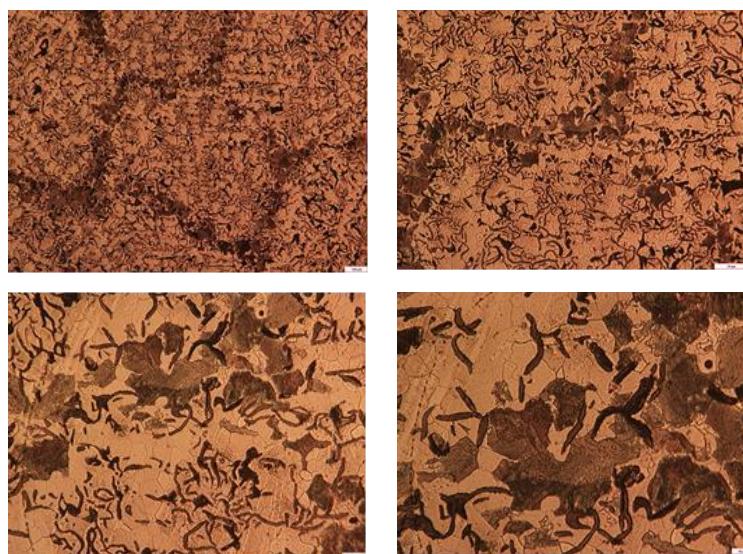
Fig. 13-Sample 4

The observed structure is of gray cast iron with slightly modified graphite (vermicular), with ferrite-perlite base mass.

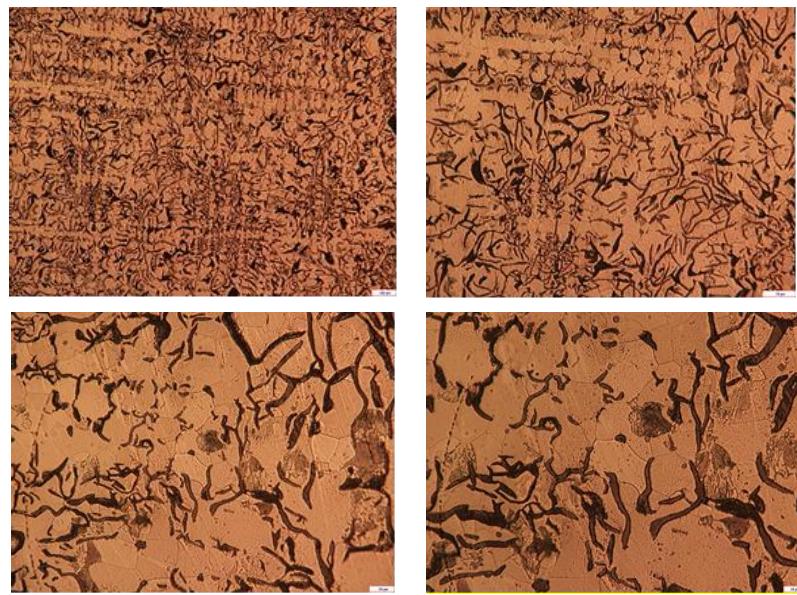
Fig. 14-Sample 5

The observed structure is of gray cast iron with slightly modified graphite (vermicular), with ferritic base mass.

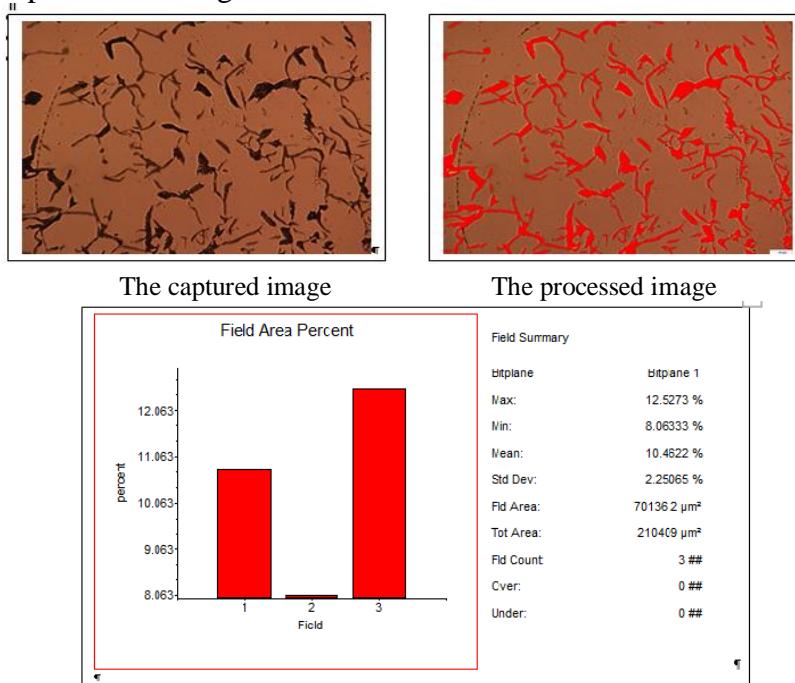
Fig. 15-Graphite sample ratio 3, calibration 0.19113 $\mu\text{m} / \text{Pixel}$

The quantitative analysis of graphite was performed on three fields, in order to be able both its proportion and its distribution in the basic mass. Thus, from Fig. 15 it is found that graphite is relatively evenly distributed between 8% and 12.5% with an average of 10.5%.

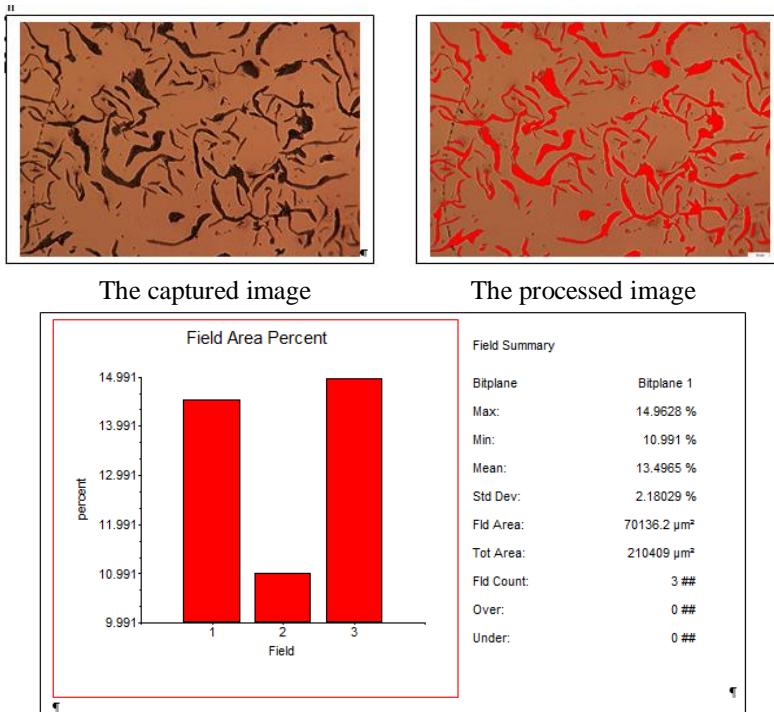
Fig. 16-Graphite sample ratio 4, calibration 0.19113 $\mu\text{m} / \text{Pixel}$

As in the case of the previous sample, the quantitative analysis of graphite was performed on three fields, in order to be able both its proportion and its distribution in the base mass. Thus, from Fig. 16 graphite is found to be relatively evenly distributed between 11% and 15% with an average of 13.5%.

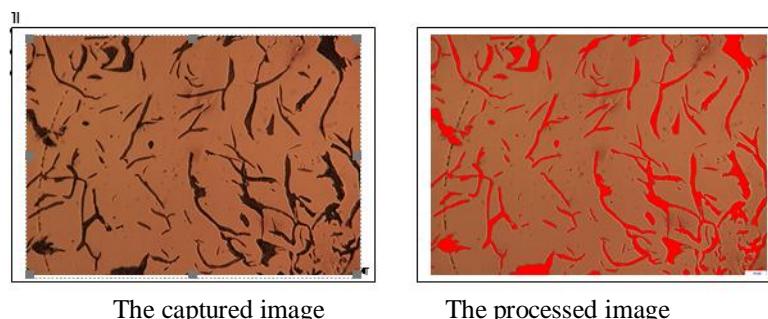
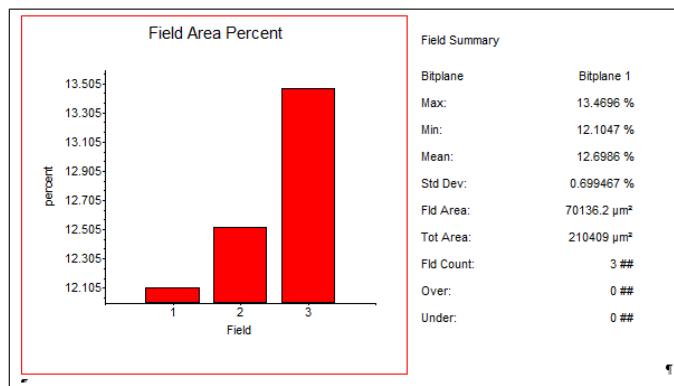
Fig. 17-Proportion graphite sample 5 calibration $0.19113 \mu\text{m} / \text{Pixel}$

From Fig.. 17 it is found that in sample 5, graphite is also relatively evenly distributed, with a ratio between 12% and 13.5% at an average of 12.7%. For the steel samples, the proportion of non-metallic inclusions was made. The results are presented in Fig.s. 18-19.

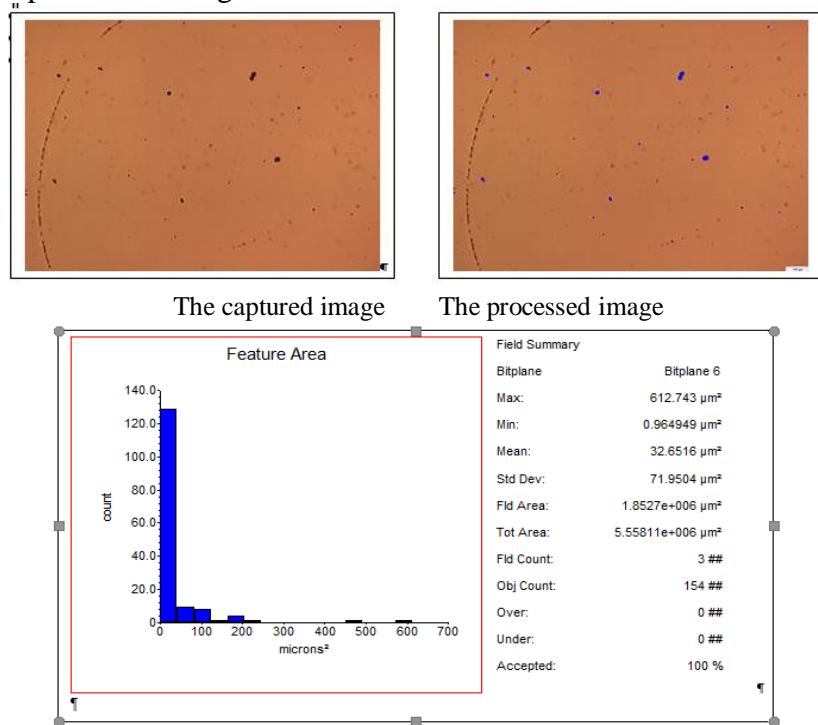
Fig.. 18-Inclusion Sample 1, calibration $0.98232 \mu\text{m} / \text{Pixel}$

For the best accuracy of the results, the analyses were performed on a number of 3 fields. The analyses aimed to classify the inclusions into a number of 10 size classes in terms of their size. In case of sample 1, the relatively fine inclusions, mainly oxides, fall within the limits of $0.9 \mu\text{m}^2$ and $600 \mu\text{m}^2$ with a weighted average of $30 \mu\text{m}^2$.

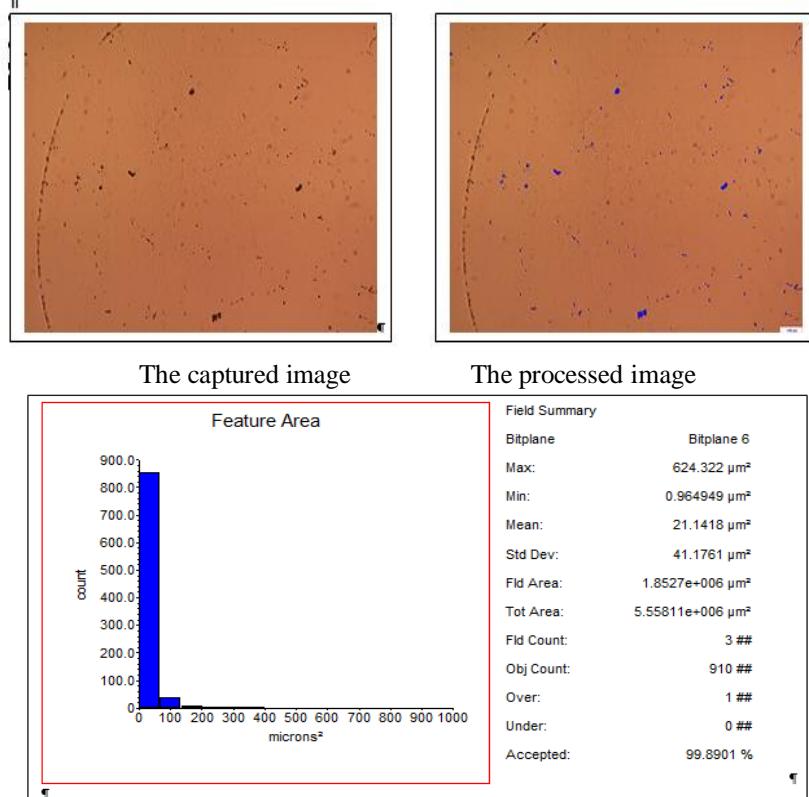
Fig. 19-Inclusion of sample 2, calibration $0.98232 \mu\text{m} / \text{Pixel}$

As in the case of sample 1, in the case of sample 2 the inclusions are relatively fine, mainly oxides and fall within the limits of $0.9 \mu\text{m}^2$ and $600 \mu\text{m}^2$ with a weighted average, slightly lower than $20 \mu\text{m}^2$.
