## FAILURE ANALYSES OF A NON-CEMENTED HIP PROSTHESES FAILED DUE TO THE STEM FRACTURE

*The paper presents the fractographic analysis of a ceramic-ceramic hip prosthesis that failed prematurely due to the fracture of the metal stem of the prosthesis. The investigation methods used were stereomicroscopy, optical microscopy, scanning electron microscopy and EDS spectrometry. Analyses have shown that the metallic biomaterial (Ti6Al4V) is suitable in terms of chemical composition and microstructural characteristics, no material defects have been identified. The analysis of the failure zones highlights a fatigue type fracture, followed by a friction-wear phenomena between the fractured components of the hip stem. The final failure of the prosthesis occurred with a shock.*

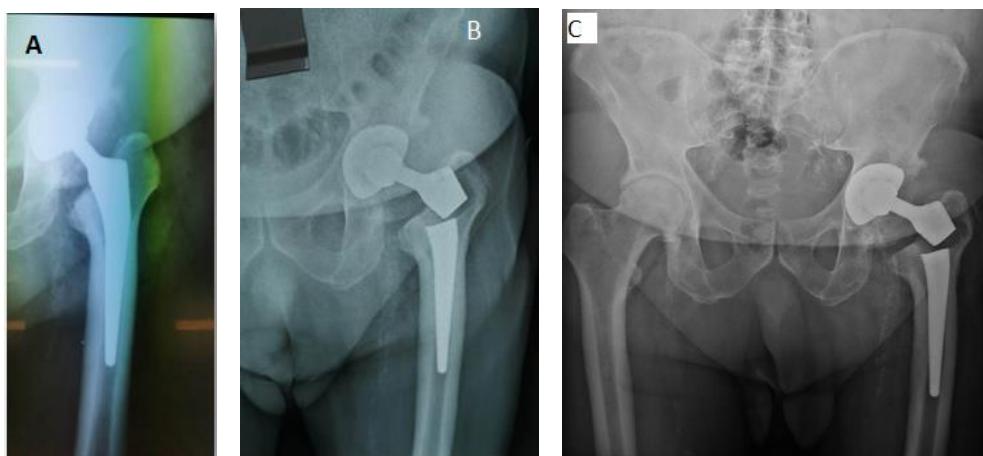
During late 2020 the patient remembers feeling a sudden onset pain in the upper left thigh and unsteadiness while getting out of the car after a 40 minutes' drive (60 km). The patient denies any kind of pain or unsteadiness after his rehabilitation period and before the upper related incident and he does not dispose of other X-rays beside his first post-op checkup X-ray (Figure 2a). After the incident he continued walking with a crutch and went for a checkup at approximately 2 weeks after the incident (Figure 2b).

Fig.2. Radiological aspects of the investigated clinical case: (a) Total hip arthroplasty with uncemented stem 6 weeks after surgery; (b, c) appearance of the stem failed 4 years after primary implantation.

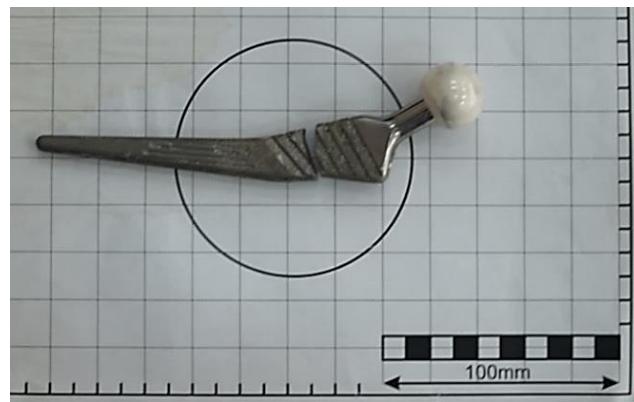
The overall picture of the total hip prosthesis is shown in Figure 3. It is observed that the rupture is in the area of the intramedullary component, in the first third of the total length of the stem. The rupture is in a direction perpendicular to the application of the loading.

Fig. 3. General view of failed HIP prosthesis

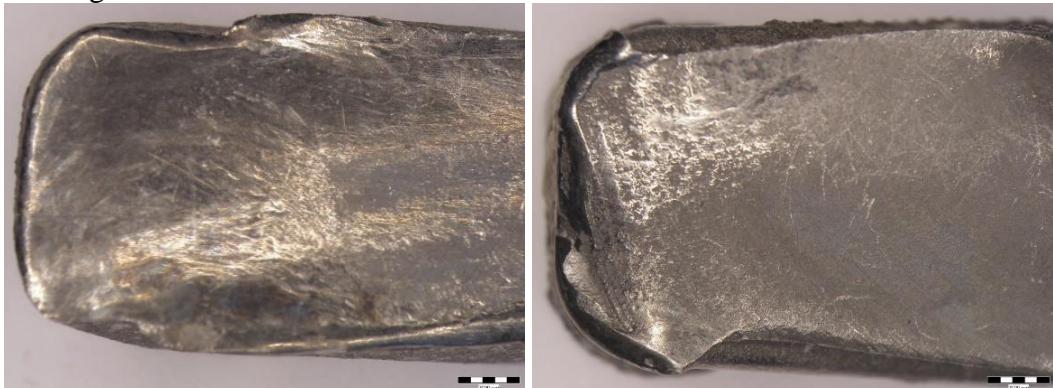
The stereomicroscopy analysis revealed both the propagation of the fracture and the different macrostructural aspects specific to the fracture of the investigated stem.

Fig.4. Macrostructural appearance of different marginal areas of the intramedullary stem of the explanted hip prosthesis

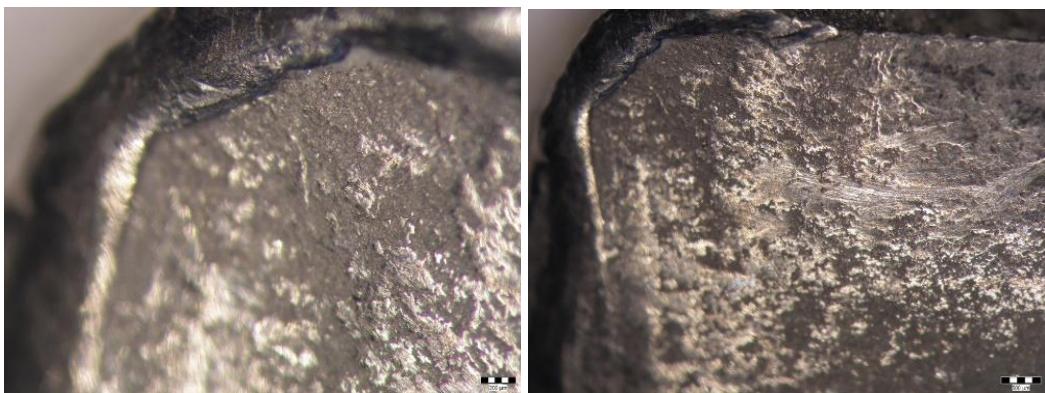
Macrostructural aspects of the stem ends, highlighting the propagation of the rupture, with beachmarks, but also with the visualization of the area of initiation of the fracture, a discontinuity of material.

Fig.5. Stereomicroscopic images showing details of rupture in different areas of the intramedullary stem of the explanted hip prosthesis

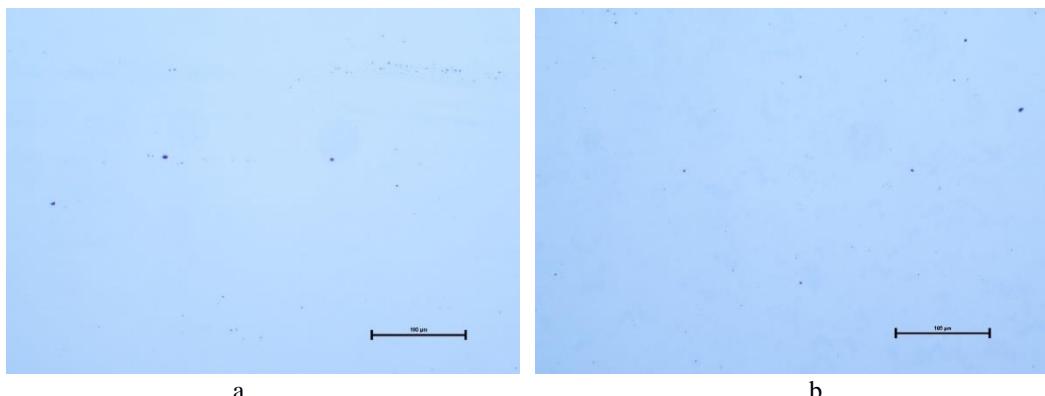
Images on the longitudinal and transversal sections (Figure 6) of the unetched samples shows an alloy without significant inclusions.

Fig. 6. Optical microscopy images - unetched samples a) longitudinal section, b) cross section

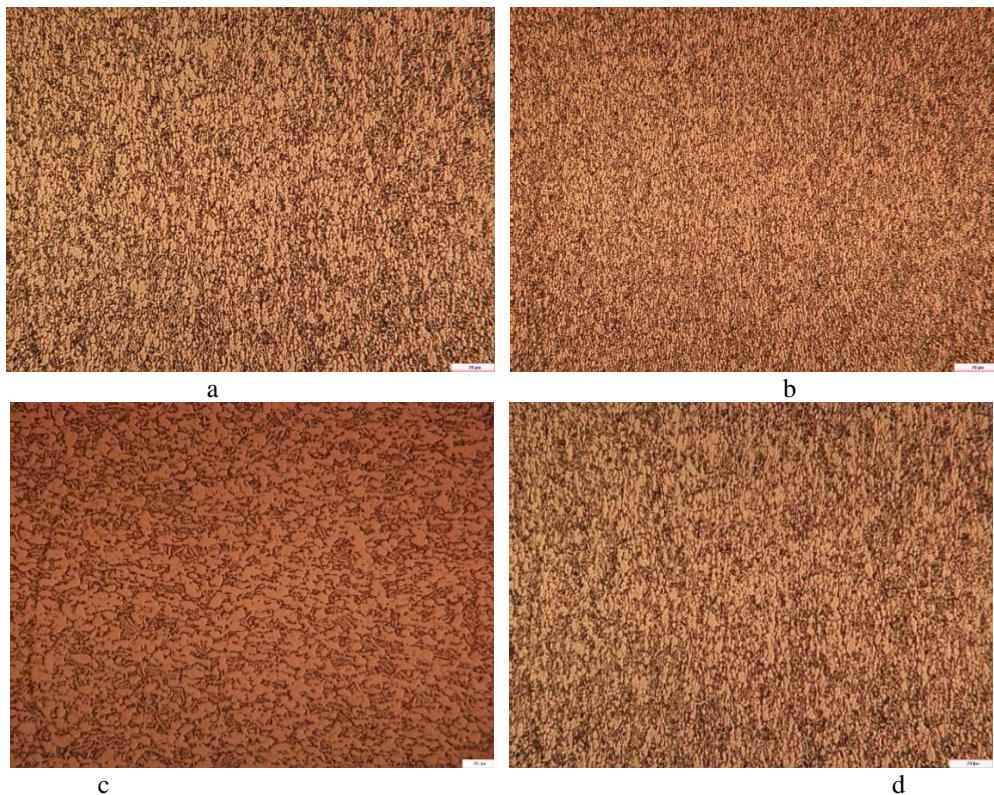
Optical microscopy determinations for the experimental sample taken from the hip prosthesis in cross section (Figure 7 a and b) showed a structure typical of the Ti6Al4V alloy. Considering the magnification at which the image was taken, it can be stated that the structure is uniform and fine. Optical microscopy determinations for the experimental sample taken from the hip prosthesis in the longitudinal section (Figure 7 c and d) showed a biphasic structure ( $\alpha + \beta$ ) typical of the Ti6Al4V alloy.

Fig. 7. Optical microscopy images - microstructure experimental sample taken from the hip prosthesis: a, b) cross section; c, d) longitudinal section

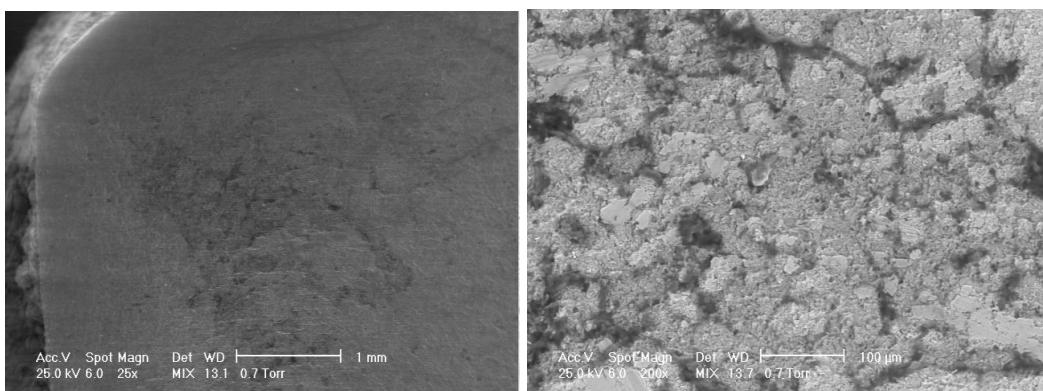
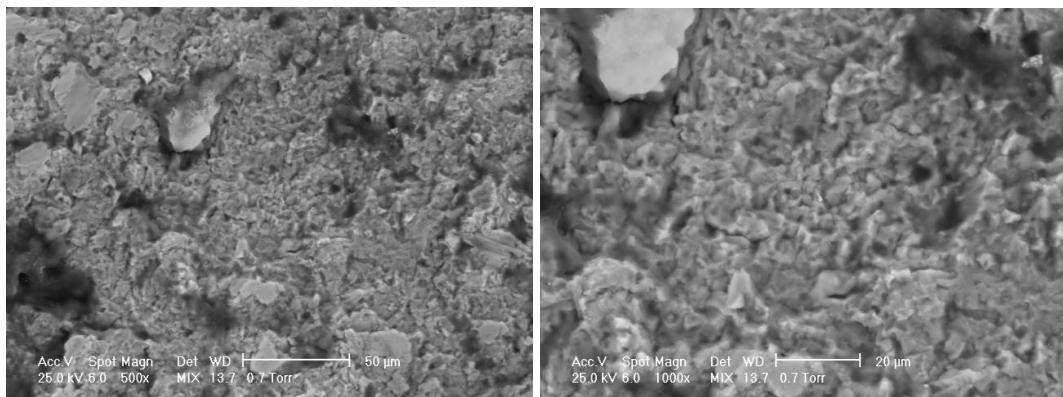
Fig. 8. a) SEM images of the fractured femoral component surface of the investigated total hip prosthesis (marginal area analysis, at different magnification)

Fig.8. b) SEM images of the fractured femoral component surface of the investigated total hip prosthesis (marginal area analysis, at different magnification)

The SEM images recorded on the samples show the morphology of each type of experimental sample taken from the investigated hip prosthesis. The margin area of the fractured area of the femoral component of the total hip prosthesis investigated reveals a matte, fibrous appearance.

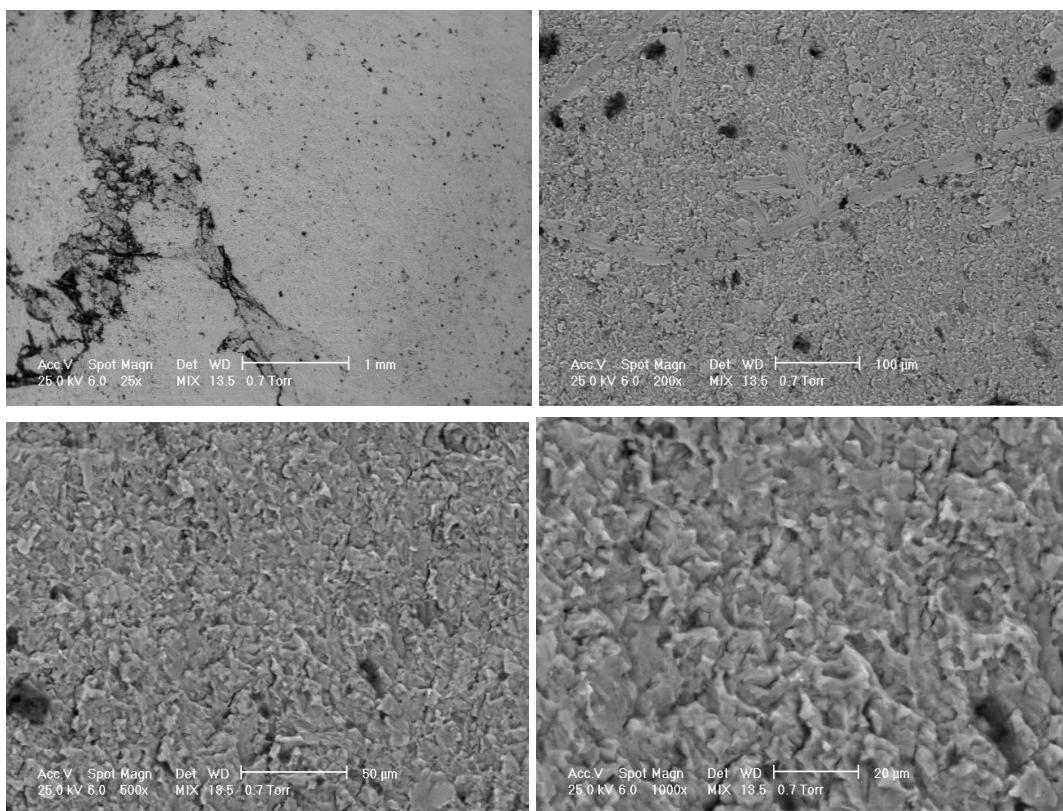
Fig.9. SEM images of the fracture area of the investigated total hip prosthesis femoral component of the (plateau area analysis, at different magnification powers)

At high magnification, the character of the rupture is highlighted, with gaps finely distributed in the analyzed field.

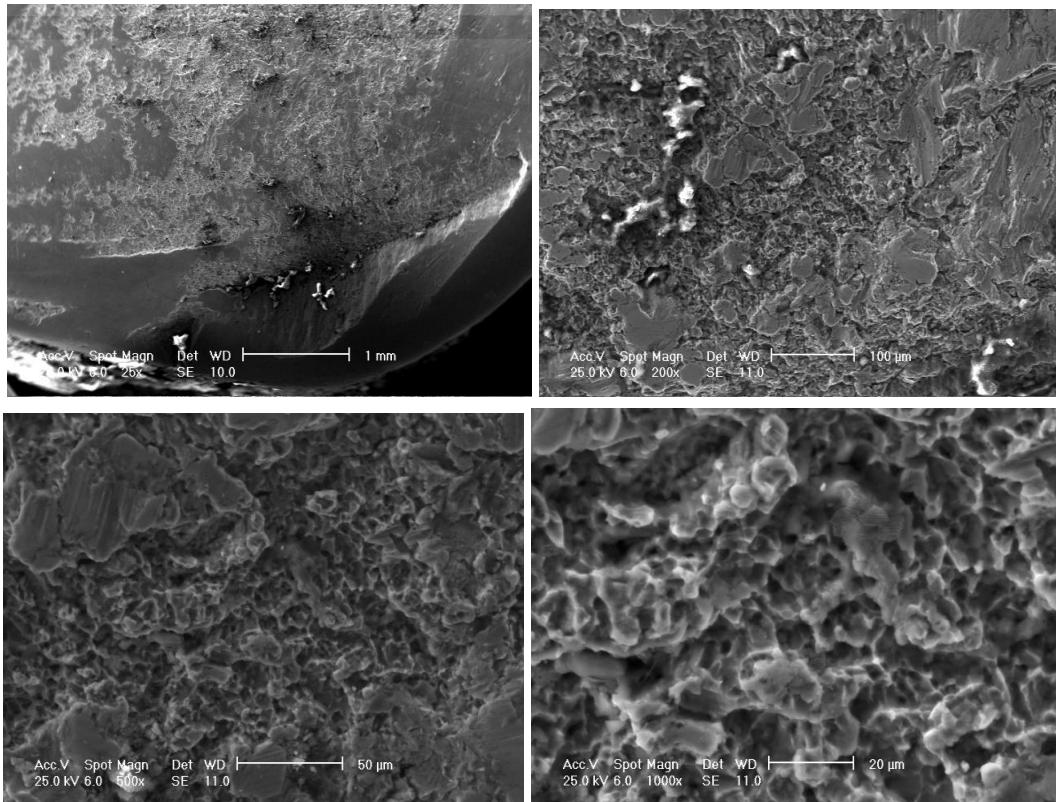
The central area of the fracture area of the femoral component of the total hip prosthesis investigated with a rough appearance. The area with propagation waves of the rupture, at high magnification, shows the fatigue fracture character.

Fig. 10. SEM images of the rupture surface of the fracture area of the investigated total hip prosthesis femoral component

The edge of the fracture area of the investigated femoral component of the total hip prosthesis, probably highlighting the place of initiation of the fracture, probably a discontinuity of material. The fracture has a fatigue character, the chamfered ends, showing a relatively long friction between the moment of rupture of the investigated femoral component of the total hip prosthesis and the moment of revision. At high magnification, this fracture character is clearly visible, with numerous gaps, but also small plateaus. The results of the EDX analysis indicate that the material from which the femoral component of the total hip prosthesis investigated is made is a titanium alloy, respectively Ti6Al4V.

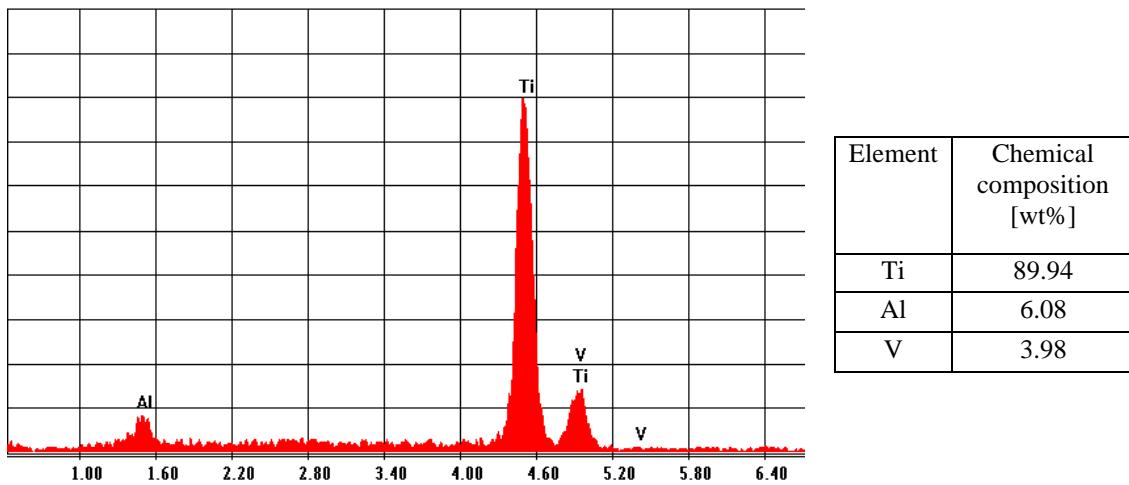
Fig.11. SEM-EDS analysis results
