MICROBIOLOGICALLY INFLUENCED CORROSION ANALYSIS ON CARBON STEEL COUPONS

Mădălina ANDREI¹, Brândușa GHIBAN²

The paper is focused on investigating the nature of the internal corrosion of a pipeline transporting residual injection water. The study was carried out using removable carbon steel disk coupons, for reproducing the effects of pipeline corrosion. Chemical composition, surface roughness and microstructure of the metal were determined and corresponded to a carbon steel used for pipelines manufacturing. Examination of corrosion morphology on metal surface was performed by analytical techniques, including optical microscopy, scanning electron microscopy (SEM) and atomic force microscopy (AFM). The localized corrosion morphology (terraced pitting) observed on the disk coupons and the presence of bacteria associated with MIC in deposit samples confirmed the internal corrosion of the pipeline as microbiologically influenced corrosion.

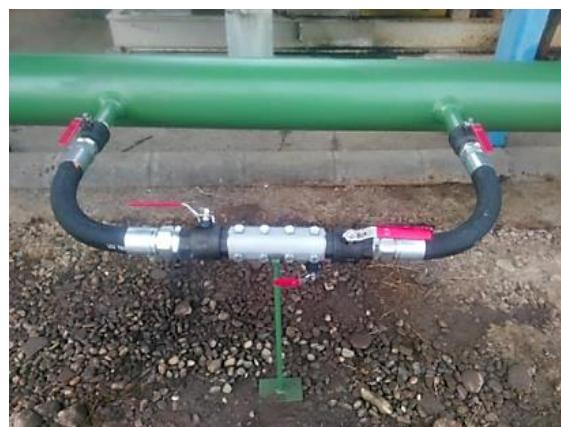
Fig. 1. Installation point of the device

The study was carried out using an in-house manufactured device installed as side stream of a pipeline transporting residual injection water, located in a Romanian oilfield. The device allowed the accumulation of deposit on disk coupons and indicated the effect of corrosion attack by examining the metal surface. The installation point of the device is presented in fig. 1.

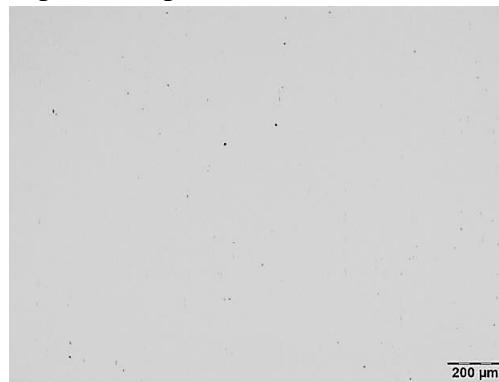
The metallographic examination of the surface revealed non-metallic inclusions of oxide type according to ASTM E45 [8] and homogeneous structure consisting in ferrite and pearlite, specific to a carbon steel.

Fig. 2. Structural analysis of the non-attacked sample of the investigated carbon steel, 100X

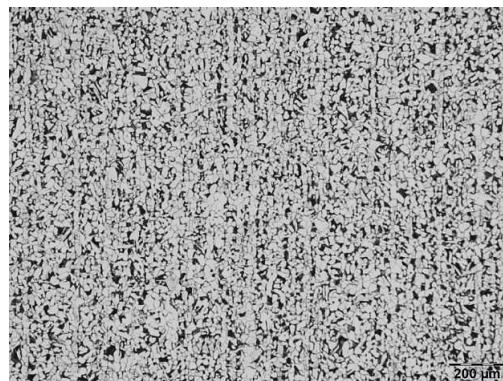
Fig. 3. Microstructure of the investigated carbon steel (2% nital attack, 100X)

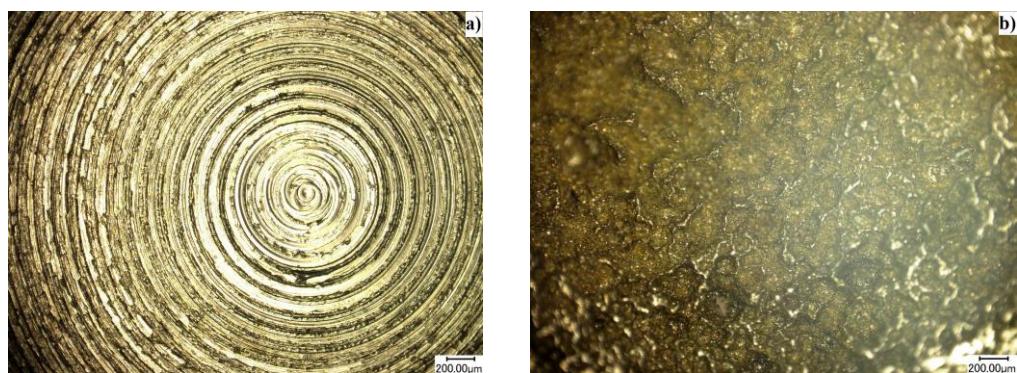
Microscopic examination of the metal surface indicated localized corrosion (terraced pitting) specific to MIC on disk coupons in “6 o'clock” position. In figure 4 is illustrated the aspect of the surface before (a) and after (b) exposure as is given under the stereomicroscope. As one can see the corrosion appears on all surface with material slices of relatively uniform and oxidized appearance.

Fig. 4. Stereomicroscope analysis (2D micrographs) of the investigated carbon steel:
a) unexposed surface, b) corroded surface

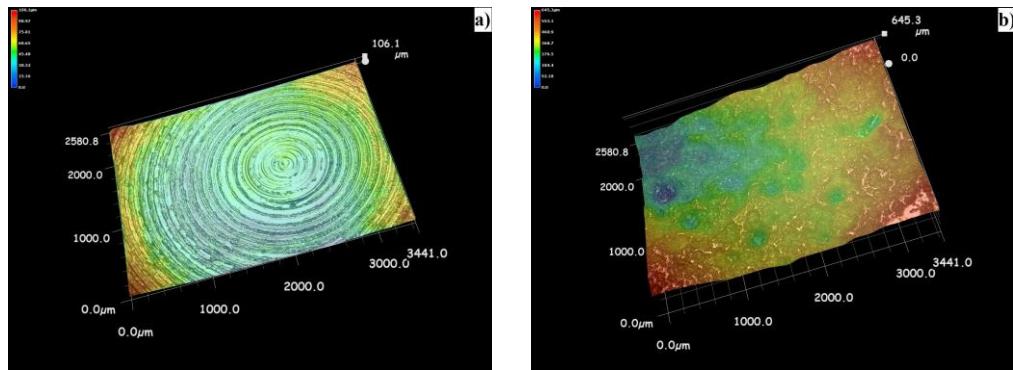
Fig. 5. 3D micrographs of the investigated carbon steel, 100X:
a) unexposed surface, b) corroded surface

Isometric representation of surface topography given in figure 5 put in evidence the morphological details. In unexposed surface (fig.5a), many scratches in circle shape are shown in comparison with corroded surface (fig.5b), where in the selected area for analysis, there is a big contrast between center and edge due to corrosion phenomena.

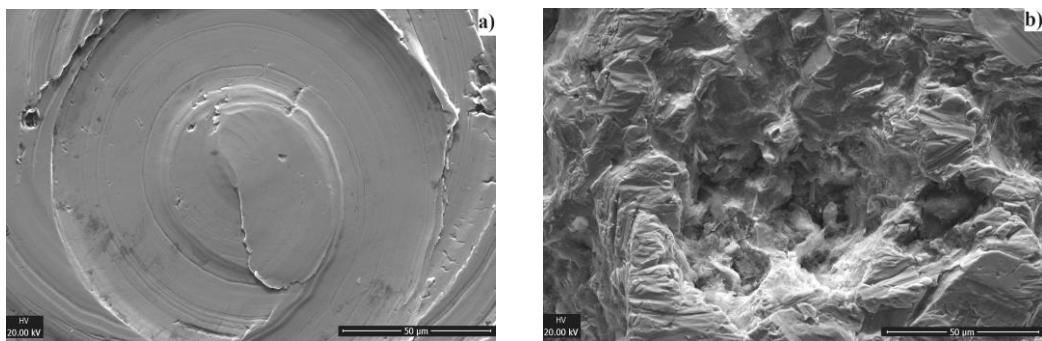
The images from the SEM are given in figure 6, where one can see the great difference between the two fractured surfaces. In unexposed surface, no scratches can be seen (fig. 6a), but in corroded surface (fig. 6b), spherical unevenness due to microbiological influenced corrosion can be observed.

Fig. 6. Scanning electron micrographs of the investigated carbon steel surface, 2.500X:
a) unexposed surface, b) corroded surface

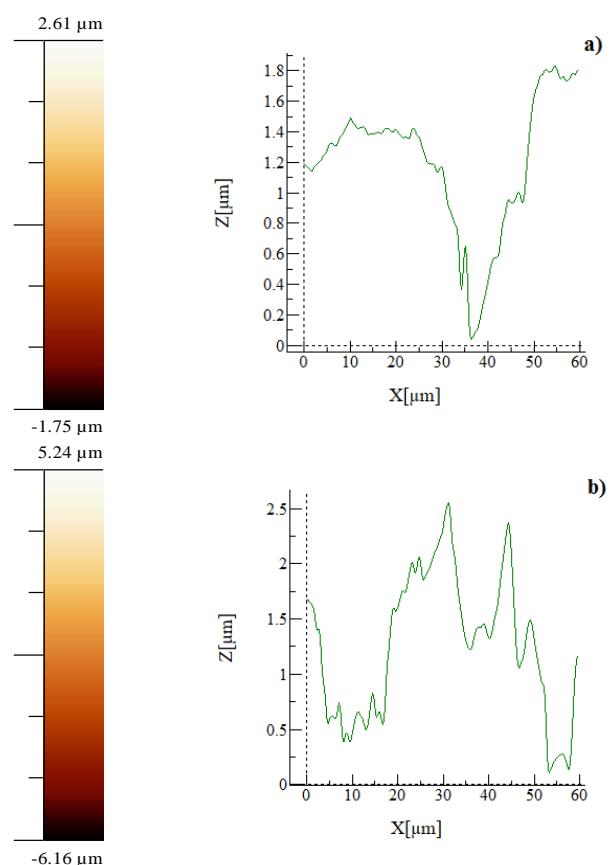
The analysis made by atomic force microscopy put in evidence an uneven appearance, with great unevenness, generated by the microbiological influenced corrosion phenomenon. If at the non-exposed surface the leveling reaches up to 1.8 μm , at the corroded surface it increases to 2.5 μm .

Fig. 7. AFM topographic micrographs and surface height profile of disk coupon:
a) unexposed surface, b) corroded surface
