EVALUATION OF IMPACT DAMAGE EFFECT ON FATIGUE LIFE OF CARBON FIBRE COMPOSITES

Daniel Kytýř¹, Tomáš Fíla¹, Jaroslav Valach², Martin Šperl³

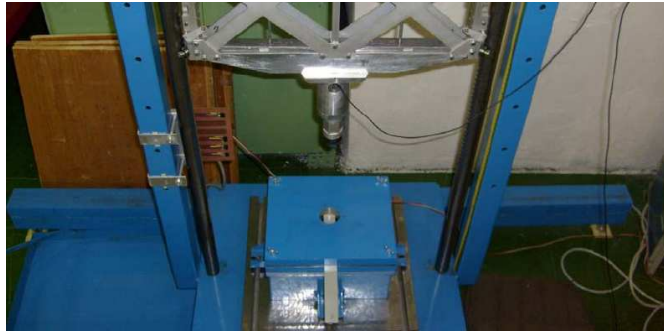
FIGURE 1. Impact damage performing using drop tester

The experimental procedure was carried out on set of samples with four different levels of initial impact damage: i) intact samples ii) impacted by impactor with diameter 10 mm and energy 10 J iii) impacted by impactor with diameter

20 mm and energy 10 J iv) impacted by impactor with diameter 20 mm and energy 20 J.

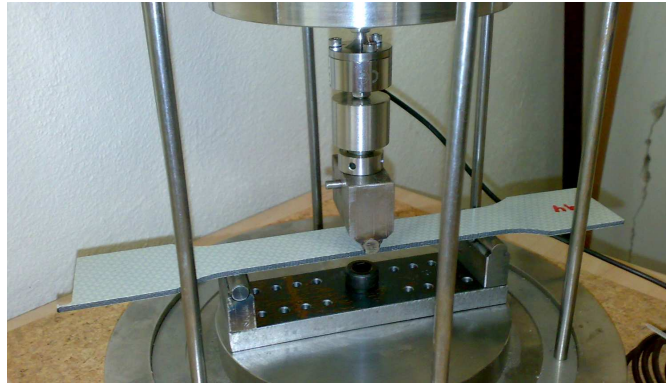
FIGURE 7. Experimental setup for three-point bending. Detail of the grips with load cell in the testing chamber

The decrement of elasticity modulus was measured using three-point bending test [9]. Custom-designed loading device [10] was employed for the test. Stepper motor with harmonic drive allowed displacement controlled experiments with accuracy 1 μm. The loadcell U9B (Hottinger Baldwin Messtechnik, GmbH) with loading range up to 100 N was used. The experiment was performed as displacement driven with maximal deflection value 1000 μm. The support span was 120 mm. The Young’s modulus was calculated using the linear regression method from loading curves.
