## EFFECTS OF WELDING METHODS ON THE STRUCTURAL PROPERTIES OF AUSTENITIC STAINLESS STEEL - X2CrNiMo 17-12-2 PIPES REPAIRED BY WELDING

*The article presents an experiment of welding an austenitic steel. The main purpose of the research is to elaborate new welding technologies for the spiral heat exchangers repairing, where the accessibility is low and difficult. Experimental program was performed by realization of welded mini-seams on the areas where an artificial defect was processed (holes with diameters of 2, 3 and 4 mm, respectively) inside pipes with a diameter of 42 mm and wall thickness of 3 mm. In order to establish the shape of the defects and the analysis of the areas in which they appeared, cross-sections were performed, then the samples were analyzed by optical and electron microscopy.*

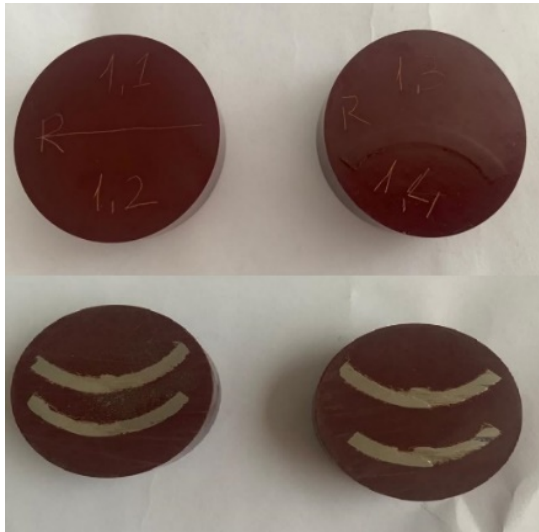
Fig. 3. Sample 1 (1x)- positioning of the welding spots

1.1. – welding spot 1 - 50 mm; 1.2 - welding spot 2 – 100 mm; 1.3. - welding spot 3 - 150 mm; 1.4 - welding spot 4 - 200 mm

- ✓ The embedding of the samples was done in phenolic resin. The samples obtained are shown in figures 3 and 4.

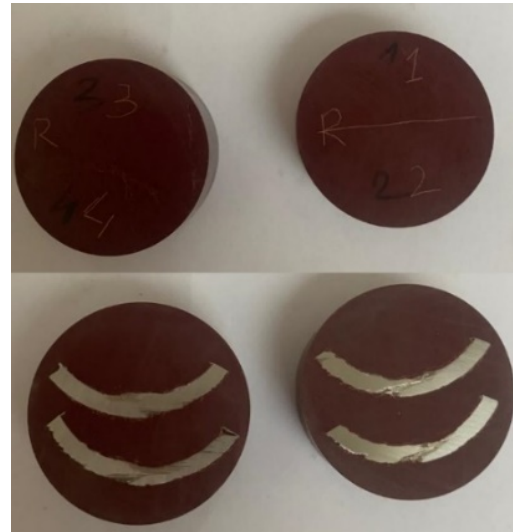
Fig. 4. Sample 2 (1x) - positioning of the welding spots

1.1. - welding spot 1 - 50 mm; 1.2 - welding spot 2 – 100 mm; 1.3. - welding spot 3 - 150 mm; 1.4 - welding spot 4 - 200 mm

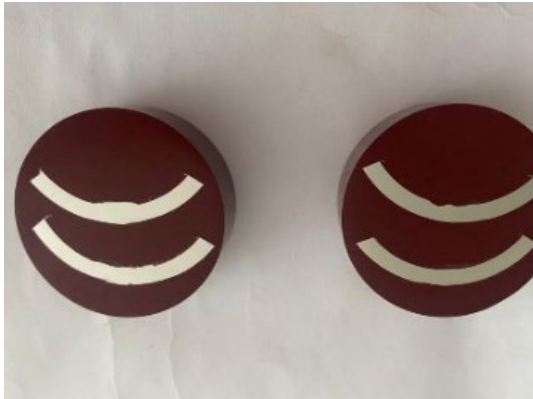
Fig. 5. Sample 1 (1x) - image obtained after polishing

- The grinding of the samples was performed manually using abrasive grit of 360, 500 and 1000;
  - The polishing of the samples was done manually with Topol 3 solution.
- The samples obtained after polishing are shown in figures 5 and 6, respectively.

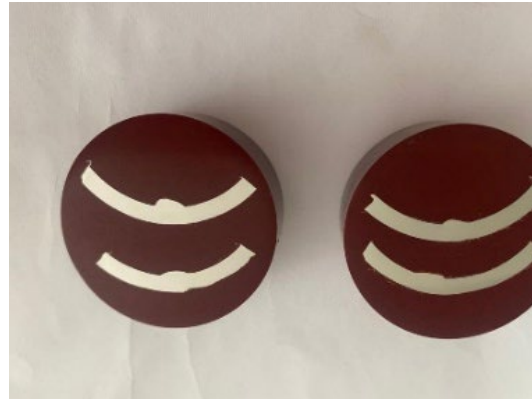
Fig. 6. Sample 2 (1x) - image obtained after polishing

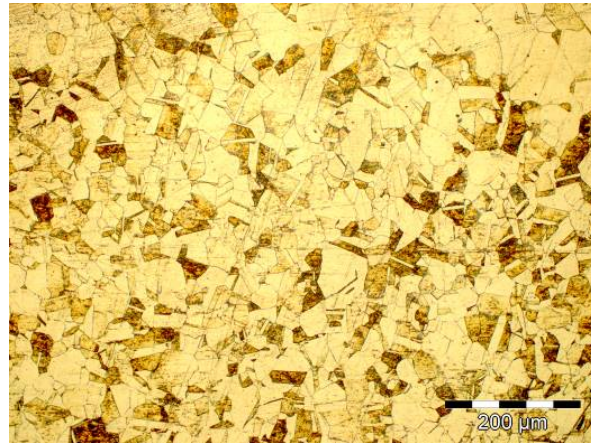
Fig. 7. Basic material (200x)

Figure 7 shows the structure of the basic material - austenite (twinned polyhedral grains) and ferrite delta - about 5%. The diameter of the grains is about 20  $\mu\text{m}$ .

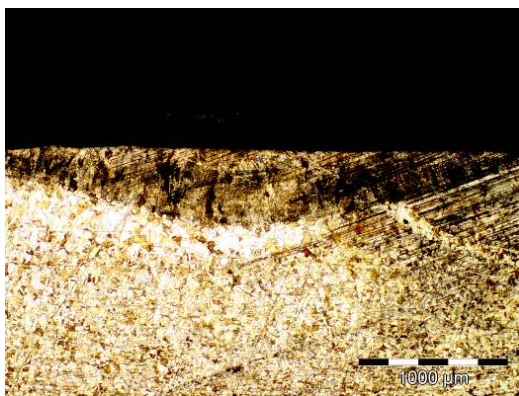
Fig. 8. Welded seam (50x) – sample 1.1

The welding was performed in two passes, with an overlap of about 500  $\mu\text{m}$ , to ensure the complete penetration and melting of the filler material, with the complete filling of the 2 mm hole (figure 8). The weld has no overhang, the upper molten area being at the surface of the base material. In the root area is observed the area of thermo-mechanical influence (light in color) with a width of about 200  $\mu\text{m}$ . On the analyzed area, the weld is well formed and without discontinuities.

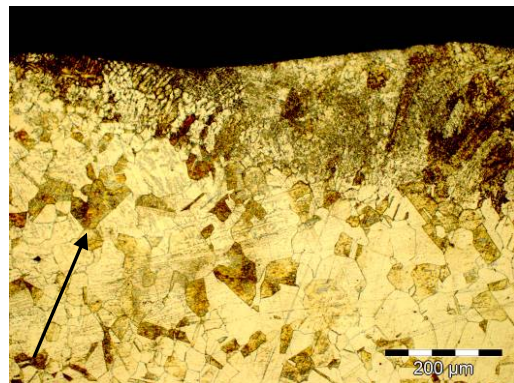
Fig. 9. Heat affected zone - HAZ (200x) – sample 1.1

The heat affected zone (see figure 9) has an overheating area with an increase in granulation, with coarse polyhedral grains with a maximum diameter of 58  $\mu\text{m}$ .

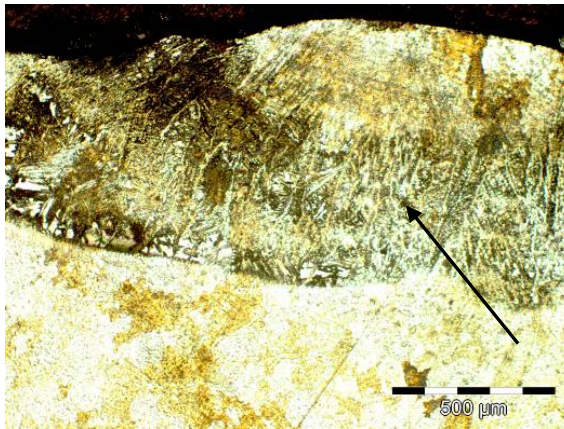
Fig. 10. Welded seam – final layer (100x) – sample 1.2

In figure 10 the final layer of the welded seam has a height of 852  $\mu\text{m}$  and a width of 3106  $\mu\text{m}$ . The connection area with the main seam has an acicular microstructure.

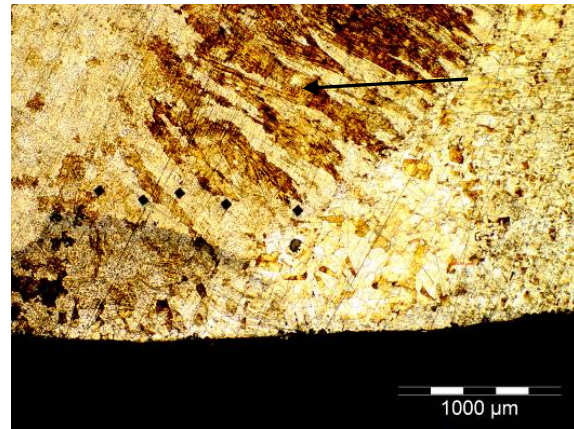
Fig. 11. Root area (50x) – sample 1.2

The main area of the welded seam (see figure 11) shows an austenite dendrites structure and delta ferrite with inter-dendritic precipitation. The grains are elongated in the direction of heat flow. The area of thermo-mechanical influence has large granulation. In figure 12 it can be observed a dendritic microstructure of austenite and ferrite delta. When the welding current increases the tendency of the molten metal to leak appears and different defects like pores and segregations are formed. In the weld also the proportion of ferrite delta increases. This mentioned aspect is not desirable, because the percentage of ferrite that ensures the best conditions of crack resistance is in the range of 5-8%.

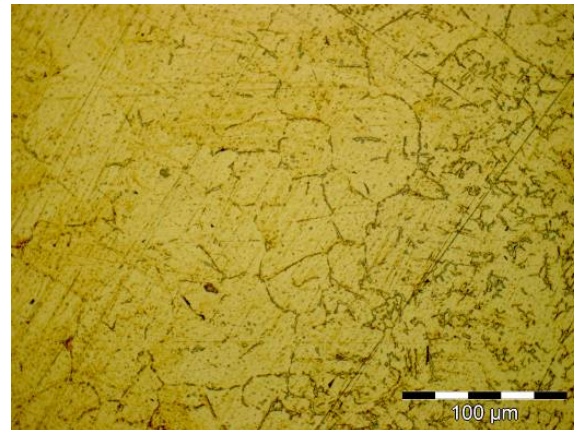
Fig. 13. Heat-affected zone - HAZ (500x) – sample 1.3

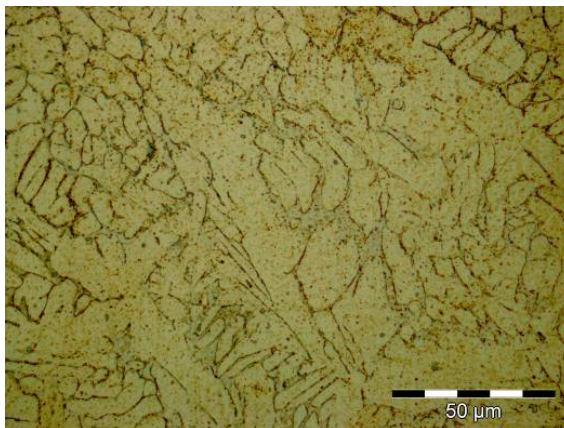
Fig. 14. Welded seam (1000x) – sample 1.4

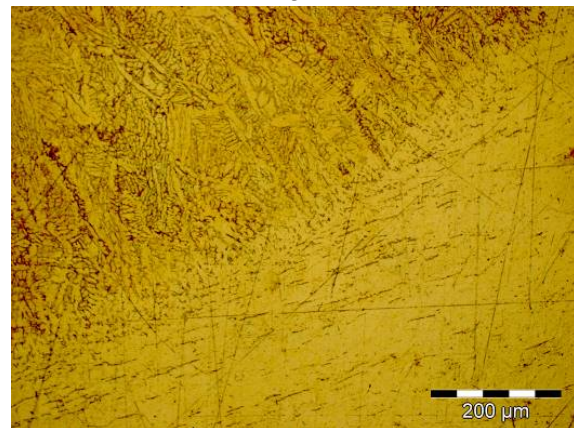
Fig. 15. Heat-affected zone - HAZ (500x) – sample 1.4

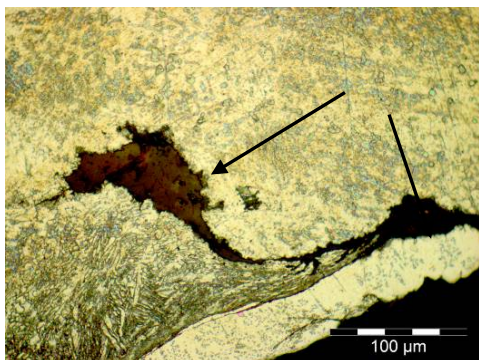
Fig. 16. Welded seam (500x) – sample 2.1

Figure 16 shows a lack of melting at the root of the weld and metal overlap. According to the SR EN 6520 standard, the lack of melting or incomplete melting is defined as the lack of connection between the deposited metal and the base metal or between the two successive layers of deposited metal. It has the

defect code 401 and the specific code for the lack of root melting is the code 4013.

According to the ISO 5817 standard this type of defect is not allowed. The main causes of this defect are the use of too low welding current, too fast feed rate, improper cleaning of materials, improper joint geometry, use of an electrode with too large diameter and improper position and incorrect handling of the electrode.

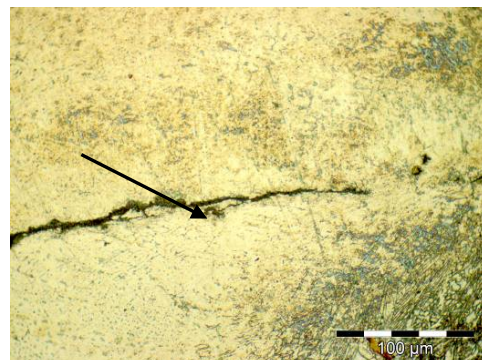
Fig. 17. Heat affected zone - HAZ (500x) – sample 2.1

Analyzing figure 17 in the root area of the weld was identified a crack developed from the inclusion at the top of the weld. Cracks are considered a dangerous defect and are not allowed. It can be defined as a discontinuity of material, having an elongated shape, a very small radius of curvature in the tip area and an opening between its flanks.

Among the main causes of cracks in welded joints are the chemical-mechanical incompatibility between the filler material and the base material, the use of too low welding current, the use of a high cooling rate, the excess participation of the base metal in the formation of the seam, lack of preheating or insufficient preheating temperature.

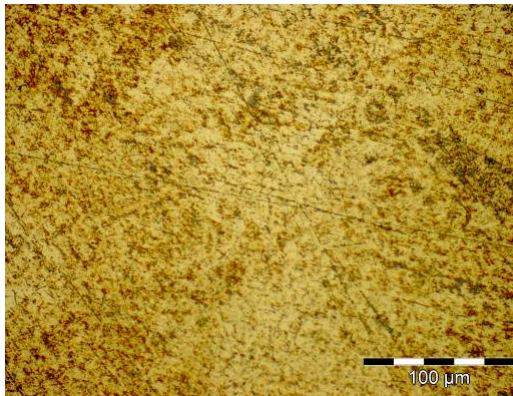
Fig. 18. Welded seam (500x) - sample 2.2

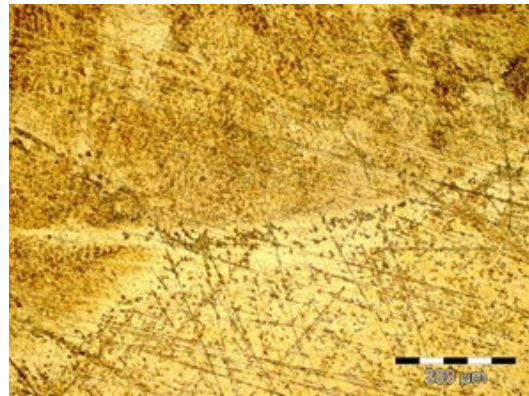
Fig. 19. Heat affected zone– HAZ (200x) - sample 2.2

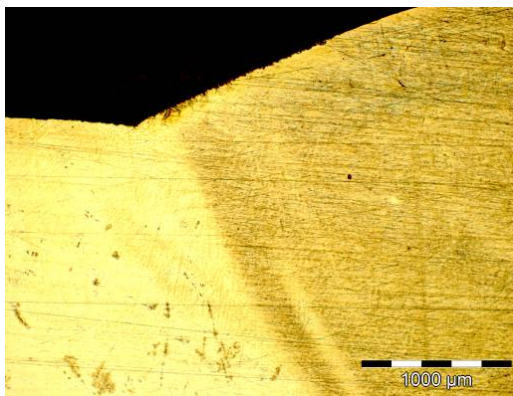
Fig. 20. Macroscopic view of the welded seam (50x) - sample 2.3

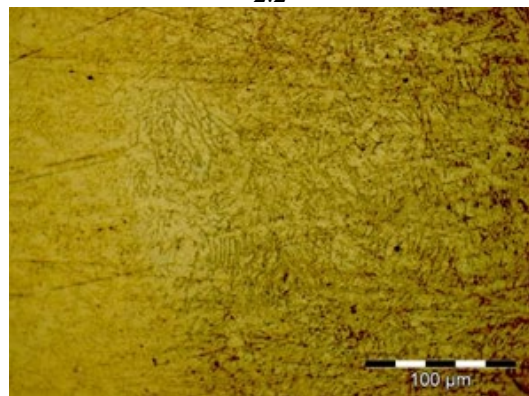
Fig. 21. Heat affected zone– HAZ (500x) – sample 2.3

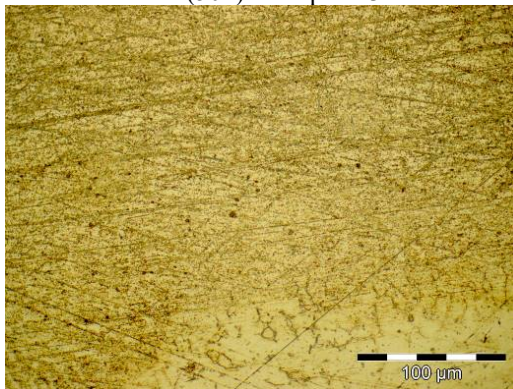
Fig. 22. Welded seam (500x) - sample 2.4

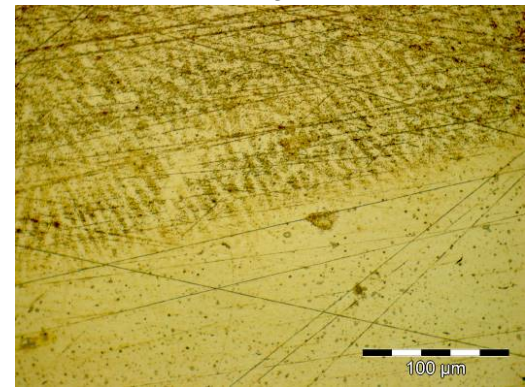
Fig. 23. Heat affected zone– HAZ (500x) – sample 2.4

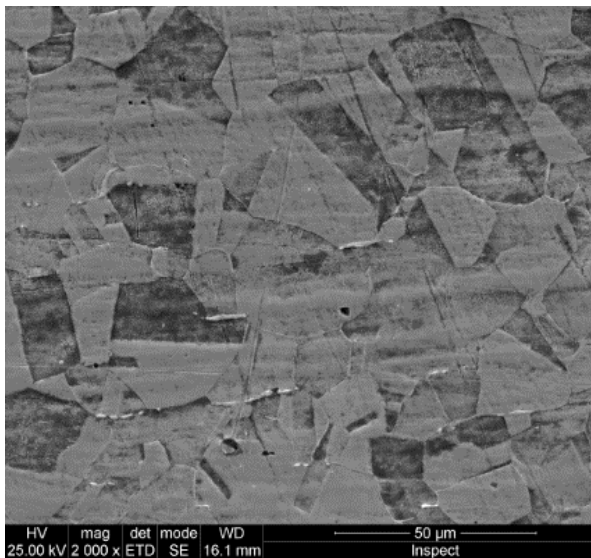
Fig. 24. Base material (2000x) - sample1.1

The base material is an austenitic stainless steel, characterized by the polyhedral microstructure of austenite with sliding planes of specific atomic blocks (twins). On the boundaries of the austenite grains, the presence of the delta ferrite, in the form of elongated islands, of a lighter color in relation to the crystalline austenite grains, is observed.

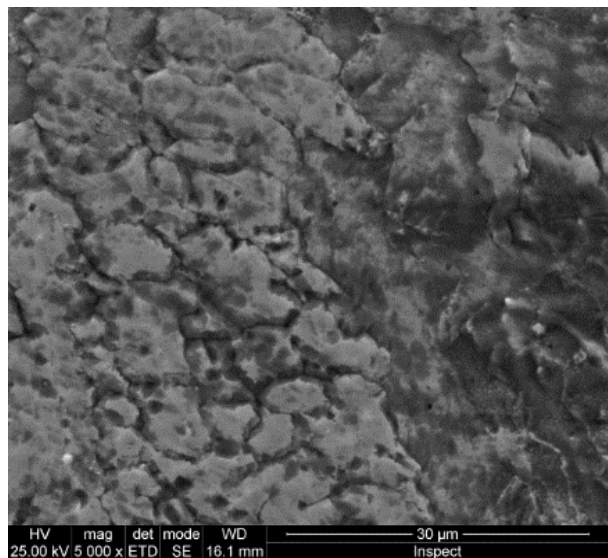
Fig. 25. Welded seam (5000x) - Austenite - dendritic microstructure and fine films of inter-granular delta ferrite – sample1.1

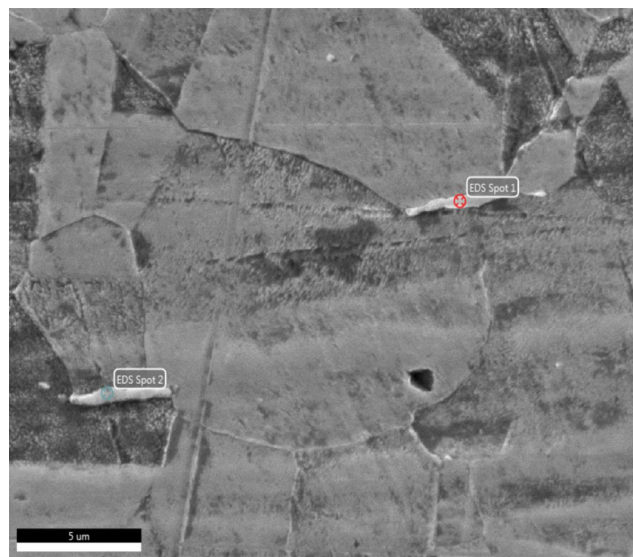
Fig. 26. Micro-zone analysis of the base material (on the delta ferrite islands) – sample 1.1

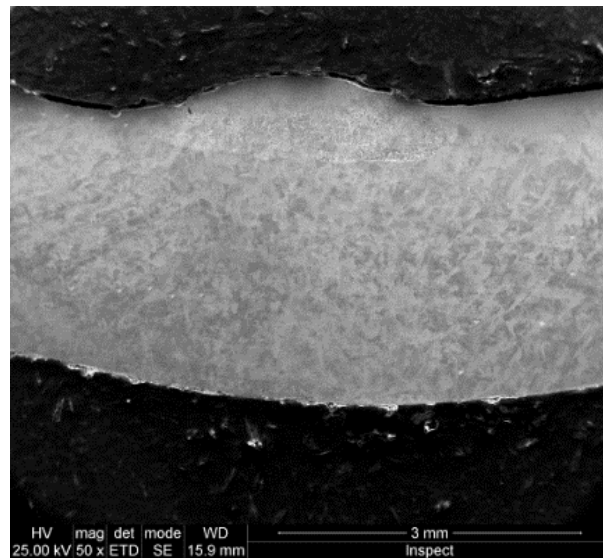
Fig. 27. Welded seam (50x) – sample 1.2

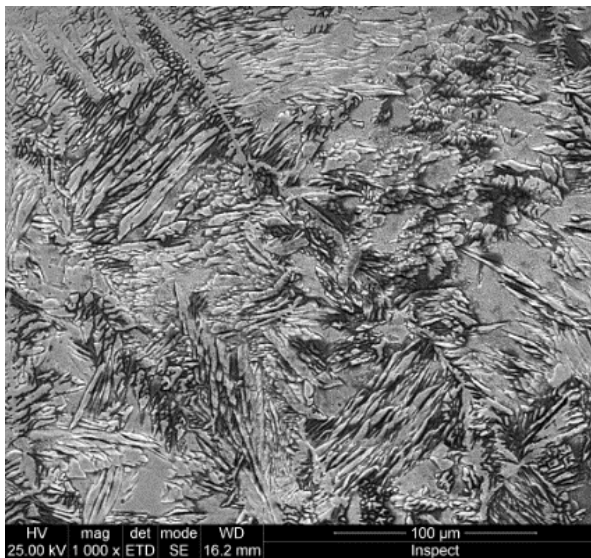
Fig. 28. Welded seam (5000x) Austenite, ferrite and martensite structure - sample 1.2

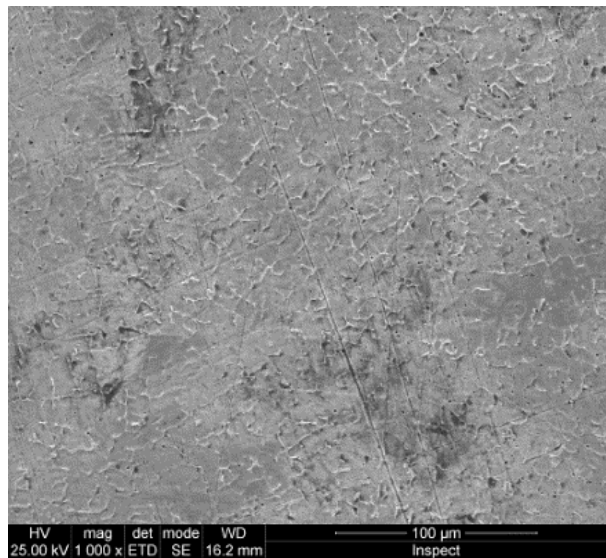
Fig. 29. Welded seam sample 1.2 (1000x)
