CAVITATIONAL EROSION RESISTANCE CONSIDERATIONS FOR ALLOY 6082 STATE T651

The study presents the results of experimental research on the behaviour and resistance to vibratory cavitation erosion of the structure of aluminum alloy 6082 state 651. The analysis performed on macro and microscopic images shows the degradation mode of the microstructure, and the comparison with alloy 5083 state H111, using the specific parameters of cavitation erosion resistance recommended by ASTM G32-2016 standards, suggests an insignificant difference. Discussions of the plots containing experimental values of the cumulative eroded mass created by cavitation erosion and the related velocities using averaging curves show a behaviour strongly dependent on the nature of the blank, structural homogeneity, mass of intermetallic compounds and mechanical property values.

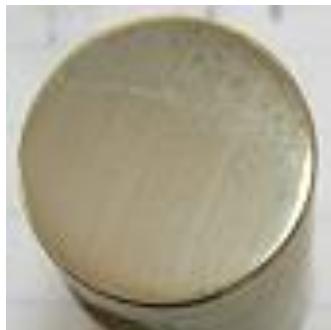
Fig. 2. Sample surface before exposure to cavitations

According to the test rigors at the start of the cavitating test, the surfaces to be exposed to cavitations were polished to a roughness, $Rz = 0.2 \div 0.8 \mu\text{m}$, fig.2

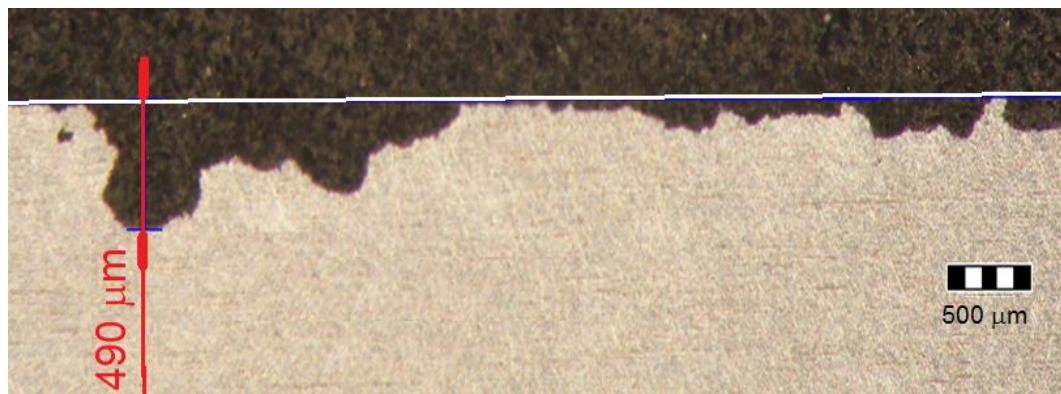
The metallographic optical microscope analysis, fig.5, shows that in cross-section the caverns are uneven, with depths varying greatly between them, reaching very large dimensions, about 490 μm .

Fig. 5. Metallographic appearance in cross section of specimen subjected to cavitational attack after 165 minutes

The complex fractographic analysis carried out on the surfaces subjected to cavitation attack on alloy 6082 samples revealed that the alloy shows numerous caverns, non-uniform on the exposed surface, with sizes ranging from very small, a few microns, up to 490 μm (as shown in Fig. 5). The attack extends over an area of more than 3/4 of the total diameter, and the appearance is brittle through cleavage. The behaviour observed on alloy 6082 in the as-delivered condition is that of a material with extremely low resistance to cavitation corrosion.

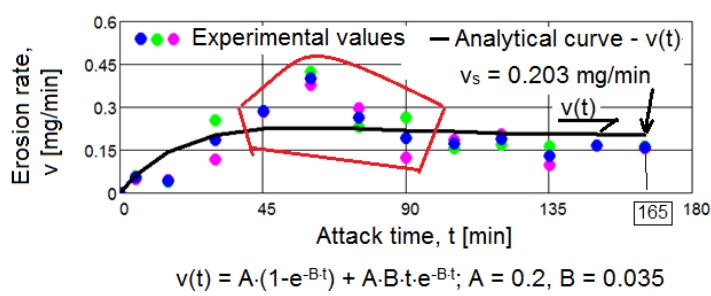
In Figs. 7 and 8 are shown the diagrams used to evaluate the behaviour and resistance to cavitation erosion. They contain the values of the cumulative mass losses and the corresponding mass loss velocities corresponding to the intermediate durations which, summed up, give the total cavitation attack duration (165 minutes).

Fig. 8. Variation of mean erosion rate with duration of exposure to cavitations

The data in Fig. 7 and 8 show the following remarks:

minutes the differences between the velocity values (fig.8) are almost identical, shows the homogeneity of the structure of the three samples and the running of the experiment with well controlled parameters;

3. the most significant mass losses occur between 45-120 minutes;
4. significant velocity jumps occur in the 45-90 minute interval;
5. the shape of the approximation/measurement curve of the experimental values of the velocity, with a slight decrease towards the stabilization (final) value, is a specific one for surfaces with average mechanical properties in value (see Table 2), which offer high plasticity but poor resistance to cyclic cavitation stresses [6, 9, 19, 20, 23, 24];

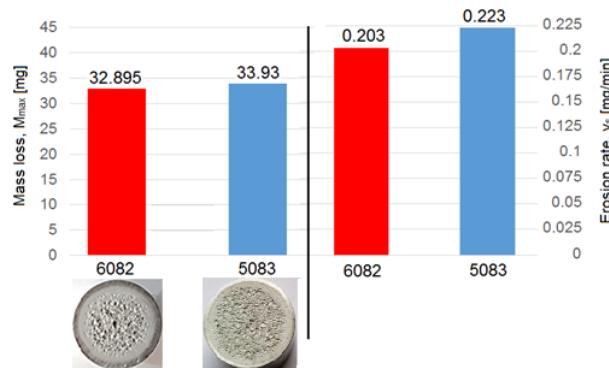
To evaluate the resistance of the structure of alloy 6082 state T651 to erosion generated by vibratory cavitations, the histogram in Fig. 9 was constructed, using the photographic image and the reference parameters obtained when testing aluminium alloy, semi-finished state 5083 state H111, characterised by the following values of mechanical properties [4]: $R_m = 235.367$ MPa, $R_{p0.2} = 135.78$ MPa, $HB = 80.1$, $KCU = 5.3$ J.

Fig. 9. Histogram of cavitation erosion resistance

The photo images, from below the histogram (fig.9), show the similarity between the size of the caverns and the eroded area. This observation is confirmed by the differences between the values of the M_{max} (about 3%) and v_s (about 9.8%) parameters shown in the histogram, recommended by ASTM G32 standards. These values are within the range of deviations accepted for a complex acting process such as cavitation hydrodynamics [5, 19-21]. Practically, these differences are of the order of those recorded between the experimental values of the three samples tested (see Figs. 7 and 8). Therefore, this experiment shows that materials with slightly different structures and with significantly different mechanical properties values, such as those of alloy 6082 compared to alloy 5083 (4 % decrease for R_m , 11.7 % increase for $R_{p0.2}$, 19.55 % decrease for HB hardness and 4.9 times increase for KCU resilience), can have close, even identical, behaviour and resistance to cyclic cavitation microjet stresses. The results reconfirm the complex mechanism, which cannot be dependent only on one single factor characteristic of the material (microstructure or only one of the mechanical properties). These differences can be substantial if technologies and treatments are applied to modify the values of the mechanical properties and the type of microstructure [20, 24-26].
