CORROSION BEHAVIOR IN AQUEOUS ENVIRONMENTS OF MARTENSITIC STAINLESS STEELS USED IN HYDROPOWER TURBINE BLADES

The paper presents the results of research carried out on three samples of martensitic stainless steel used in the manufacture of hydropower turbine blades. The experiments were carried out under normal aeration conditions at ambient temperature (22 degrees C) in freshly prepared solutions of 1N potassium sulfate and 3% NaCl. The corrosion rates were calculated using the Tafel slope method.

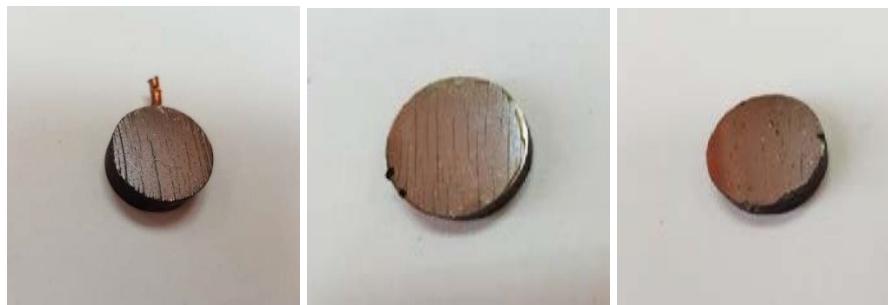
Fig. 9 Macro image of the three samples after the electrochemical corrosion test

Samples 1 and 2 showed large attacks of the order of millimeters that seem to follow a preferential direction on the surface. When analyzing in detail by SEM microscopy of sample 1, it was observed that the attack started at the interface of the ferrite particles with the areas resulting from the decomposition of martensite and continued by the dislocation of large surfaces of the material advancing into intercrystalline material, fig. 10.

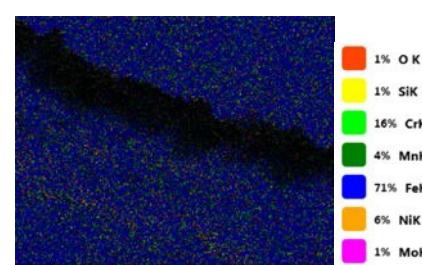
Fig. 15 The distribution of the homogeneity of the elements on the analyzed area from sample 3
