FREIGHT RAIL VEHICLE BUFFING IMPACT TESTING

Railway vehicles must be subjected to a series of tests in order to verify aspects related to safety traffic. These tests are similar for all rail vehicles (locomotives, passenger cars and freight vehicles), in accordance with European standards. In particular, freight vehicles are subjected to a different set of dynamic structural tests (buffing impact tests). Buffing impact tests are carried out in order to test the inertia effects of the vehicle parts and also to test the effect of a load on the superstructures. This paper presents the study of a freight rail vehicle structure and the results for a series of buffing impact tests performed in Romania at the Făurei railway test center.

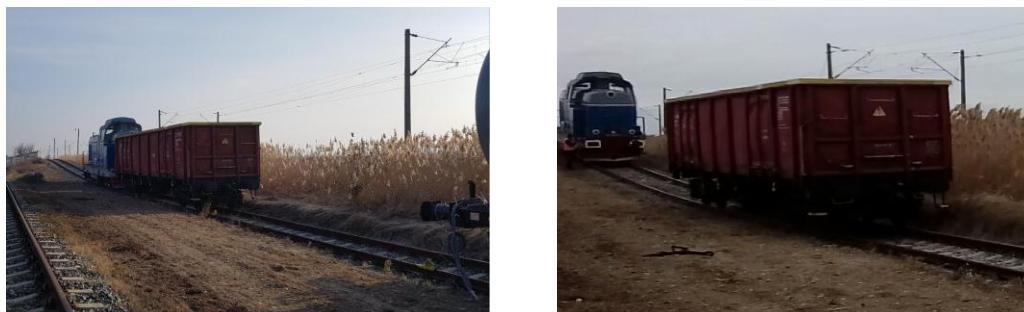
Fig. 1. Railway line equipped with hump

Some of the wagons are operated in special conditions on railway lines equipped with humps (Fig. 1) used to compose or decompose trains. During this time, impact forces transmitted from a structure to another appear between vehicles, as is explained in [1] and [2].

The tested wagon should be stationary and the impact test is carried out using a second rail vehicle as a partner wagon, loaded to a total weight of 90 t which is released from the railway hump towards the tested vehicle [4].

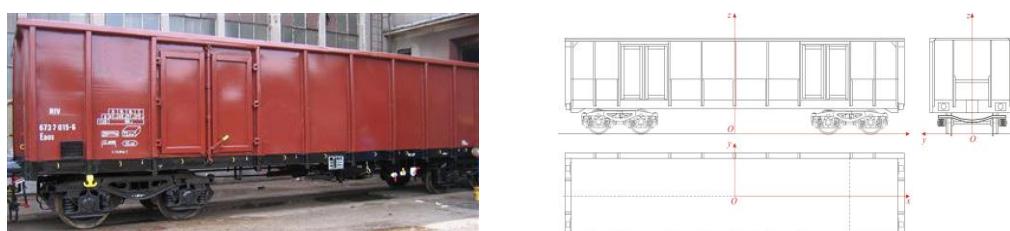
The tested rail vehicle (Fig. 2) is an Eaos type open wagon used for transport of goods like: ore, coal, woods, scrap metal, boxed materials etc.

Fig. 2. Tested wagon

- Length of the vehicle body: 12792 mm;
- Width of the vehicle body: 2772 mm;
- Height of the vehicle body: 1890 mm;
- Body vehicle surface: 36 m²;
- Vehicle mass: 22 t;
- Maximum axle load: 22,5 t [5].

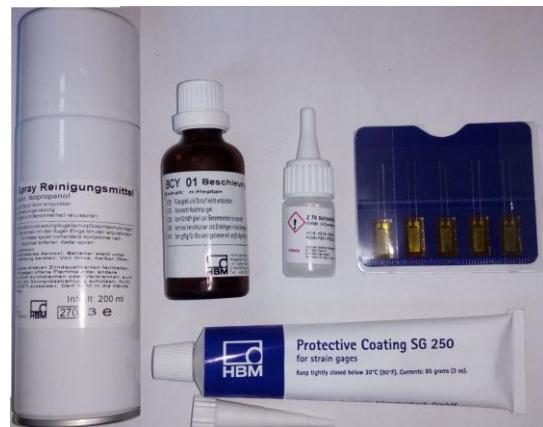
- HBM 1-LY11-10/120 strain gauge;
- HBM RMS 1 spray for surface cleaning;
- HBM BCY01 accelerator for the Z70 glue;
- HBM Z70 strain gauge special glue;
- HBM SG 250 silicone protection for strain gauges;
- HBM connection cables with 4 wires [6].

Fig. 4. HBM materials used for tests

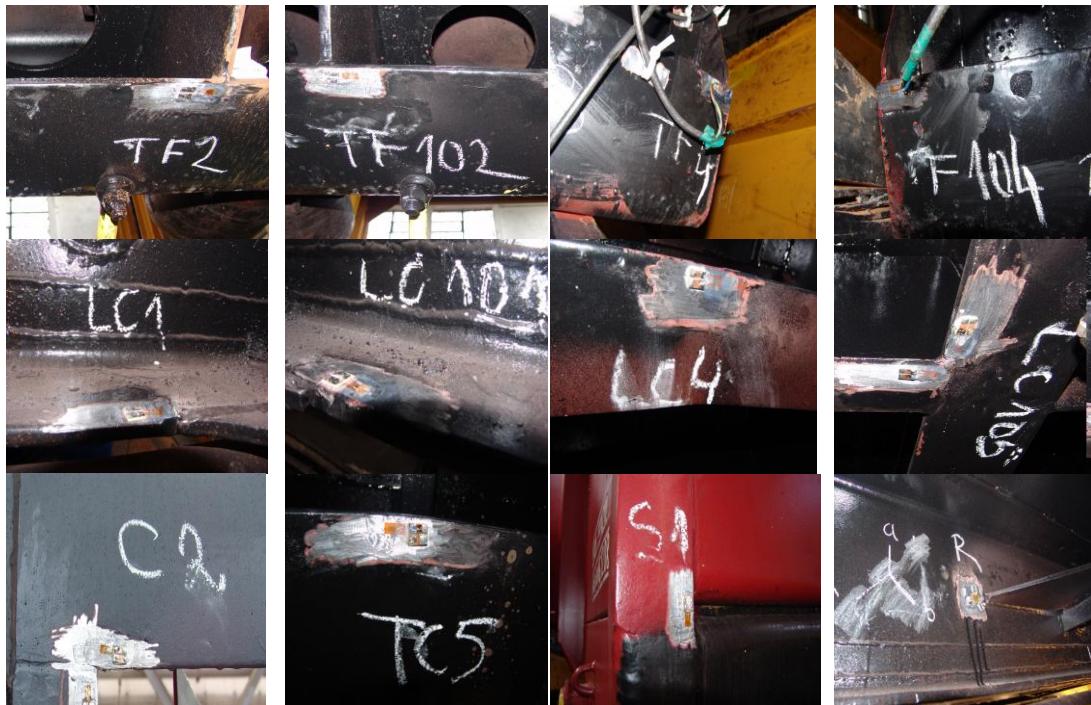
Figs. 5 and 6 show the structure of the vehicle equipped with strain gauges:

Fig. 6. Strain gauges mounted on the vehicle structure

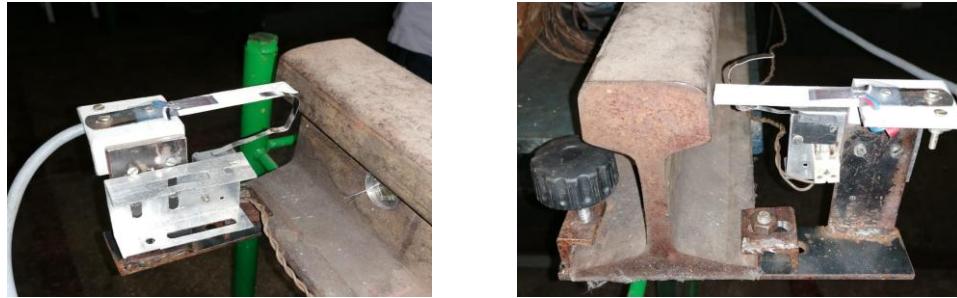
In the case of fully loaded vehicle, the behavior of the vehicle, the evolution of the force, displacement and strains in the measuring points were tracked. The speed of the buffering vehicle was measured using a special device (Fig. 8), mounted at the rail level, before the tested wagon [2].

Fig. 8. Speed measuring device
