## CAVITATION BEHAVIOUR OF A BIODEGRADABLE ZnCu ALLOY

**Keywords:** Zinc-copper alloy, cavitation erosion resistance, stereomicroscopy, biomedical application, cardiovascular applications

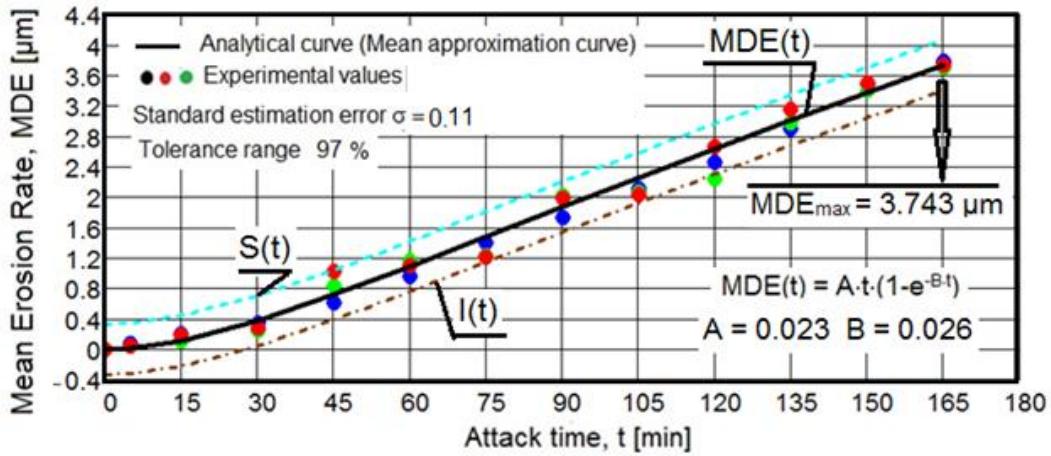
Fig. 3. Variation of the average cumulative depth over the duration of cavitation exposure

Figs. 3 and 4 display diagrams that include the experimentally determined values and the average curves for cumulative erosion depths and average erosion penetration rates in the structure of the surface exposed to cavitation attack.

Data from Fig. 3 shows:

- the average cumulative depth continuously increases throughout the duration of the cavitation attack. After 30 to 45 minutes, the average cumulative depth increases linearly, as indicated by the MDE(t) curves and the evolution of the experimental values;

- the behavior of the three specimens, marked by some differences between experimental values, is determined by each structure's response to the specific mechanism of destroying the peaks of roughness, through creating deformations and generating microcraters, and the response to the impact with pressure forces developed by cavitation microjets, which are influenced by the dendritic microstructures of each, the number and dispersion mode of fragile compounds of

the two basic chemical elements (Zn and Cu), as well as by the use of potential pressure energy for deformation, cracking, breaking, and hardening [6, 25-29];

- the dimensions of the dispersion bands, given by the values of the 97% tolerance fields and the average standard deviation,  $\sigma = 0.11$ , show that the three tested specimens are identical in terms of structural and mechanical property values both within the volume of the specimens and in the cavitated surface area. Additionally, the values of the two parameters (tolerance range and standard estimation error), as well as the dispersion mode of experimental values among themselves and compared to the average curves, confirm the accuracy of the testing program, with strict control of the hydrodynamics of vibratory cavitation through the parameter values of amplitude and frequency of vibrations, power of the electronic ultrasonic generator, the distance between the surfaces of the vibrating and tested specimens, and the temperature of the distilled water.

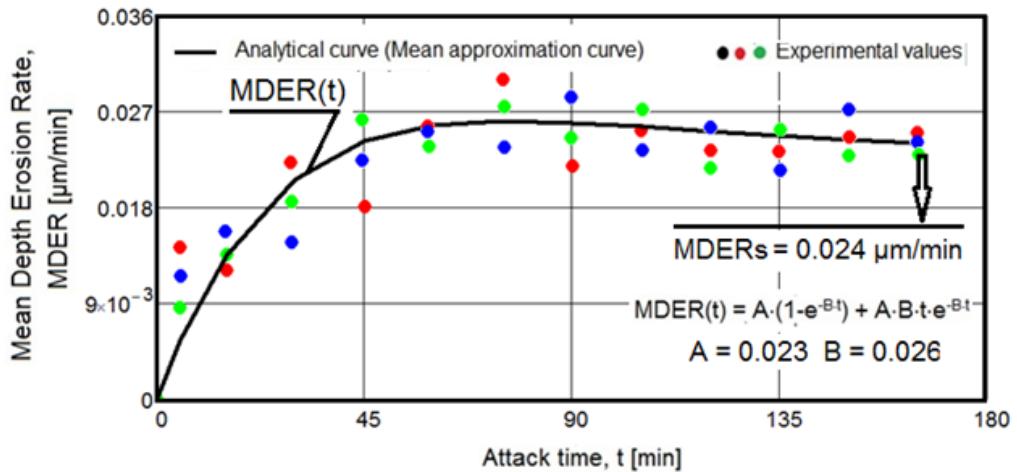
Fig. 4. Variation of the average erosion penetration rate with the duration of cavitation exposure

Data from Fig. 4 confirms the similar behavior of the three specimens, and in addition to the observations made through the analysis of Fig. 3, it is noted the evolution of the MDER(t) curve, which increases with an asymptotic decrease towards the stabilization value  $v_s = 0.024 \mu\text{m}/\text{min}$ , as a result of the absorption of potential energy, created by the impact pressure of the surface with microjets and shock waves. This mode of evolution is beneficial for devices used in the blood circulatory system, as the decreasing tendency of the MDER(t) curve, after reaching its peak value (at 75 minutes), is caused by the hardening of the surface layer, a beneficial effect in terms of increasing the operational lifespan under cavitation conditions [30-32].

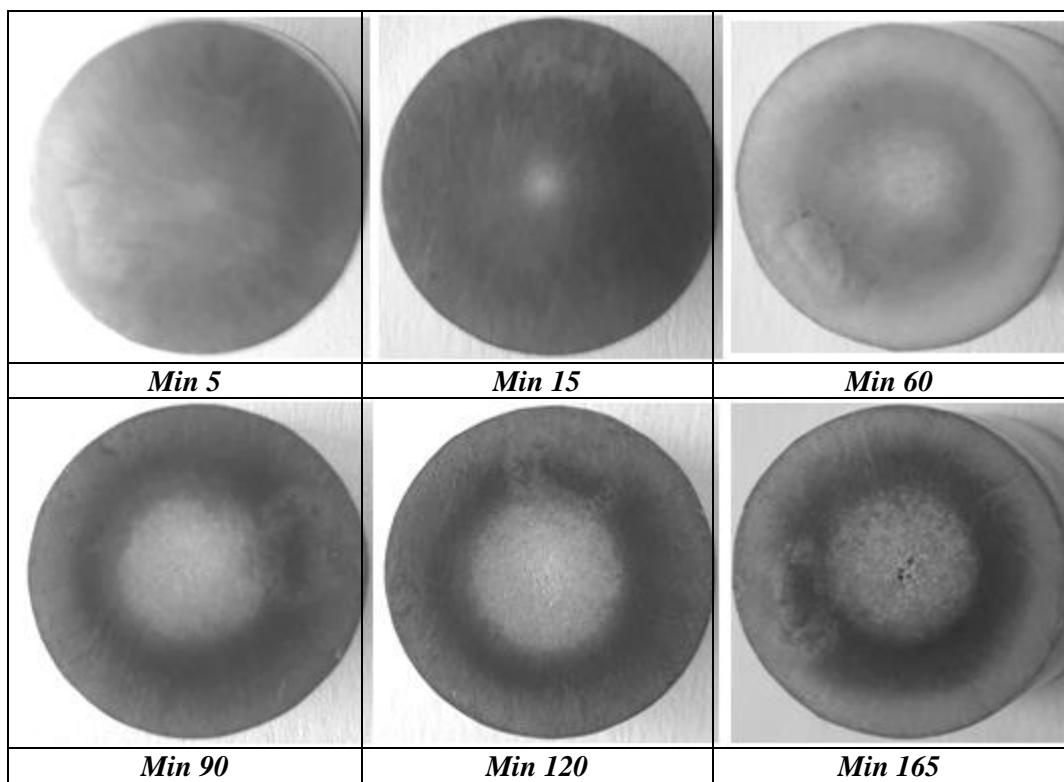
Fig. 5. Macroscopic images (photos) showing the erosion progression in the area of the cavitating surface

In Fig. 5, photographic images from six durations of the cavitation attack are displayed, taken with the Canon Power Shot A 480 camera. These images show how the increase in cavitation duration leads to an increase in the eroded area, both in depth (the area becomes progressively darker) and in extension across the plane of the attacked surface. The microscopic images in Fig. 6, as well as those in Fig. 5, confirm the assertions made in the analysis based on data from the diagrams in Fig. 3 and 4. Note: The images in Fig. 6 were obtained using a stereomicroscope after sectioning the specimen perpendicular to and along the diameter of the cavitated surface.

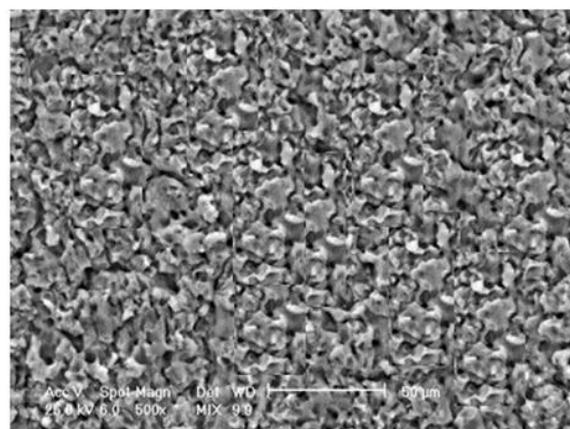
a)

Fig. 6. Microstructural appearance and cavities on the eroded surface, after completing the 165-minute test: a- SEM fractographic image, in frontal section, b- stereomicroscope image, in cross-section

**Note:** The images in Fig. 6 were obtained using a stereomicroscope after sectioning the specimen perpendicular to and along the diameter of the cavitated surface.

The shape of the cavities in these photographic and microscopic images indicates that the sizes of the grains expelled upon impact with cavitation microjets are small, characteristic of structures with high resistance to cavitation stresses [15, 20, 25, 26, 33], which, through biodegradation, can dissolve quickly in the blood circulatory system, thus ensuring a long life for devices used in cardiovascular surgery without endangering life. The aspects captured at 500x magnification (Fig.6a) display a brittle, shiny crystalline appearance, with flattened cavities. However, the shapes of the cavities (see images obtained with the stereomicroscope, Fig.6b) call for caution/medical assistance in cases involving cardiac patients with devices made from these alloys, because from the perspective of hydrodynamics in the blood circulatory system, the use of stents is necessary and beneficial but also disadvantageous for two reasons: 1- because they degrade rapidly, and 2- because these cavities alter the configuration of the hydrodynamic field, generating strong turbulence and pressure variations [6, 34], with effects that can become problematic (even destructive) for the cardiac stability of the patient. The fractographic analysis performed with the scanning electron microscope (Fig. 6a) allows for the evaluation of cavitationally eroded surfaces. Thus, a surface with fine interconnected cavities in a network is noted, with intergranular propagation of the fracture front. The cavities are extremely fine, with an average size of 10-30 $\mu$ m. The general appearance of the cavitationally eroded surface is that of intergranular brittle fracture. The analysis with the stereomicroscope in cross-section allowed the measurement of the instantaneous penetration depth of the cavitation attack, which is 21 $\mu$ m (Fig.6b).

Fractographic analysis conducted with the scanning electron microscope allowing the evaluation of cavitationally eroded surfaces. A surface with fine interconnected cavities in a network was noted, with intergranular propagation of the fracture front. The cavities are extremely fine, with an average size of 10-30  $\mu\text{m}$ . The general appearance of the cavitationally eroded surface is that of intergranular brittle fracture. Analysis with the stereomicroscope in cross-section allowed the measurement of the instantaneous penetration depth of the cavitation attack, which is 21  $\mu\text{m}$ .
