VIBRATIONS LEVEL ANALYSIS DURING THE OPERATION OF PUMPING STATION GÂLCEAG

During spring of 2006, both hydro units of the Gâlceag pumping station have been damaged, the diffuser vanes being broken or deformed. This is why it became important to analyze the operating behavior under the vibration level aspect for the pumping units.

The aim of this study is to analyze the vibration levels for the two pumping units of the Gâlceag station.

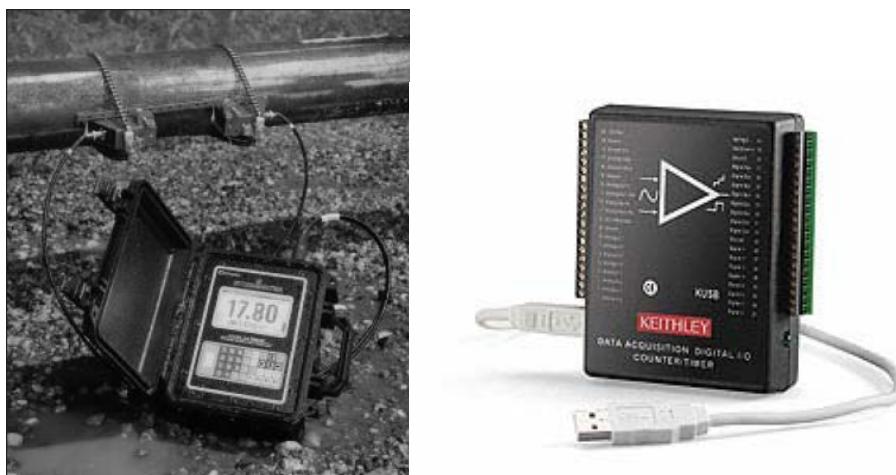
For discharge measurement was used a portable flowmeter CONTROLOTRON 1010P. It was connected to a KUSB – 3100 data acquisition module (see figure 1).

Fig. 1. Flowmeter and data acquisition module.

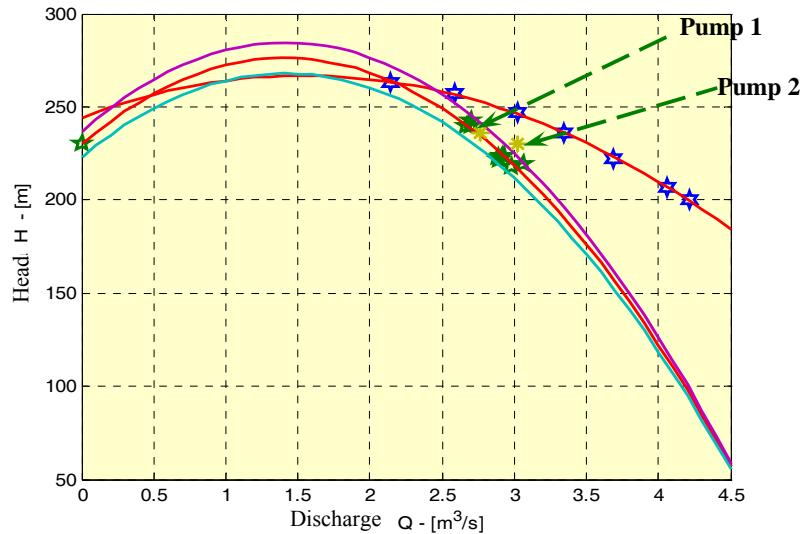
The first step in data processing was analyzing the position of the obtained operating points on the pump operating characteristic. In the figures 2, 3, 4 there are presented the obtained results.

It is obvious that the operating points obtained respect the operating characteristic resulted after processing the data from the two previous measuring campaigns. (made for pump 1).

Fig. 2 – Head characteristic curve $H = H(Q)$ provided by the constructor and resulted from measurements and the uncertainty domain.

It can be seen that the operating points for pump 1, respectively pump 2, operating isolated and in parallel, confirms the results from others measurements campaigns, the pumped flow rate being smaller that those given by the manufacturer, without supplementary energy consumption. The operating points are situated right on the curves (see fig. 2, 3, 4).

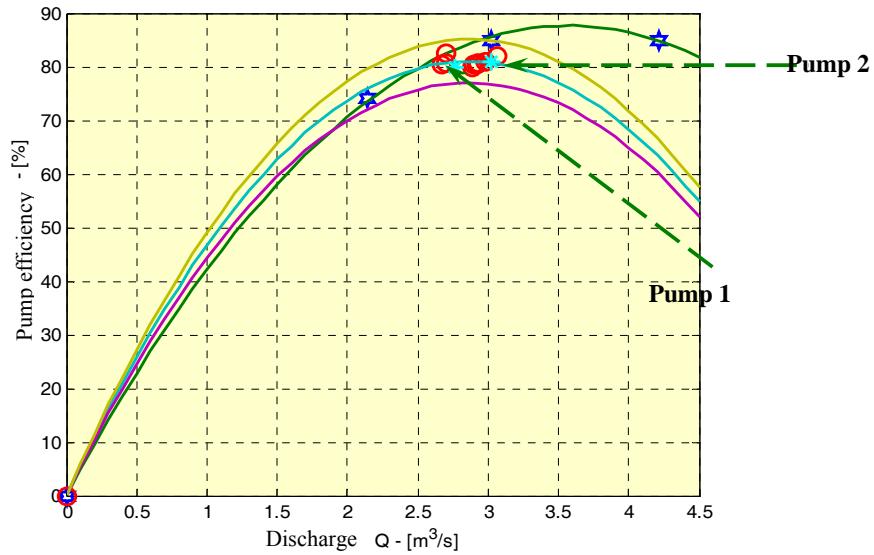
Fig. 3 – Efficiency characteristic curve $\eta = \eta(Q)$ provided by the constructor and the resulted from measurements and the uncertainty domain

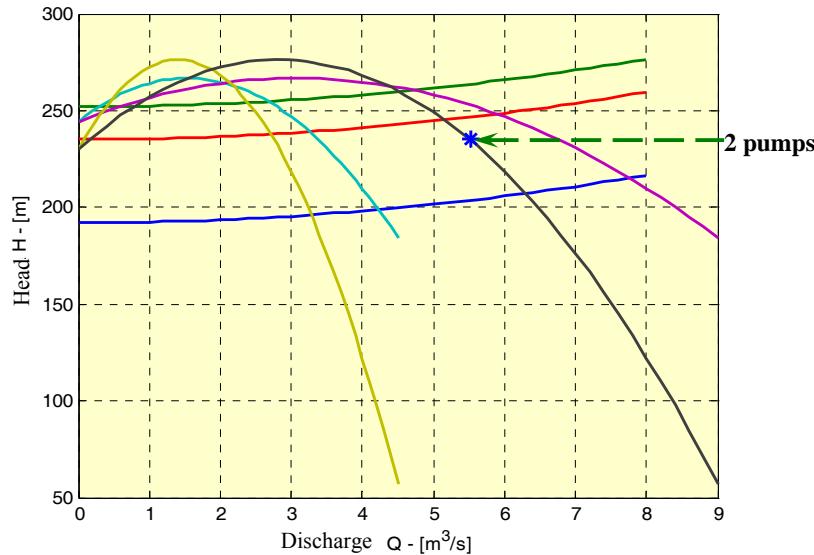
Fig. 4 – Determinarea punctelor de funcționare a stației pentru sarcinile geodezice maximă și minimă

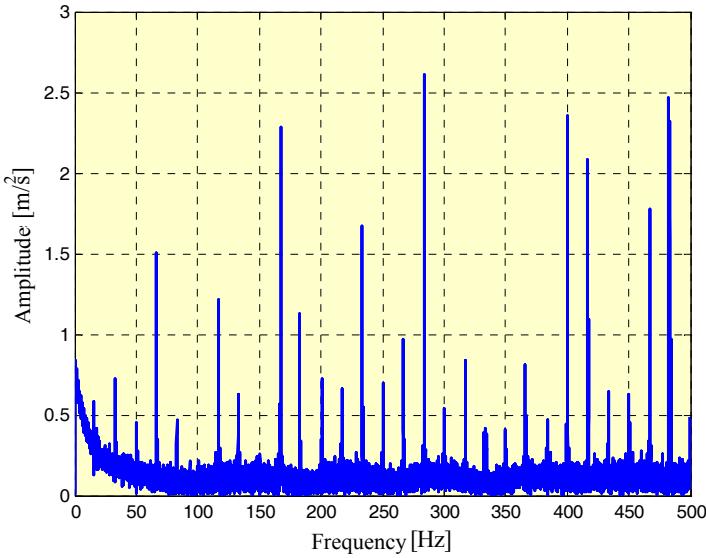
Fig.5 – The spectrum obtained when the vibration transducer is placed on the bearing opposite to the engine, radial orientated – pump 2

Because of the high amplitudes registered at relatively low frequencies it can be considered that, in the case of the pump 2 operation, there are mechanical vibrations of rotating parts (see fig. 5). Those high amplitudes are not found in the other cases of operation at pump 2 (fig. 6 and 7) and they can be neglected. In the measurements made at pump 1, similar values had not been found (fig. 8 and 9).

- it is considered that the bearing opposite to the engine at pump 2 has a very good running behaviour, the level of vibrations being 1.3 mm/s;
- the bearing next to the engine of pump 2 is considered to have a very good vibrations behavior, with a level of 0.16 mm/s on the radial direction and 1.3 mm/s on axial direction;
- the bearing next to the engine of pump1 is considered to have a very good operating behavior, the level of vibrations being 0.15 mm/s on radial direction and 0.91 mm/s on axial direction.

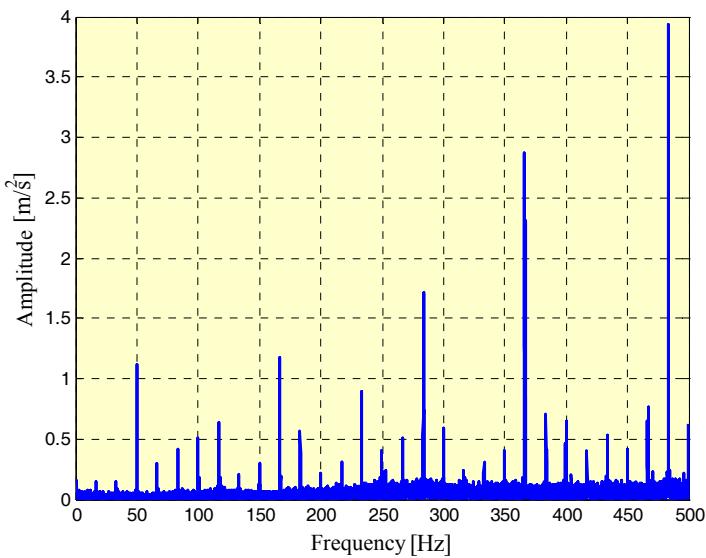
Fig.6 – The spectrum obtained when the vibration transducer is placed on the bearing next to the engine, radial orientated – pump 2

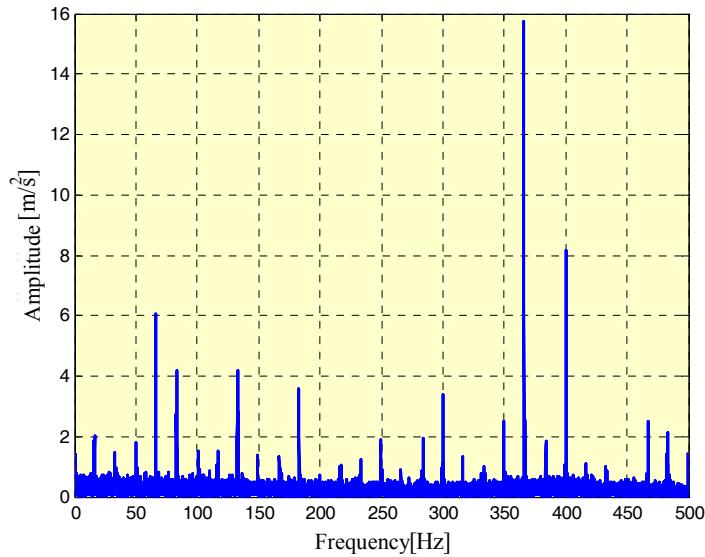
Fig.7 – The spectrum obtained when the vibration transducer is placed on the bearing next to the engine, axial orientated – pump 2

The component with the biggest amplitude was reached for the bearing next to the engine, axial orientated – pump 2 (6.8 mm/s) corresponding to a frequency of de 366.67 Hz.

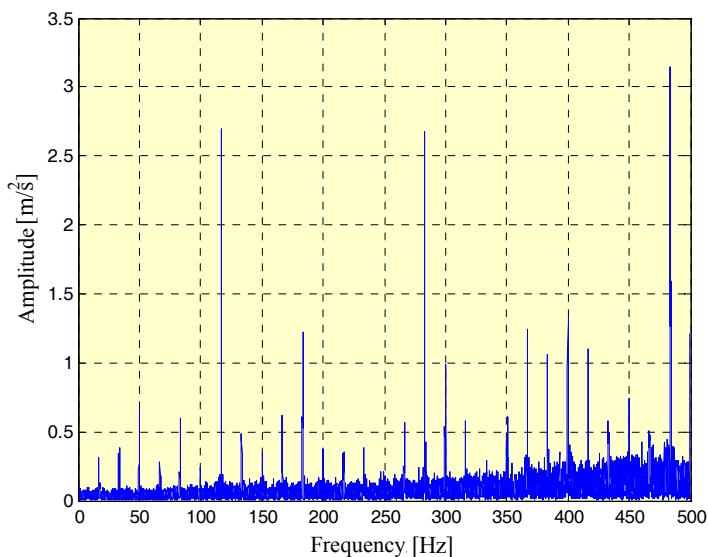
Fig.8 – The spectrum obtained when the vibration transducer is placed on the bearing next to the engine, radial orientated – pump 1

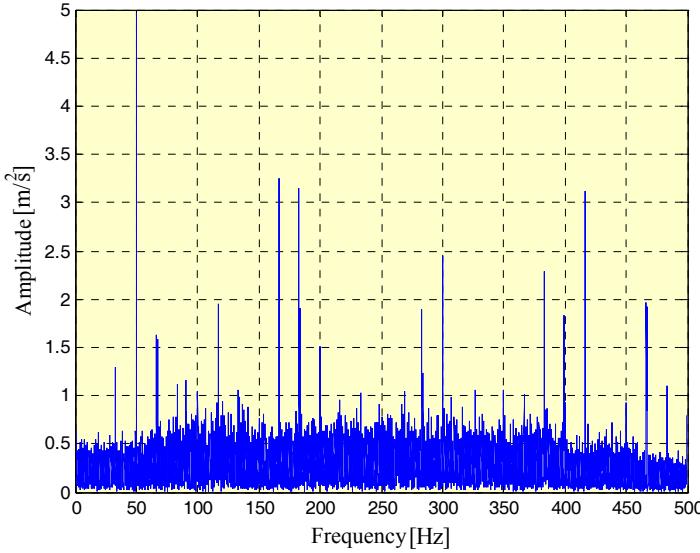
Fig.9 – The spectrum obtained when the vibration transducer is placed on the bearing next to the engine, axial orientated – pump 1
