CONCERNING THE DAMAGE OF STAINLESS STEELS BY CAVITATION EROSION

This paper presents the experimental results of cavitation erosion behavior of some stainless steels. The experimental investigations were performed in magnetostrictive vibrating apparatus at Cavitation Laboratory of Polytechnic University of Timisoara (LMHT) in according with ASTM G32-2006. Several investigations were done on macro structural analysis and electron microscopy where determined many structural features, such as affected area destroyed by cavitation, ratio between affected and nonaffected cavitation areas through diameter measurements. Also, the samples was analysed through X-ray diffraction where there phases were identified.

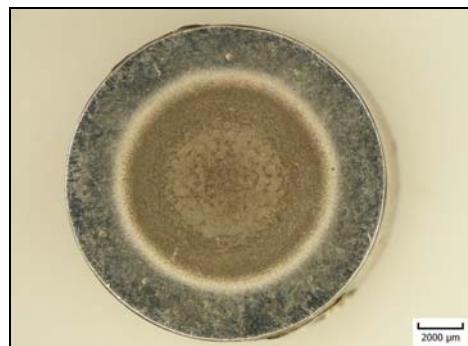
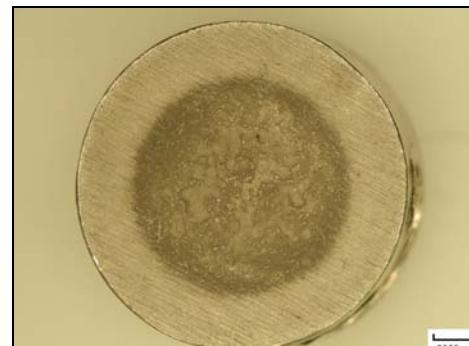
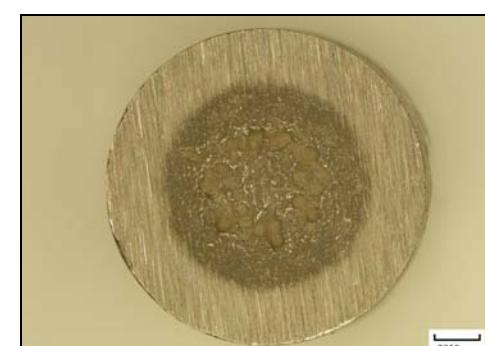
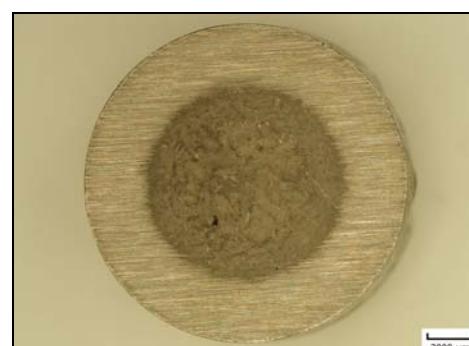
Fig. 1 Stereomicroscopic aspect of experimental samples, x8:

In steel A and steel B the surface attacked by cavitation is found approximately in a concentric circle (Fig. 1a, 1b), one may observe that macroscopic interconnected cavitations with radial disposal so this aspect gives best behavior from a macroscopic point of view.

a- steel A ; b- steel B ; c- steel C ; d- steel D ; e- steel E ; f- steel F ; g- steel G ; h- steel H

Steels C, E, F, with the behavior given in figures 1c, 1e, respectively fig. 1f, has also concentric circle aspects of the affected surfaces by cavitation. The difference from previous images consists a highly degraded surface with many interconnected cavitations and radial disposal.

In the steel D from figure 1d, with 100% austenite, the surface degraded through cavitation is well delimited and it has huge interconnected cavitations with radial disposal.

On steel G, with 60% austenite and 40% ferrite, the surface degraded through cavitation is well delimited and it presents many cavitations with uniform disposal (Fig. 1g). At, steel H from figure 1h, with 80% austenite and 20% ferrite, the cavitation attack is also found approximately in a concentric circle, many cavitations with non-uniform disposal and the right side is more affected by corrosion than the left.
