INTRODUCTION IN FUKUSHIMA WATER LEAK PROBLEM

The purpose of the paper is to present the water leak problem from Fukushima Daiichi Reactors. A short review of the existing condition which represent interest for developing a water stopper technology is presented. In the end it is recommended to use sealing technology which will use liquid metal.

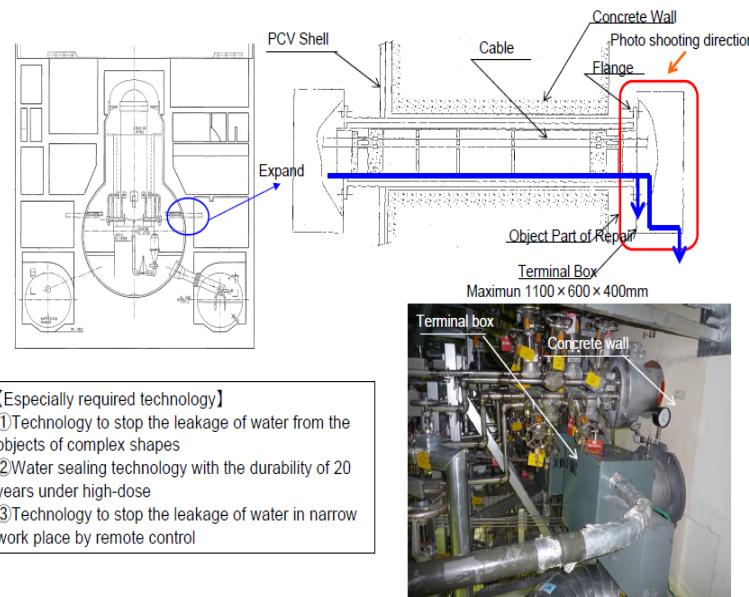
Fig. 1 – Electrical penetration problem [2]

One of the Drywell problems is the electrical penetration. In Fig. 1 it can be observed that water can leak through the terminal box and a solution to seal it must be found before starting to flood the PCV.

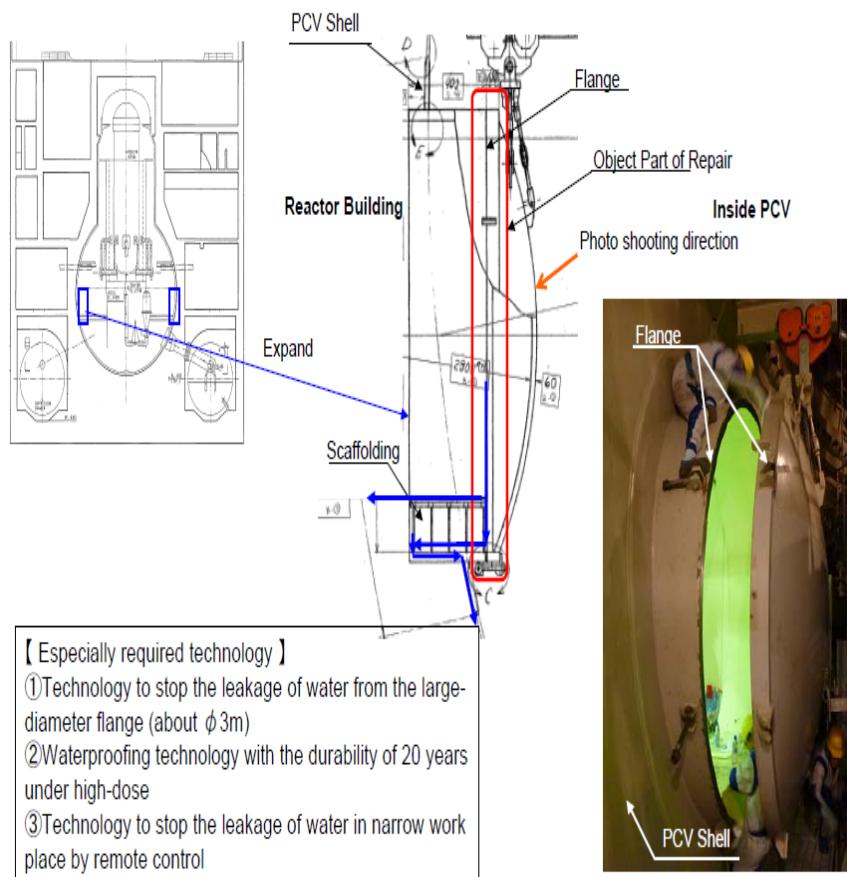
The second drywell problem is the equipment hatch. The water leak present there is hard to seal because of the large dimensions of the parts which needs repairs. The Equipment hatch problem is presented in Fig. 2.

Fig. 2 – Equipment hatch [2]

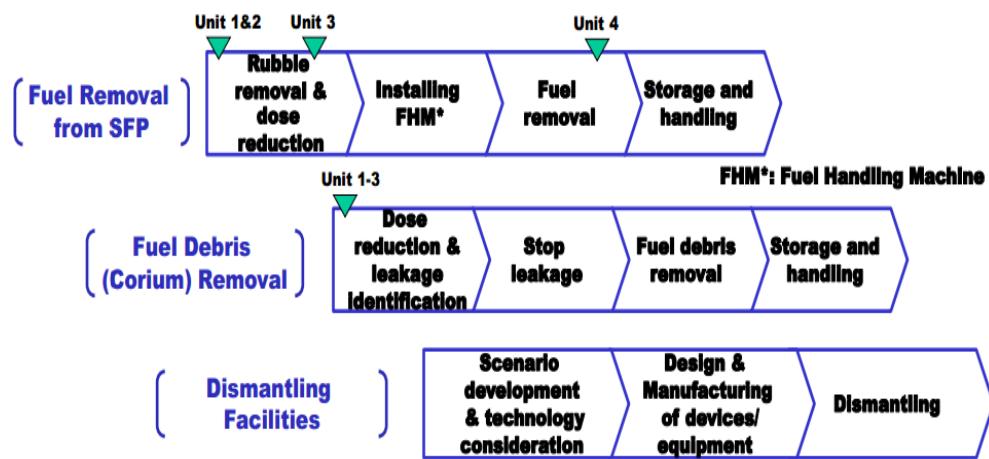
The main steps toward decommissioning [3] are shown in Fig. no. 4, below. The fuel removal from Reactor 4 were finished at the end of 2014 and preparatory works for removing the fuel from SFP (spent fuel pool) and fuel debris from reactors 1-3 are ongoing.

Fig. 4 – Main works and steps toward decommissioning [3]

From Fig. 4 it can be seen that the main work for Units 1-3 is still the dose reduction. This is necessary in order to go to the next steps such as installing the fuel handling machine and start of the fuel removal. In case of Unit no. 4, the fuel removal operations were stopped for two months in order to inspect the crane. The operations were restarted at the beginning of September 2014 and were finished at the end of 2014.

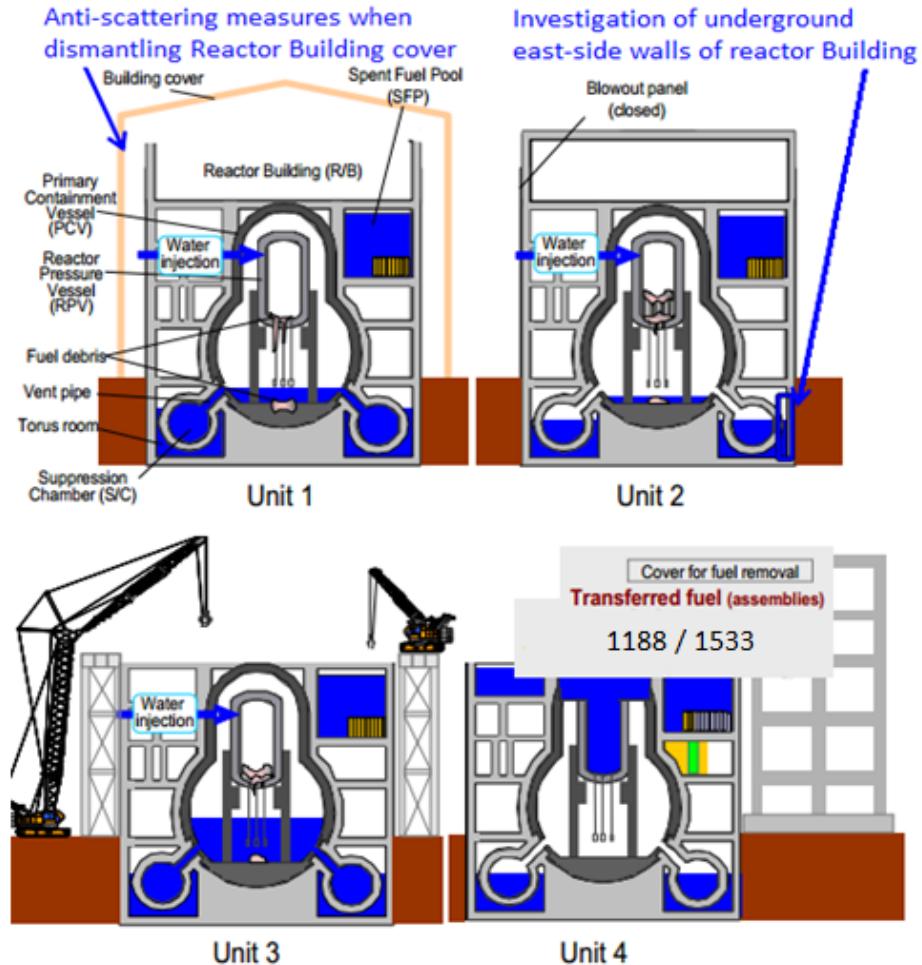
In Fig. 5 the status of the 4 units is briefly shown. The figures present the believed status of the 4 reactors.

Fig. 5 – Believed status of the reactors [3]

It can be seen that the first 3 reactors are the most damaged ones and the reactor core has melted and also escaped the reactor vessel. The most severe problem is believed to be at Reactor 1 where the core of the reactor has totally escaped the reactor vessel. In the first 3 units there is a continuous water injection to cool down the corium. The water temperature inside the reactor is measured by thermocouples in multiple locations. For water stopping reparations, the water temperature, the temperature of the RPV bottom and also the temperature of gaseous phase inside the Reactor Containment Vessel is very important and can be seen in Fig. 6.
