FRACTOGRAPHIC EVALUATION OF THE METALLIC MATERIALS FOR MEDICAL APPLICATIONS

Brandusa GHIBAN¹

Keywords: fractography, stereomicroscopy, titanium, self-locking plate, implant

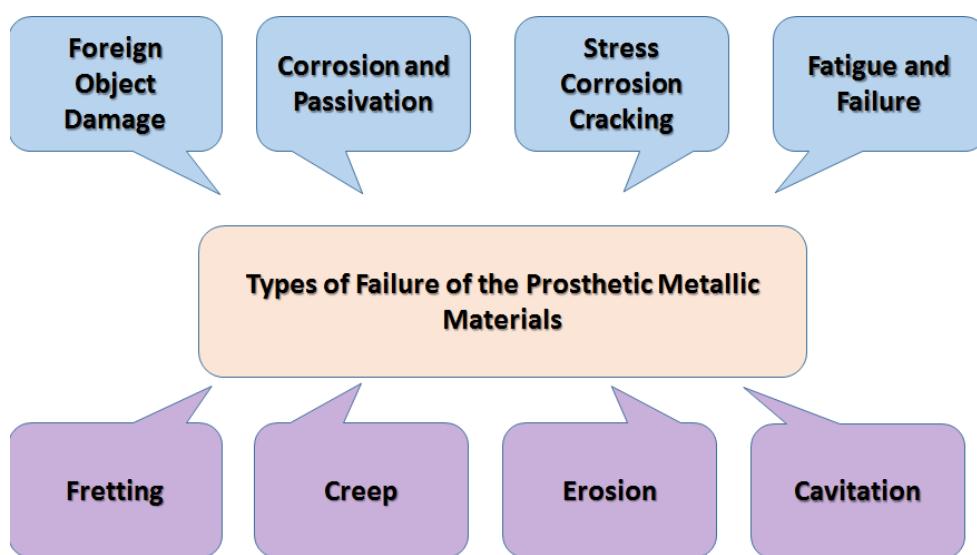
Fig. 1- Main types of failure of the prosthetic metallic materials

Fracture is a form of failure where the material separates in pieces due to stress, at temperatures below the melting point. The fracture is termed ductile or brittle depending on whether the elongation is large or small. There are several types of failure for a given metallic material used as biomaterial, as is illustrated in Fig. 1, such as Foreign object damage (FOD), Fatigue failures, Stress corrosion cracking, Corrosion and passivation, fretting, creep, erosion, cavitation [10-11].

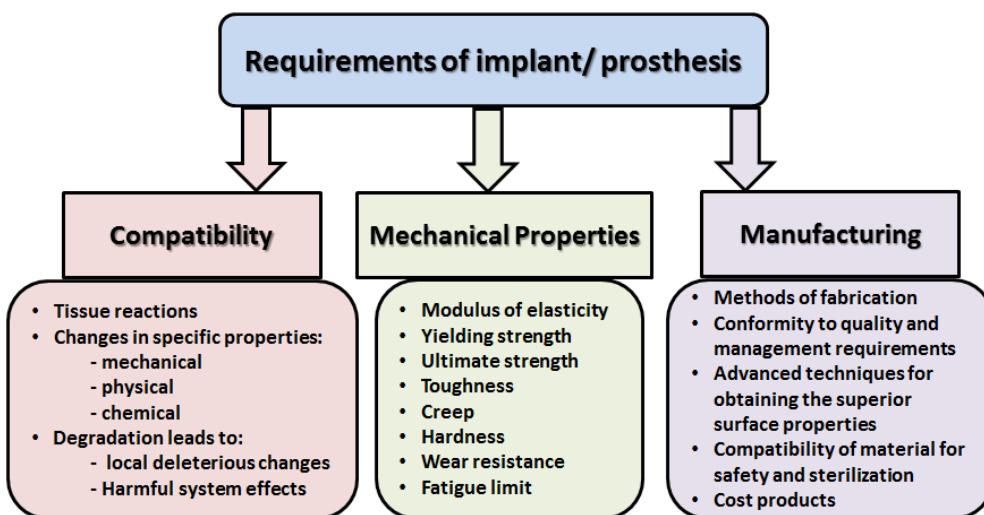
Fig. 2- Requirements of implant / prosthesis

On the other hand, there are specific requirements for the implant / prosthesis, as is given in Fig. 2, such as compatibility, mechanical properties and manufacturing.

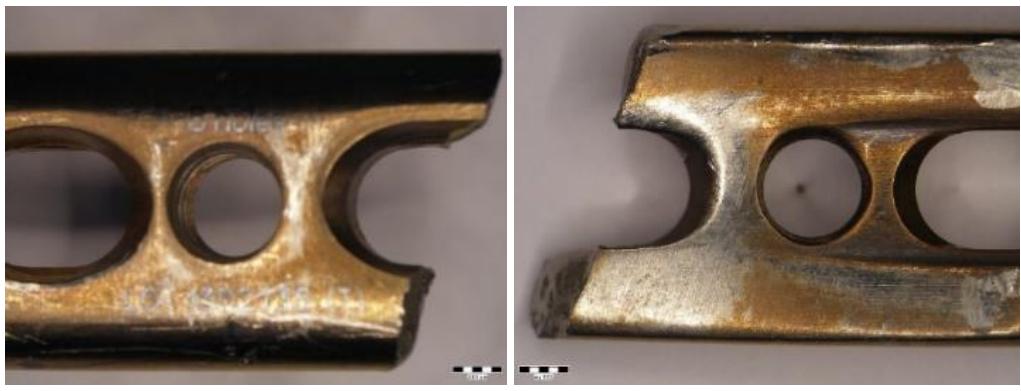
Fig. 3- Different macroscopic aspects of the self-locking plate after stereomicroscopic analysis: a- right side view, b- back side view

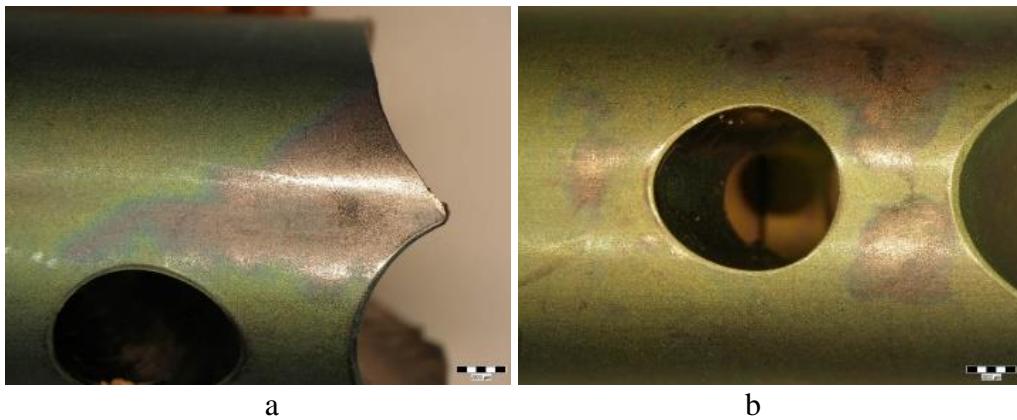
Fig. 4- Macroscopic aspects of the hip rod with the evidence of the fracture head (a) and changing in color at the zone between mounting holes (b)

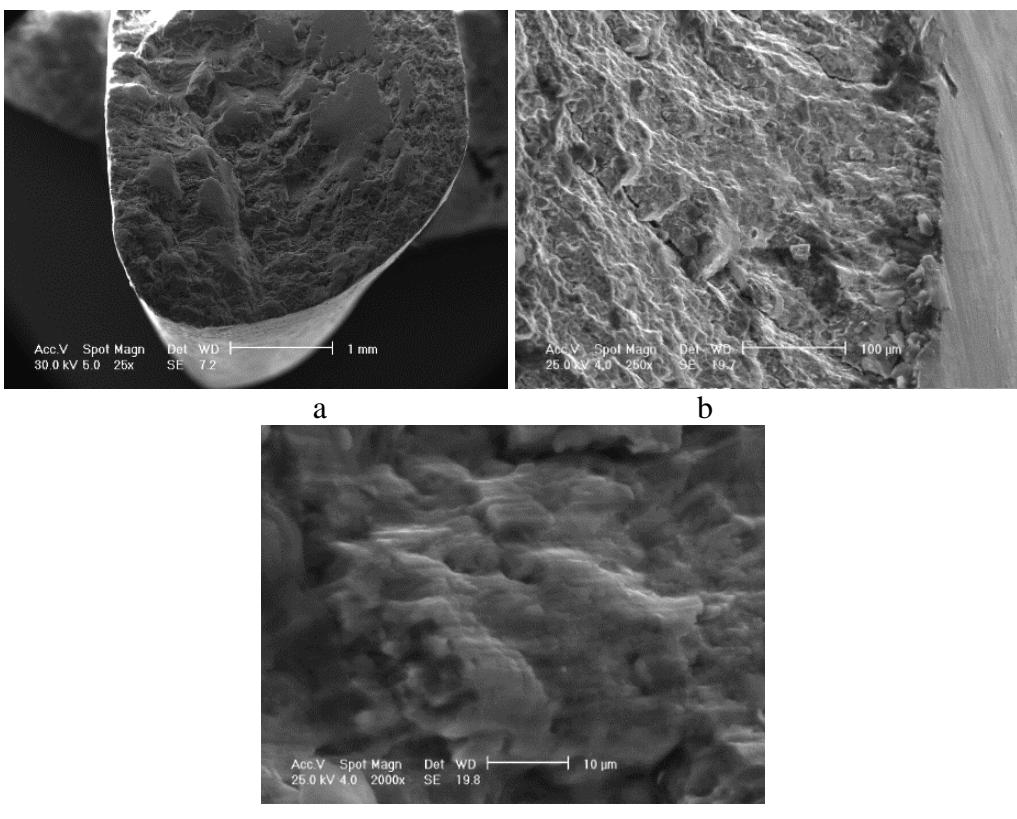
Fractographic analysis made by scanning electron microscopy (Fig. 5) revealed that self-locking plate cracked in an area with high purity embedding. Breaking looks brittle by cleavage transgranular with sharp facets. There were also highlights and intergranular cracks between planes of the cleavage side. It should be noted that after tearing of the two components of self locking plate underwent relative friction that led to chamfering breaking peaks. The analysis

shows that the extraction time to rupture and self-locking plate there was a relatively long period in which the friction surfaces chamfering and breaking.

Fig. 5- Fractographic images at SEM in transversal cross section of the retrieved self-locking plate at different magnifications

Concerning the first case study, complete analysis of the fracture surfaces of the plate-locking led to the final conclusion that the metallic biomaterial which has been made self-locking plate, respectively pure titanium grade 4, has an inadequate chemical purity in term of non-metallic impurities, which has led to fracture within an area of non-homogeneous structure. Breaking looks brittle by transgranular cleavage with sharp facets. There were also highlights and secondary intergranular cracks between cleavage planes. Failure analysis of different metallic implants used in traumatology appear to be very useful for biomaterials scientist but especially to the manufacturers of orthopaedic implants. They must pay attention to the metallic biomaterials microstructure not just to the chemical composition and to the processing technologies that could

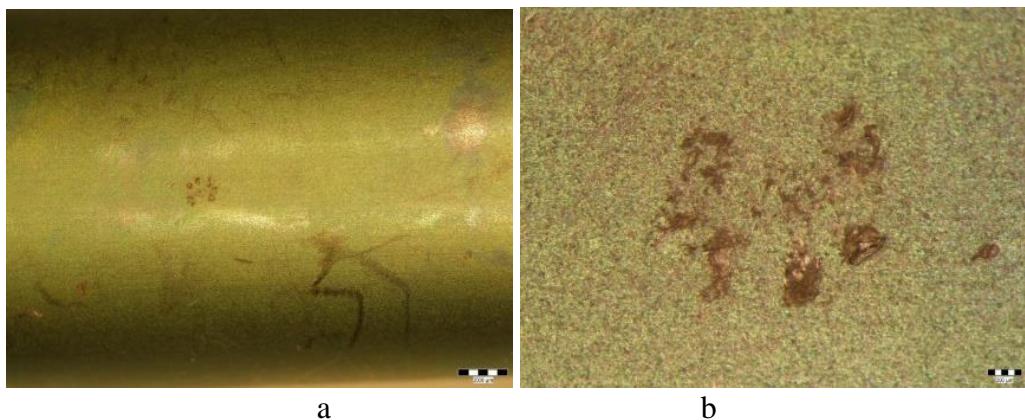
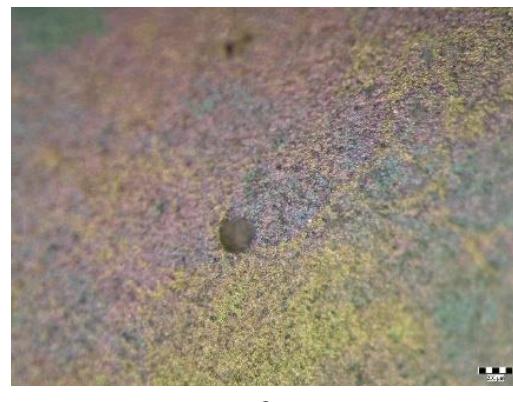
The investigated rod used for hip revision has the dimensions $\Phi 10\text{mm} \times 125^\circ$. Note that the investigated area comes after thread, there are traces of interaction with the bone, such as color changes (Fig. 6a), or the presence of a surface defect (Fig. 6b). We have the observation of two comcatity defects on the rod, either on the external surface (such as macroporozities (Fig. 6a and Fig. 6b), or dimple on internal surface (as is illustrated in Fig. 6c). On the rod under fractographic stereo macroscopic review a number of issues were highlighted, as can be seen in Fig. 7. Both sides breaking the impression of fatigue breaks, with clear evidence of the three specific areas of strength: the initiation of fracture (lateral ends of Fig. 7a and Fig. 7c); propagation area, beach marks, with concentric arcs appearance (as demonstrated in Fig. 7b and Fig. 7d), and the suddenly final rupture (having the appearance chamfered).

Fig. 6- Macroscopic aspects of the hip rod, with the evidence of a compactity defect on external surface (a,b), and a dimple defect on internal surface (c)

Concerning the second case study the rod material is made of titanium alloy type Ti6Al4V, falling trade requirements of ISO 5832. The rod was broken after one year of implantation, having the dimensions as $\Phi 10\text{mm} \times 125^\circ$. Investigation of the area after thread, there are traces of interaction with the bone, such as color change and presence of a surface defect. On macroscopic stereo rod under review were highlighted a number of issues fractographic. Both sides breaking the impression of fatigue breaks, with clear evidence of breaking the three specific areas: the initiation of the tearing (the side ends); the propagation, with beach marks line, appearance concentric arcs, and the final sudden fracture (the remainder heads having beveled appearance). fractographic aspects highlighted the character of fatigue breaks, but compactness of defects, both on the outer surface and in the internal surface of the stem lead to the general conclusion that the material is not as described product, having problems with the technological processes before implantation.

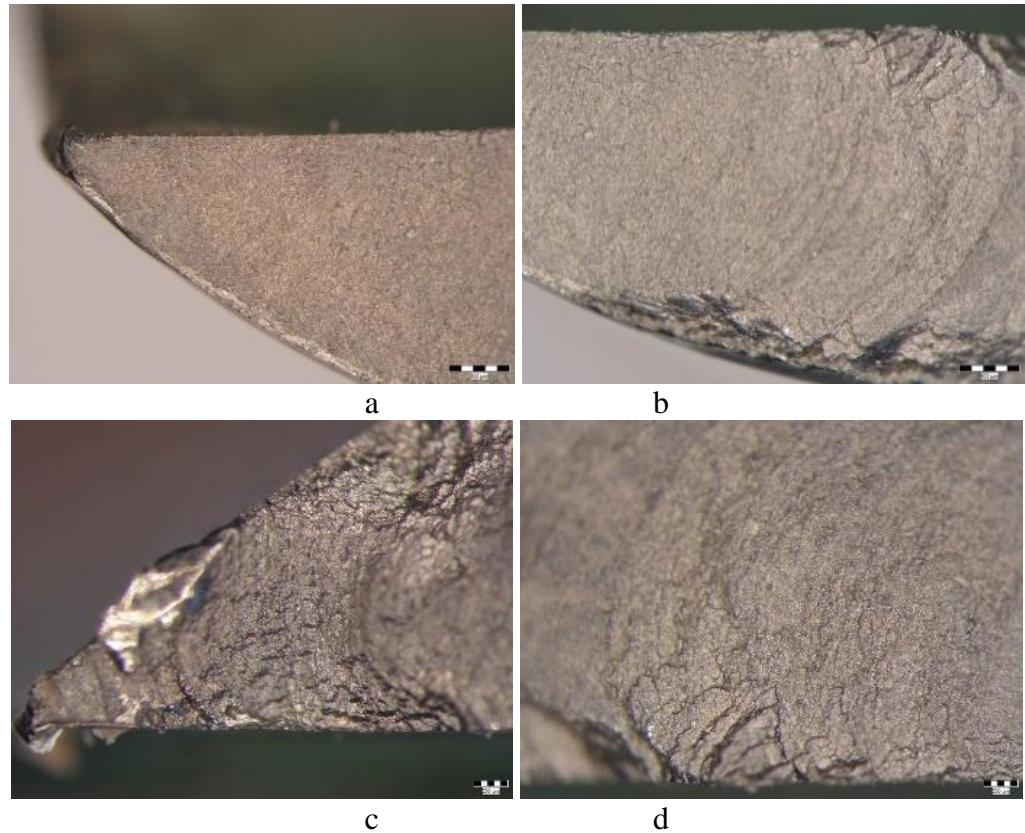
Fig. 7– Fractographic aspects of the hip rod
(a,b lower part band), (c,d upper part band)

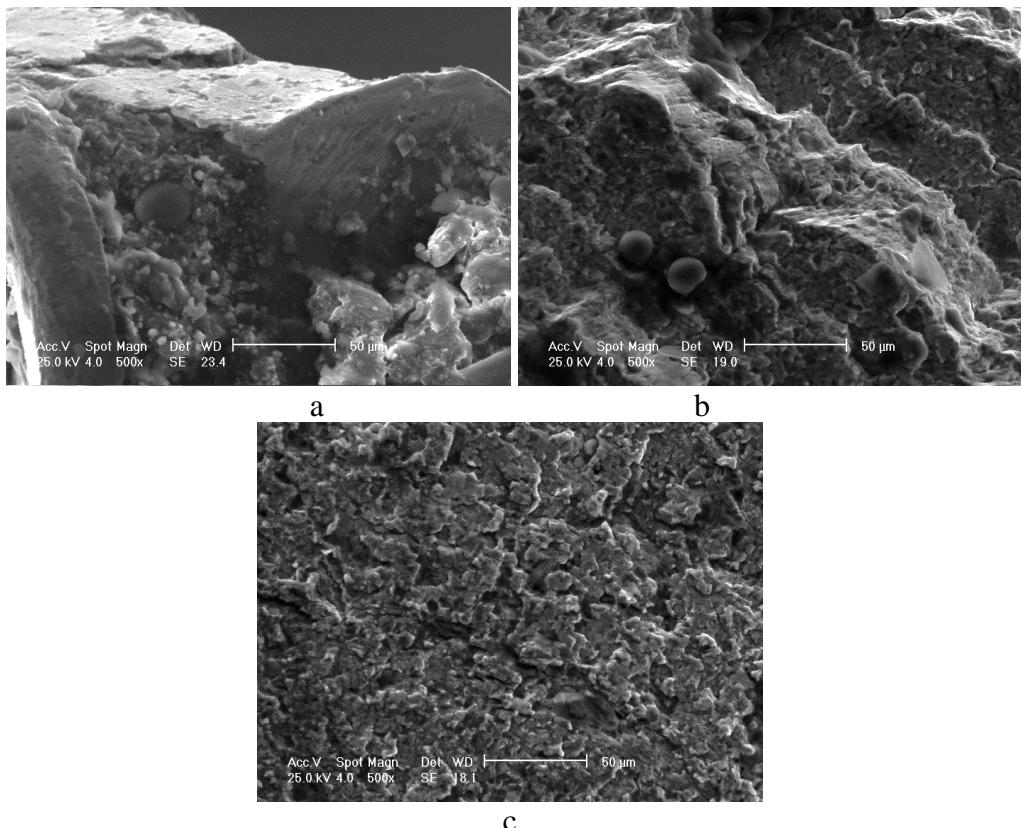
Fractographic analysis made on scanning electron microscope highlighted the character of fatigue breaks, with all specific zone: initiation (Fig. 8a), propagation zone (Fig. 8b) and final fracture (Fig. 8c). The fractographic images from Fig. 8 highlights aspects of fatigue fracture in the final sudden fracture, respectively the opposite end initiate fatigue fracture were evidenced. Breaking character is fragile, by cleavage with numerous fine secondary cracks, and voids, probably between the two phases type α and β present of Ti6Al4V titanium alloy rod belonging hip investigated.

Fig. 8- Fractographic aspects of the rod for hip revision:
a- initiation zone, b- propagation zone, c- final fracture zone
