INVESTIGATION THE CORROSION OF HEAT TRANSFERRING UNIT IN HYDROGEN PEROXIDE & SODIUM CHLORIDE SOLUTION USING WEIGHT LOSS MEASUREMENTS

Keywords: Heat transferring unit, austenitic stainless steel, corrosion rate, weight loss

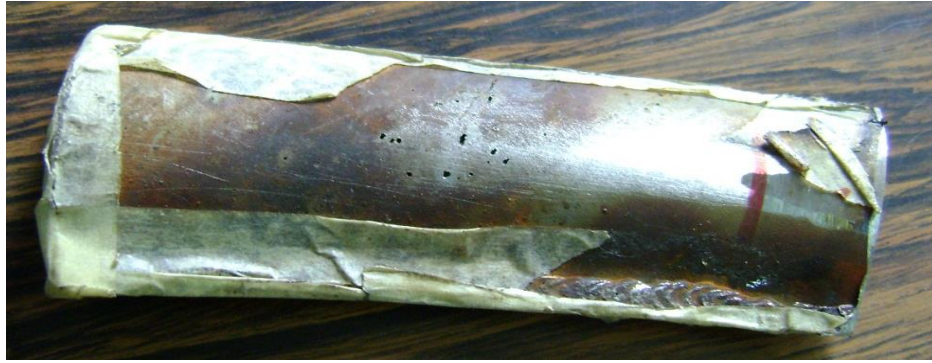
Research aim is to know the reason of the fault in the HTU, and why it failed in terms of studying the working conditions and the corrosive environment. A good understanding of the materials used for HTU, in terms of mechanical properties and corrosion rate, enables us to determine the performances that are affected under high temperature and pressure or not, or if there are other causes. A macroscopic image of a sample taken from the HTU which has been exposed to corrosive processes is presented in Fig. 1.

Fig. 1. Heat transferring unit section exposed to corrosive process

So, as a final conclusion it can be said that 304L is not a proper material for HTU fabrication and should be replaced by 321H austenitic stainless steel that will improve its usage in this application.

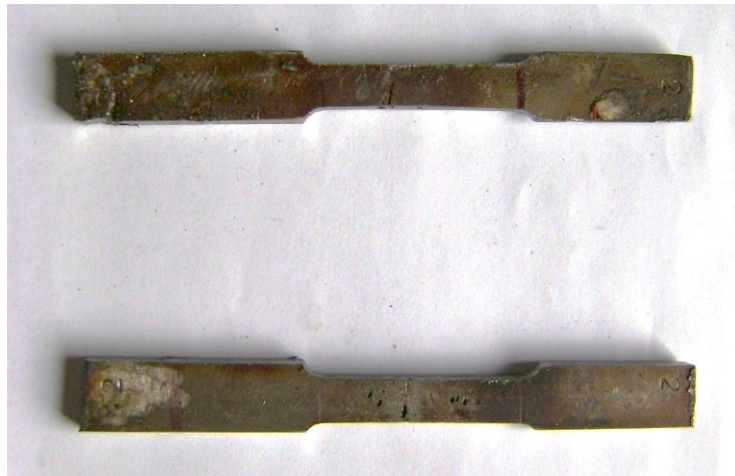
Fig. 3. Refers to tensile specimen used in research, the Load - Displacement curve of the body of the HTU specimen are shown in Fig. 4 and the bar charts shown in Fig. 5 shows the comparison of the tensile parameters obtained from testing and standard 304L alloy respectively.

Fig. 3. Macroscopic images of the 304L samples used in the mechanical tests

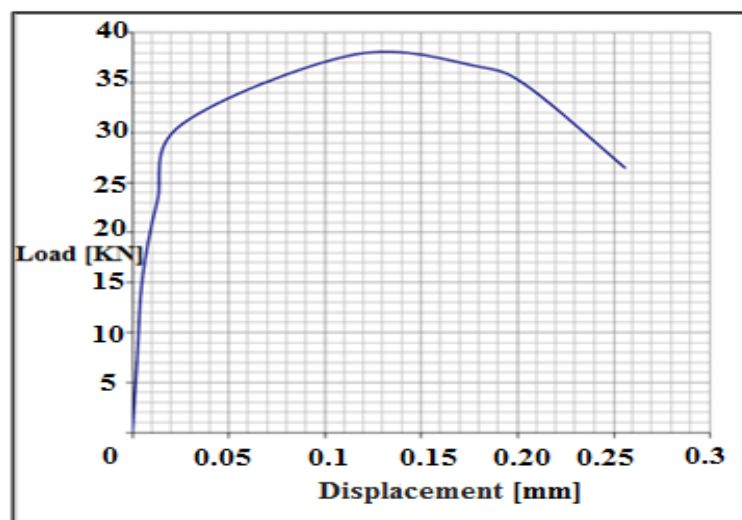
Fig. 4. Load - Displacement curve

The mechanical tests have evidenced that the body of the HTU specimen, presents lower tensile when compared to a standard 304L alloy.

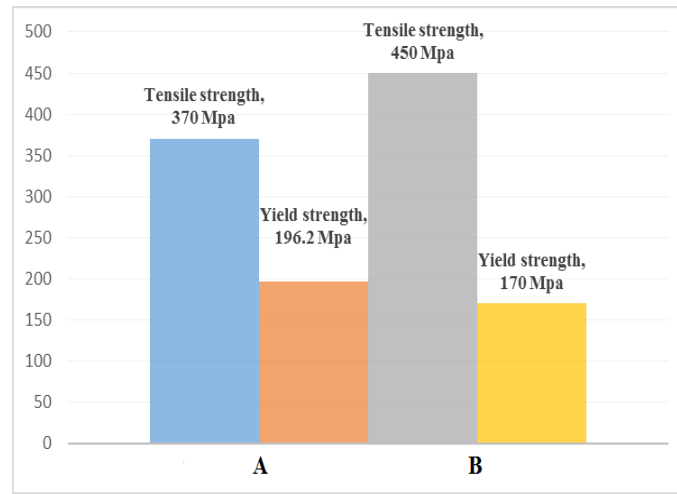
Fig. 5. The tensile strength and yield strength of the tested specimens:
A) body of the HTU specimen and B) standard alloy 304L
