CHARACTERIZATION OF SPARK PLUG ELEMENTS USED IN SPARK IGNITION ENGINES

Corneliu BIRTOK BANEASA¹, Doru SAPTA², Ana SOCALICI³

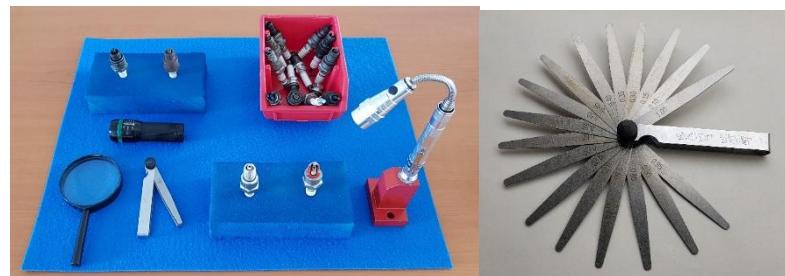
Fig. 1. Spark Plug Analysis Educational Kit

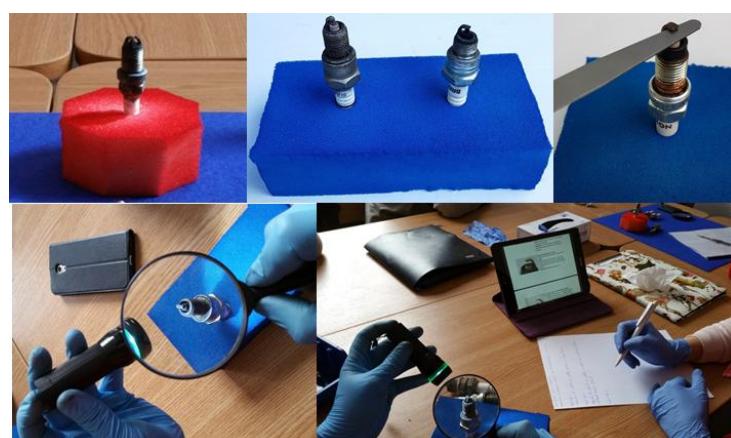
In the first stage, the characteristics of the spark plug were determined: brand/code, architecture (dimensions), number of side electrodes, and heat value. Based on the brand and code of the spark plug, the specific distance between the electrodes was determined, the thread dimensions (diameter/length) and hexagon size were established, and the type of spark plug was classified according to the number of side electrodes. Then, the dimensions of the central electrode were analysed, and the heat value of the spark plug was determined. In the second stage of the tests, the defects were identified by following these steps: the spark plugs were mounted on the study support, measurements of the electrode distance were taken using feeler gauges for spark plugs with one side electrode, and the components of the spark plug were analysed to identify the defects. The aspects from the tests conducted are presented in Fig. 2.

Fig. 2. Aspects from the tests conducted.

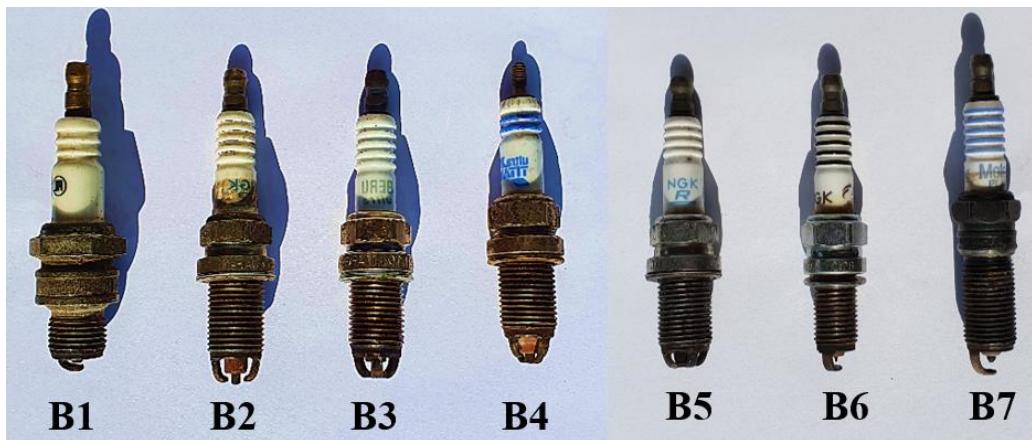
A batch of seven spark plugs with the following construction characteristics was subjected to experimental tests (fig. 3): B1 – spark plug with one side electrode;

B2 – spark plug with two side electrodes; B3 – spark plug with three side electrodes; B4, B5 – spark plugs with four side electrodes; B6, B7 – spark plugs with one side electrode (Denso Iridium [16]). A stereomicroscope was used to analyse the evolution of electrode wear on the spark plugs.

Fig. 3. Batch of spark plugs subjected to experimental tests

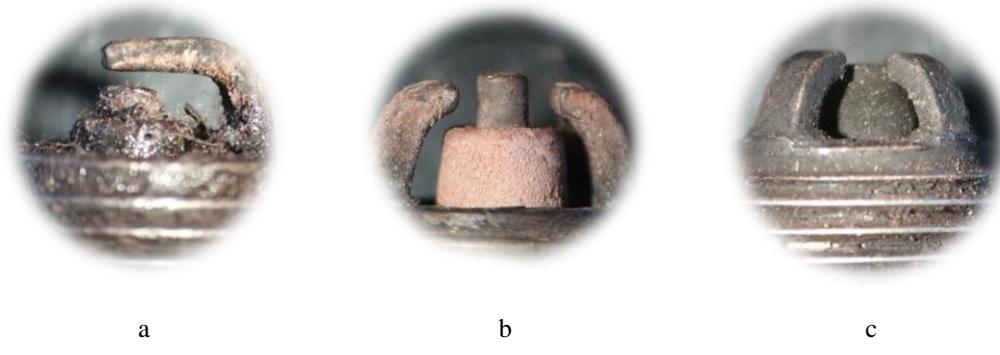
Fig.4. Deposits:

- a - spark plug with one side electrode;
- b - spark plug with two side electrodes;
- c - spark plug with three side electrodes

A stereomicroscope was used to analyse the evolution of electrode wear on the spark plugs. The aspects identified in the batch of analysed spark plugs are presented in figures 4-7.

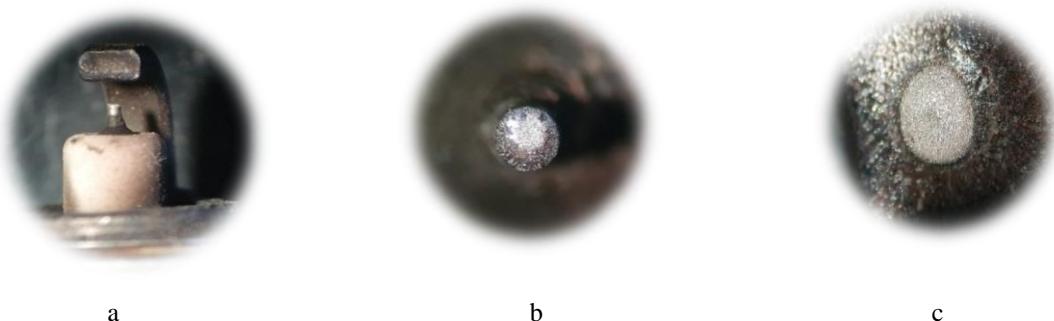
Fig. 5. Denso-Iridium Spark Plug

a - between iron; b - central electrode; c - side electrode

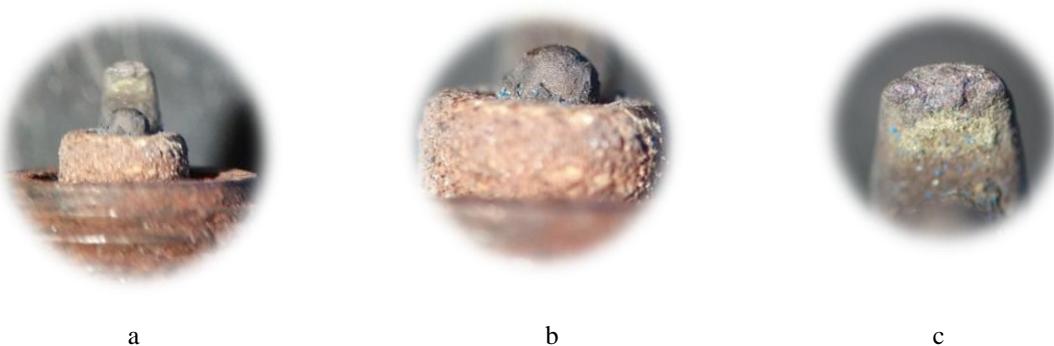
Fig. 6. Spark plug electrode wear

a - between iron; b - central electrode; c - side electrode

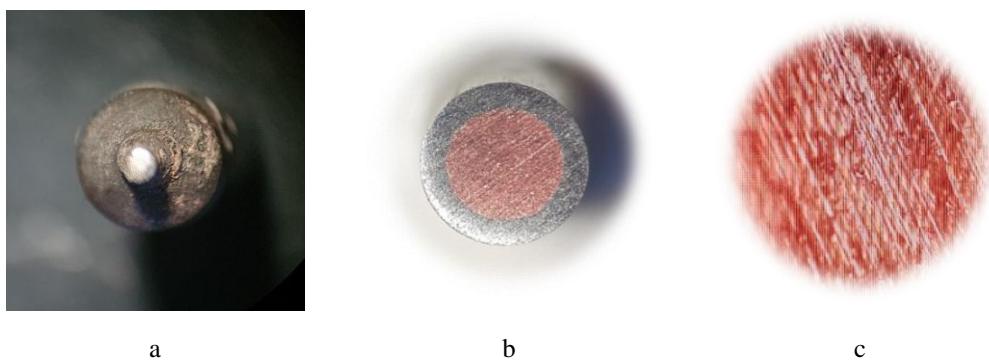
Fig. 7. Iridium central electrode

a - frontal part; b - layered section; c - copper core

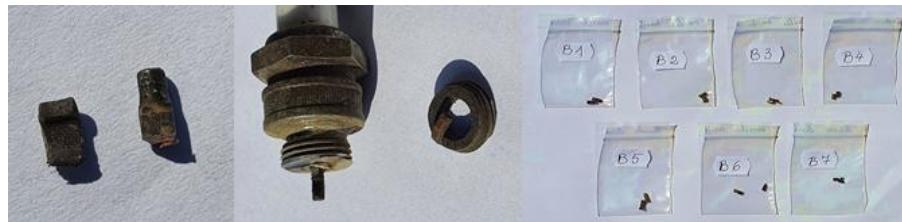
Subsequently, tests were conducted on the materials of the central and side electrodes, which required their extraction through cutting (fig.8).

Fig. 8. Samples for topographic and morphological analysis

The extracted samples were analysed for the purpose of performing topographic and morphological analysis at the Institute for Research in Renewable Energies in Timișoara.

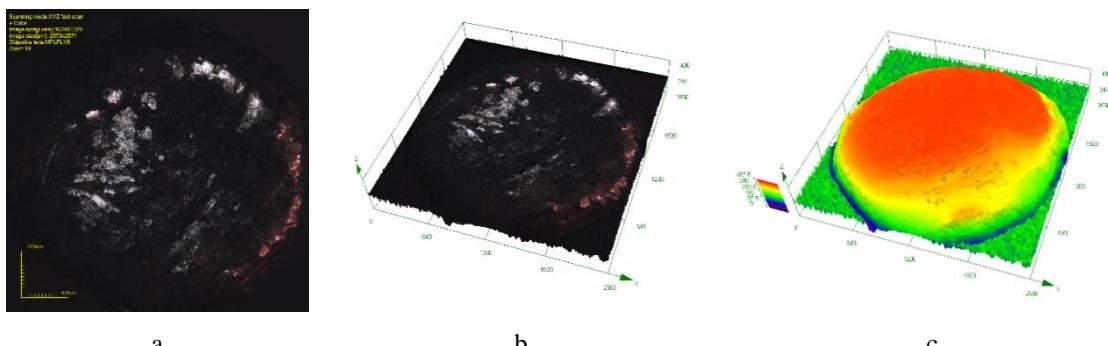
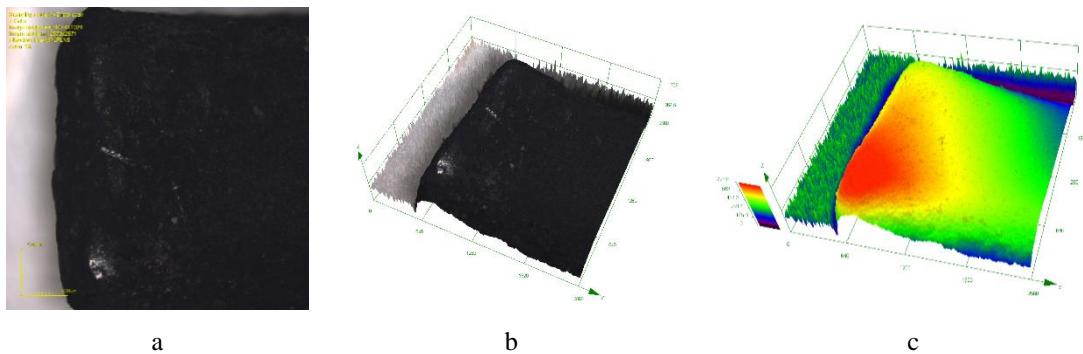
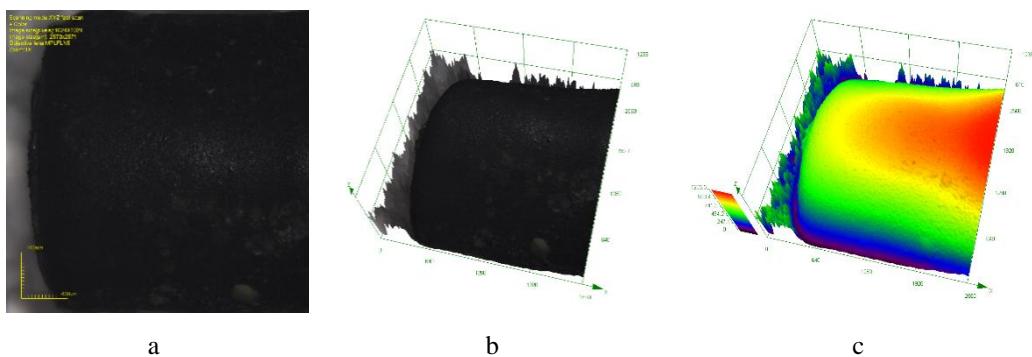
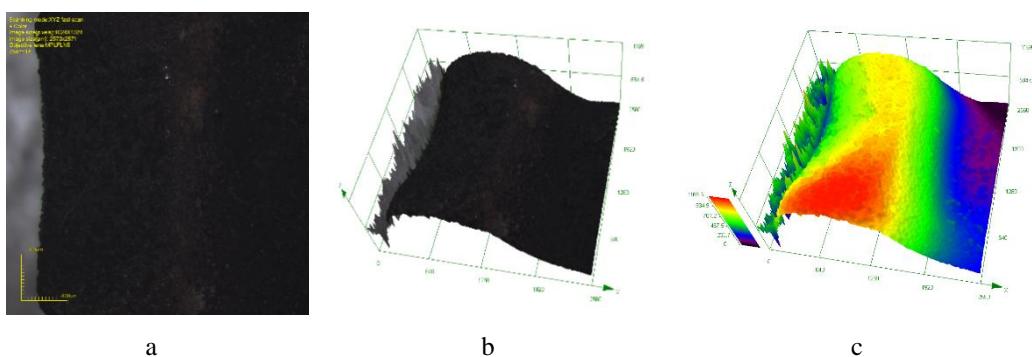
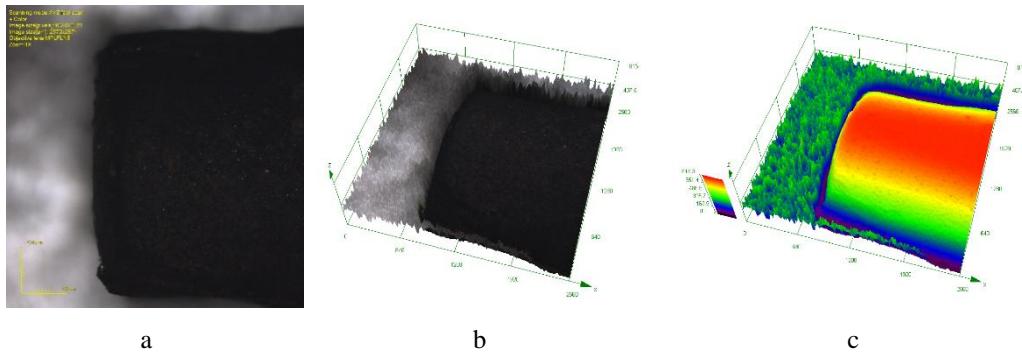
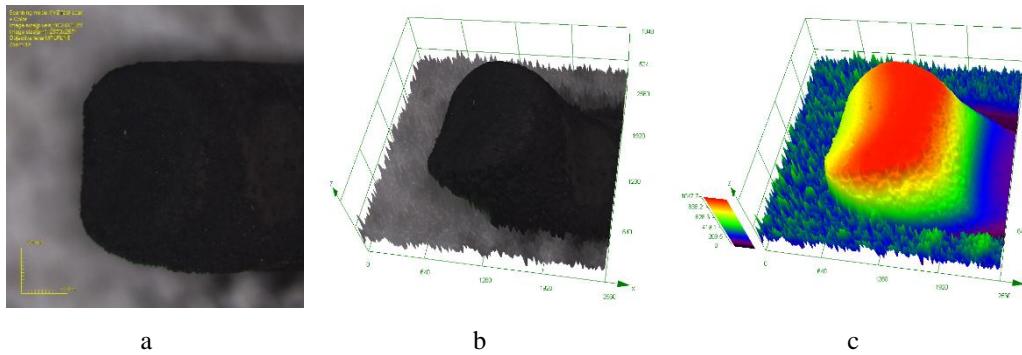
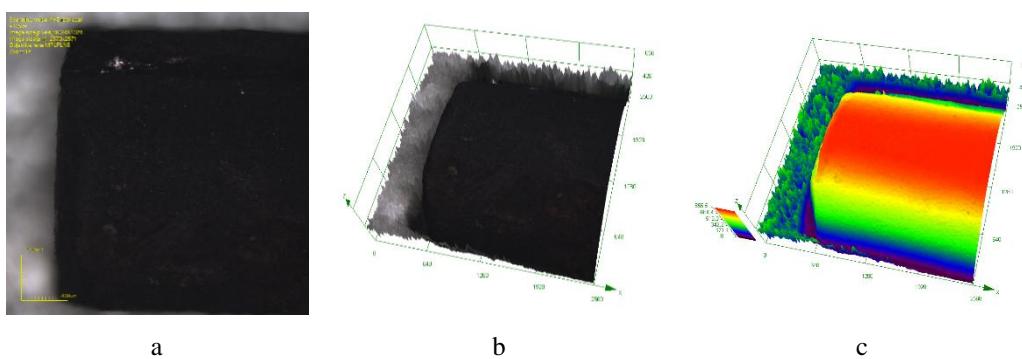
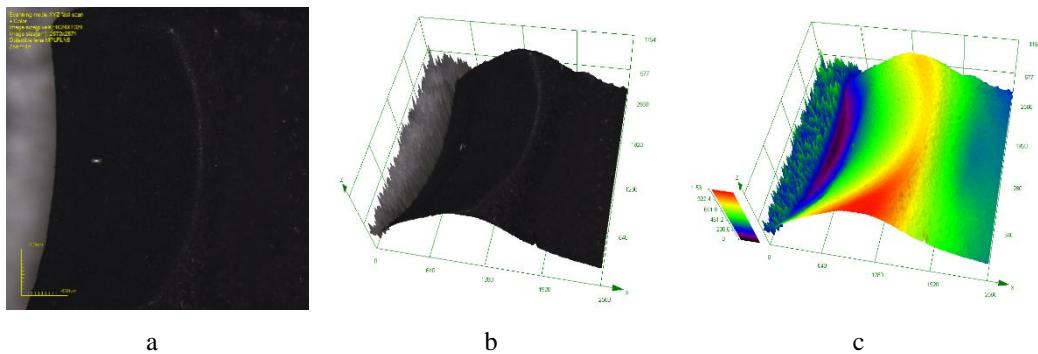
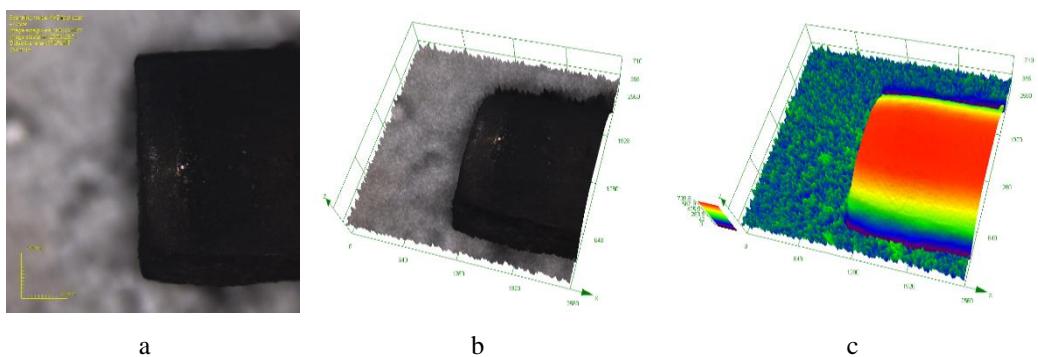
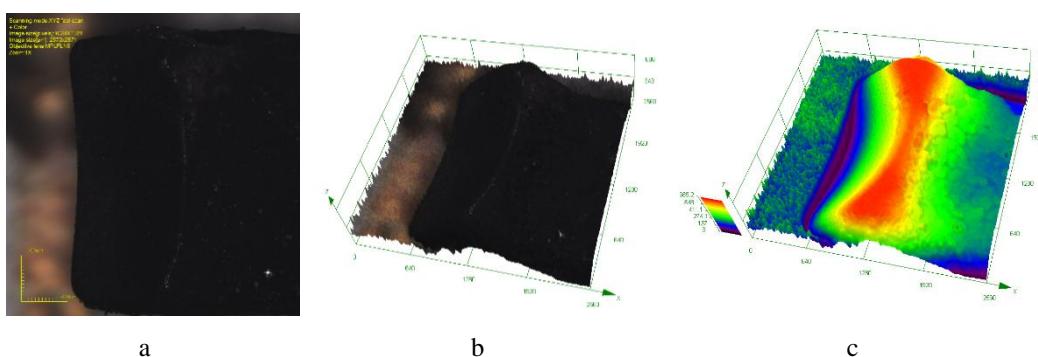
Figures 9 – 22 present captures taken with the Olympus confocal laser 3D microscope, as follows:

- a – electrode photograph (zoom: 1X);
- b – topographic analysis of the surface;
- c – highlighting the height irregularities

Through topographic analysis, the wear due to the spark formation process and combustion process is highlighted, which stresses the front and side surfaces of the spark plug electrodes. Figures 19-22 present the topographic analysis of the central and side electrodes of Denso Iridium spark plugs installed on a 1.4L cylinder capacity engine of a Ford Puma vehicle.

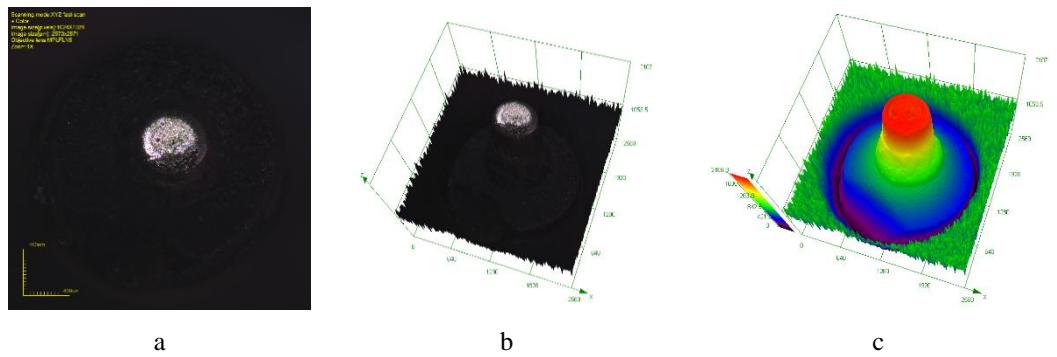
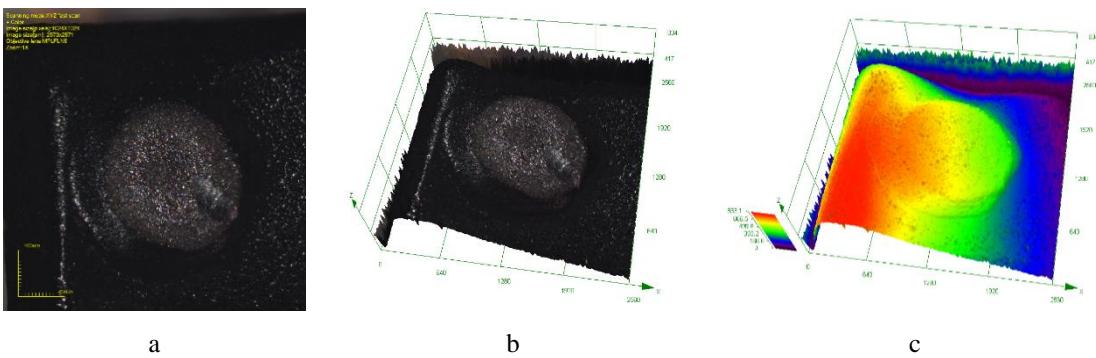
Fig. 19. B6 Central electrode

Fig. 20. B6 Side electrode

The operating duration of the spark plugs from which the samples were taken is 25,000-29,000 km, whereas the manufacturer guarantees an average duration of 60,000 km.

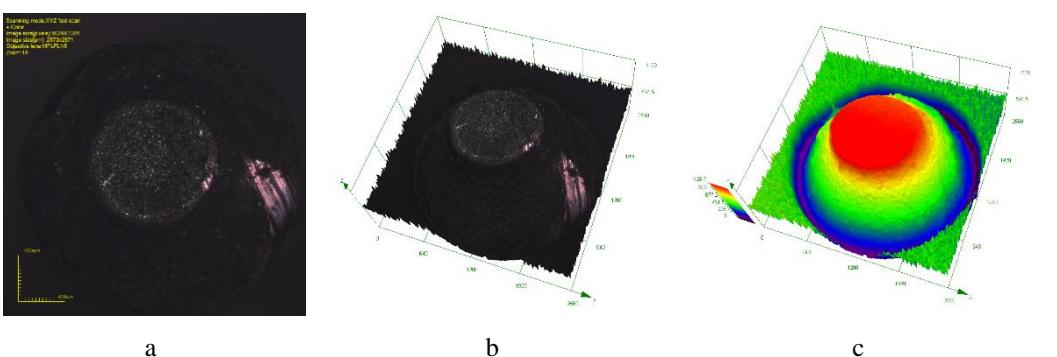
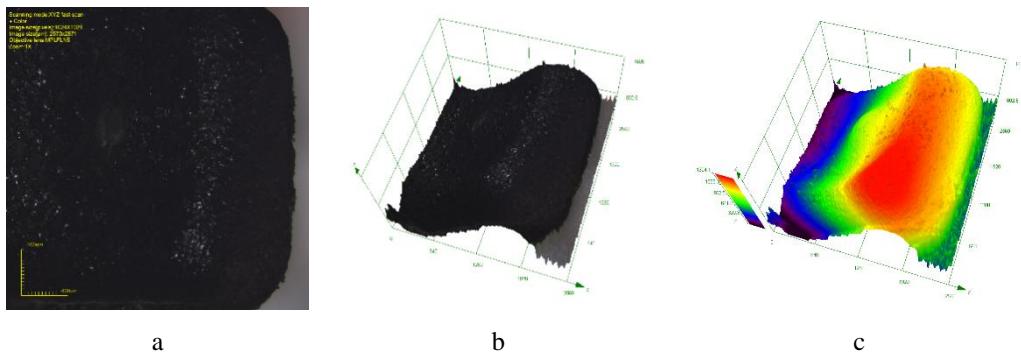
Fig. 21. B7 Central electrode

Fig. 22. B7 Side electrode

From the analysis conducted, pronounced wear is observed in the case of sample B7 as a result of non-conforming engine operation due to the presence of coolant inside the engine cylinder, caused by a crack in the cylinder head combustion chamber.
