INFLUENCE OF ZINC MICROSTRUCTURE ITS RESISTENCE IN AGGRESSIVE ENVIRONMENTS

Maria FAUR¹, Georgeta COSMELEAȚĂ²

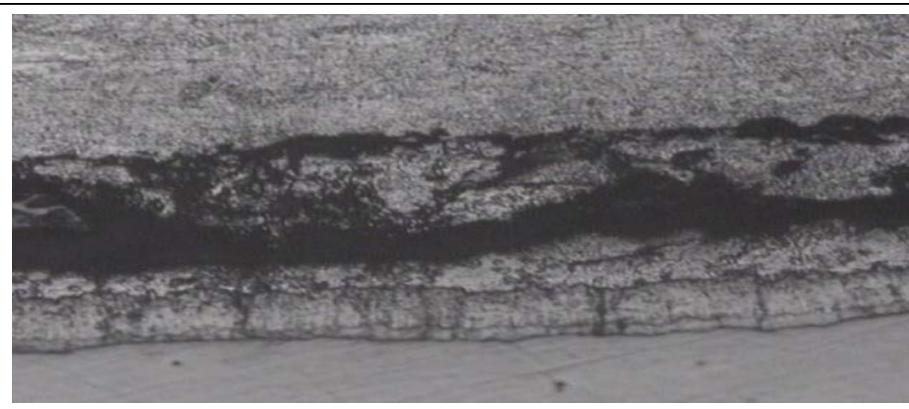
Fig. 7. Optical micrograph (Material COD B) after trying to determine the resistance to stress-corrosion cracking, $\times 200$; ($\text{Na}_2\text{SO}_4 2\text{M}$, $\text{pH} = 4-5$; the value of the applied tension: $74,9 \text{ N/mm}^2$; the period of time until the sample teared: 56 hours)

Under the combined action stress-environment [6], the samples taken from the zinc metallic material alloyed with 0,19%Cu were fractured after 56 hours. The microstructure presented in the Fig. 7 shows that under the action of a additional stress ($74,9 \text{ N/mm}^2$) the layer of corrosion products formed on the metallic surface were severaly cracked creating in this way the paths by which the electrolyte reached the metallic surface. The electrolyte was adsorbed on the active areas of the metallic surface (tension areas) releasing electrons for the cathodes reaction of the corrosion process. As a consequence increase of the local acidity in the tension conditions activated the corrosion process on crystallographic planes with a more electropositive potential than the one of zinc. The cracks seen in the metallic material present a character mostly transcrystalline and are stopped in their growth by a unfavourable orientation of some crystallographic planes already existing in the structure of the metallic material.

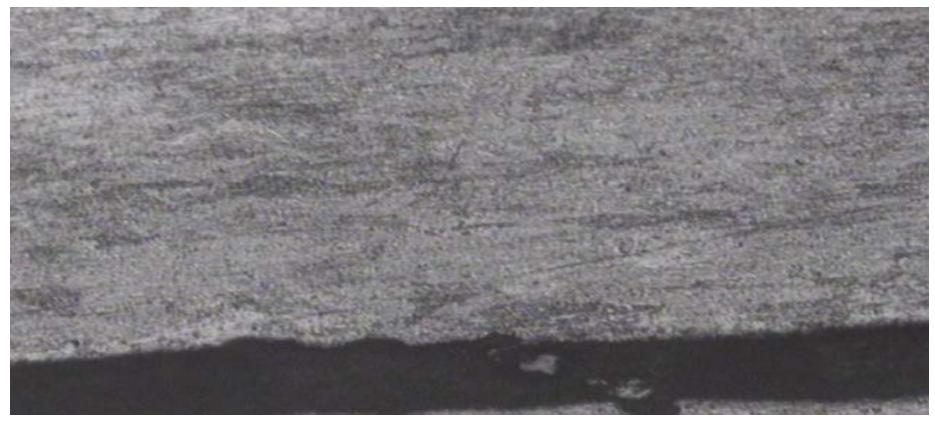
Fig. 8. Optical micrograph (Material COD C) after the attempt to determine the resistance to stress-corrosion cracking, x 200; (Na_2SO_4 2M, pH =4-5; the value of the applied tension: 85,75 N/mm 2 ; the time period until the sample was torn: 72 hours)

Alloying zinc with copper and titanium changes the behaviour of these metallical materials under the combined action stress-aggressive environment. The microstructure of the selected sample from the proximity of the crack area (Fig. 8) doesn't show the presence of the cracks in the structure of the zinc alloyed with 0,09%Cu and 0,19%Ti. This demonstrates that this metallic material is not liable to stress-corrosion cracking, under the conditions of the experiment. This fact is due mainly to the structural homogeneity that creates an equilibrium of the stresses on the metallic surface and between the crystallographic surfaces with different orientations and electrochemical potentials. Even more, the presence of the compound TiZn_{15} , uniformly distributed in rows in zinc limited the increase of the dimensions of the crystalline grains to the spaces between the rows, providing

in this way a mean dimension of the zinc crystallites characterized by a mean adsorption capacity of the oxianion SO_4^{2-} , which doesn't allow the local increase of acidity. On the other hand, the presence of the compound TiZn_{15} , uniformly distributed in longitudinal direction stops the development of cracks in the metal.
