BONNET CABLE DEFECT ANALYSIS USING SIX SIGMA DMAIC TECHNIQUES

Dina DIGA¹, Irina SEVERIN²

Study presents the implementation of Six-sigma techniques to identify the root cause of bonnet cable problem at the customer's request. The process was developed in detail, using five main (DMAIC) steps: Define, Measure, Analyze, Improve and Control. In this research, Quality Management tools such as SPD – Standard Problem Definition analysis, Data Analysis, Quality Assurance Part Inspection, Data Collection Plan, Process Capability Study - DPMO, Initial Verification Diagnosis, Visual and Control Charts etc. are used in defining the problems to find the root causes for the problem and carrying out experiments in order to suggest improvements, through which the company could bring in quality and reliability in their process.

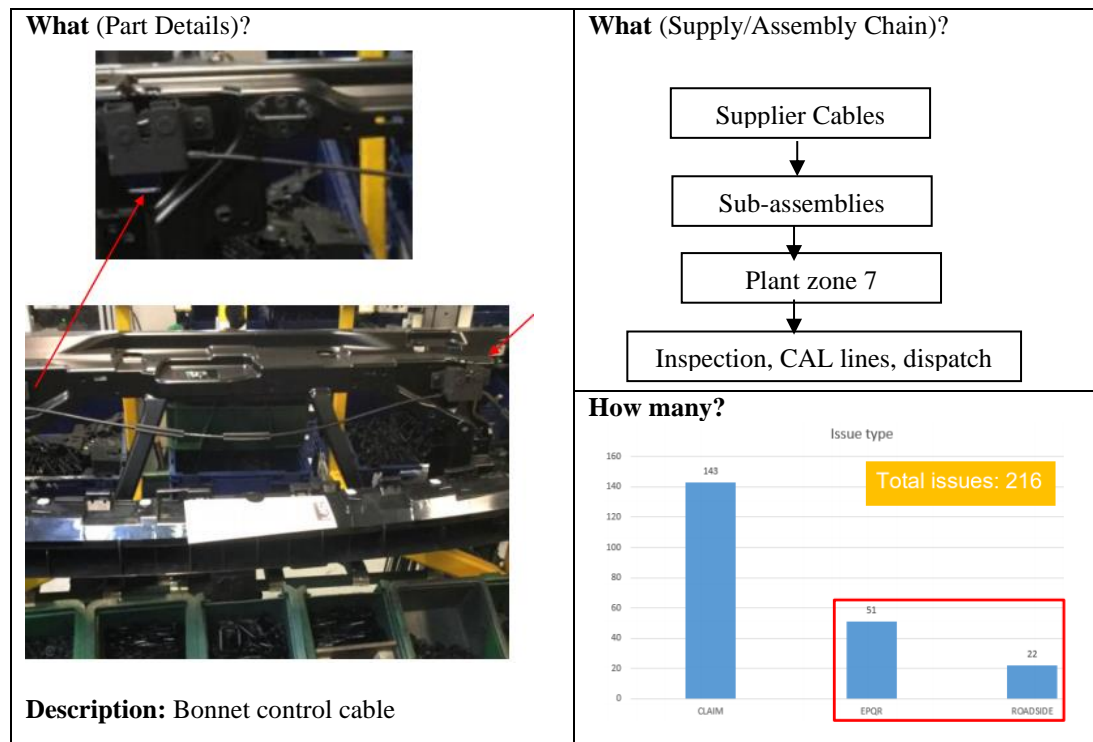
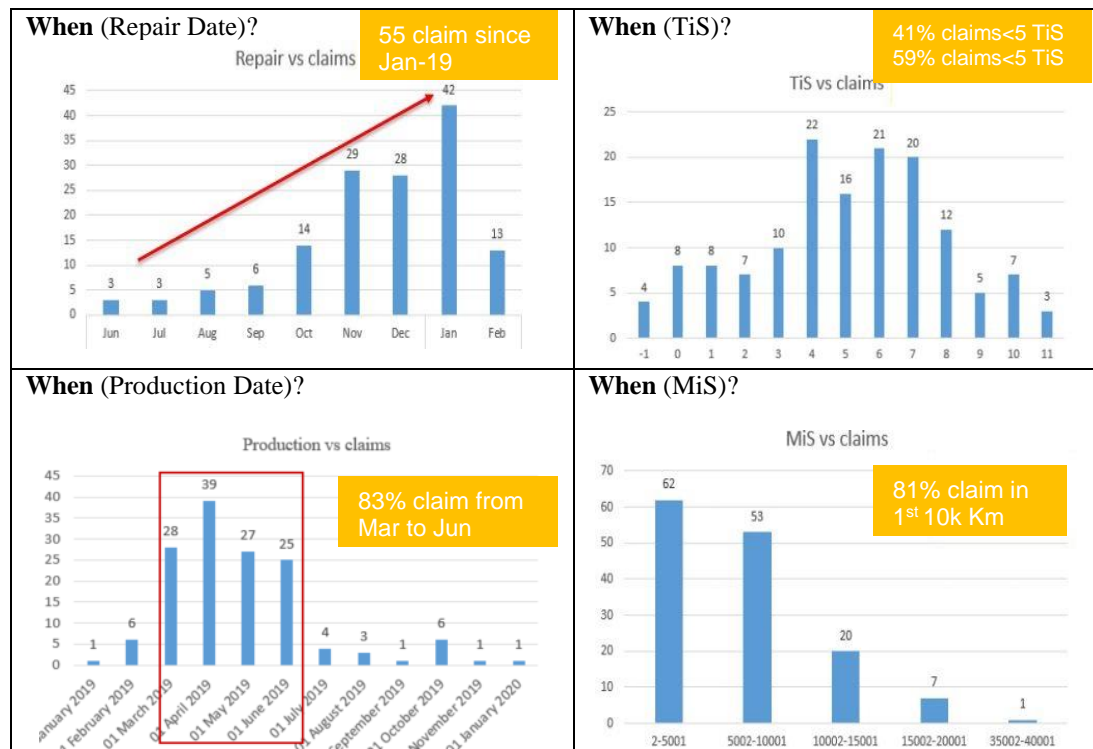
Fig.1. Data Collection Plan

Following the data analysis, 300 complaints were identified from customers and dealers regarding the bonnet cable problem. From this a total of 143 claims, 51 EPQR and 22 RSA are found. Based on the above data, DPMO was calculated using the following formula:
