## FAILURE ANALYSIS AND CORROSION MECHANISM INVESTIGATION OF HEAT EXCHANGER PLATES FROM AN OIL REFINERY

*This paper presents research conducted on four plates from a heat exchanger located in an oil refinery, aiming to identify the causes leading to their severe corrosion. The chemical composition, macro- and microstructural analysis, and hardness characteristics of the material were analyzed. Results obtained were compared with material standard specifications outlined in the equipment documentation. A separate chapter details optical and electron microscopy analyses of corrosion developed on plate surfaces. Finally, the probable causes of premature plate failure caused by severe corrosion are discussed.*

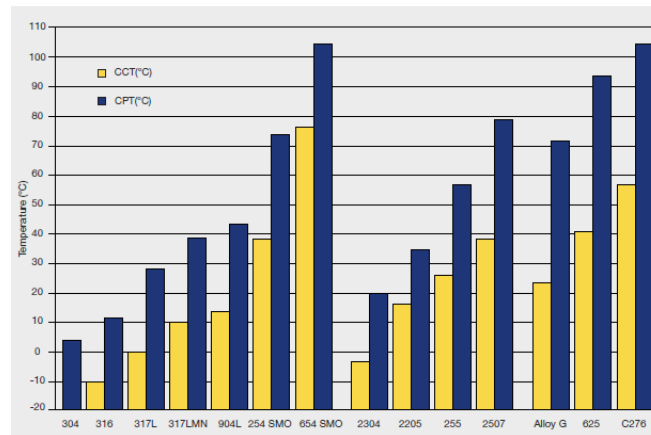
b) The resistance of stainless steel to localized corrosion attack by pitting or crevice corrosion increases with the Cr, Mo and N content. To order the steels according to their sensitivity to localized pitting (CPT) or crevice corrosion (CCT), laboratory tests are performed with highly corrosive solutions whose aggressiveness is stimulated by increasing temperature. Critical temperature is the temperature at which a steel shows corrosion initiation. Figure 10 shows the critical temperatures for crevice or pitting corrosion determined for a number of stainless steels in a ferric chloride solution.[11] It should be noted that these temperatures

cannot be interpreted as indicating in detail the behavior of a given steel in a given environment, but steels with higher CCT or CPT critical temperatures generally have superior corrosion resistance in a wide range of real environments.

**Figure 12.** Spot (CPT) or crevice corrosion resistance (CCT) of different stainless steel grades [4]

It can be observed that the steel of the grade 1. 4404 according to EN 10028 used in the execution of the analyzed exchanger plates can be appreciated as showing satisfactory resistance to spot or crevice corrosion in cooling water environment with temperatures up to 40 ÷ 50 0C and controlled acid number [5,6].

The steel grades mentioned in Table 3 shows superior resistance to spot or crevice corrosion.

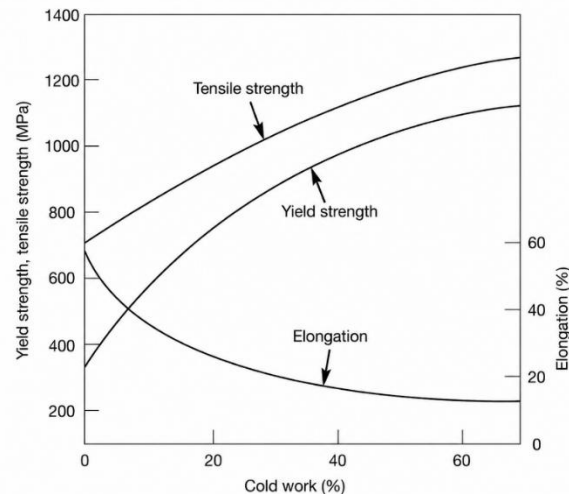
c) The plates of the heat exchanger show areas with significant plastic deformation of the material, i.e. with thickness reductions reaching values of approx. 20 ÷ 25 %. As it can be seen in the diagram in Figure 13, the plastic deformation generates a strain hardening process identified in the case of E-01 heat exchanger plates by local hardness increases of approx. 100 % compared to the average values identified in the undeformed areas on the contour of the plates.

**Figure 13.** Effect of cold deformation on the mechanical properties of an austenitic steel with 0.2% nitrogen [4]

Scaling is a factor that sensitizes the material to spot or crevice corrosion. In the case of the material of the exchanger plates, this aspect is evidenced by the intensity of the corrosion process revealed by microscopic examination. The initiation of the corrosion process was favored by the presence of adherent deposits of products carried by the cooling water, as well as by the constructional particularities of the plates, such as the proximity of circular perforations. [12,13]
