## RESEARCH ON CORROSION DEGRADATION PROCESS OF SOME THERMAL POWER PLANTS STEAM BOILER PIPES

**Keywords:** degradation, corrosion, steam boiler pipe

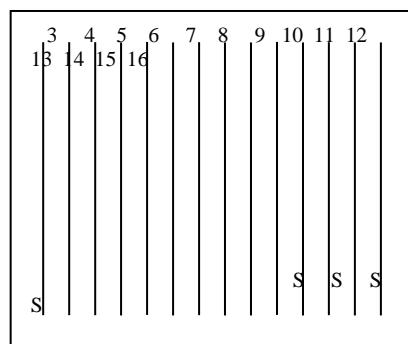
Vickers hardness measurements were performed both on samples taken from the boiler and on undamaged pipes found in the vicinity of the replaced ones. Table 2 shows in – situ Vickers hardness values measured in the damaged area of the installation. Five determinations were performed on each sample. The location of the hardness tests performed near the damaged area can be seen in Figure 5.

Fig. 5. Schematic representation of the in-situ hardness tested pipes.

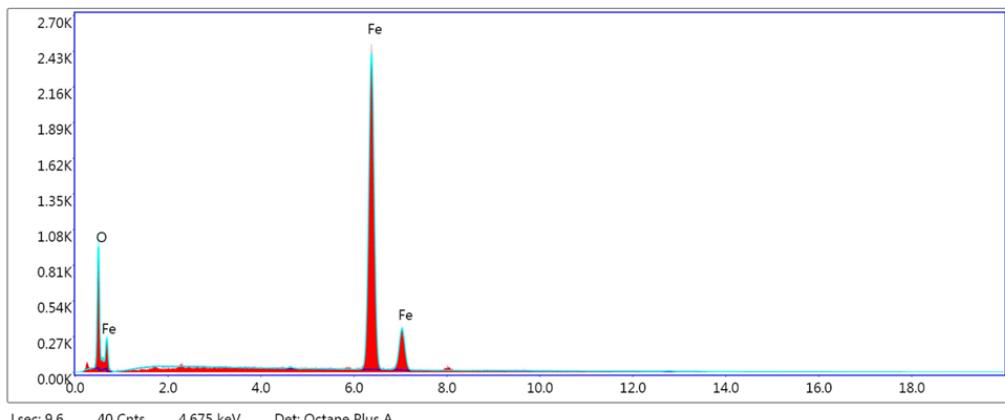
Fig. 12. Energy dispersive spectrum of chemical elements for pipe 13 (Zone 2, Selected Area 1)

Fractured microzones are observed in both secondary electron images, their presence resulting in a strong discontinuity of the material. At the same time, the areas are characterized by a certain porosity, which suggests the existence of a high content of iron oxides. The local chemical analysis confirms, through the energy dispersion spectra, the existence of the atomic species Fe and O. In both areas, the local chemical composition is:

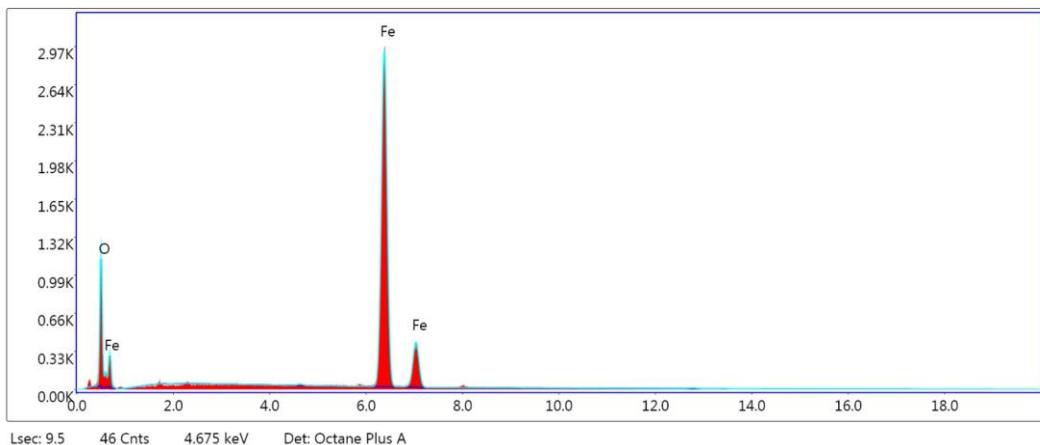
Fig. 14. Energy dispersive spectrum of chemical elements for pipe 13 (Zone 3, Selected Area 1)
