EVALUATION OF THE CONSERVATION STATUS OF THE FOUNTAIN ENSEMBLE FROM BRĂILA'S TRAJAN SQUARE, USING LASER INDUCED BREAKDOWN SPECTROSCOPY

Monica SIMILEANU¹, Roxana RADVAN², Dumitrel PANDREA³

Keywords: LIBS, stratigraphy, corrosion, cast iron

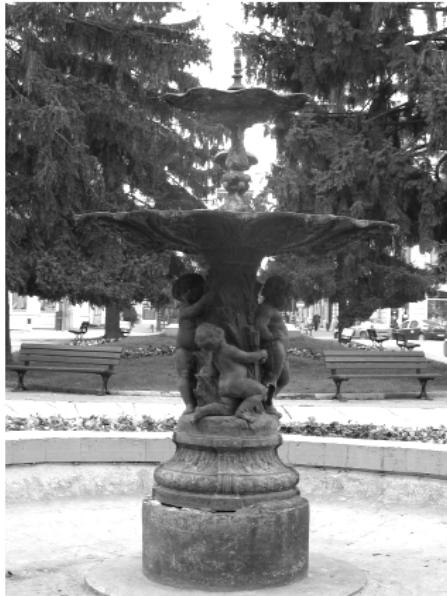
Fig.2. The Fountain ensemble

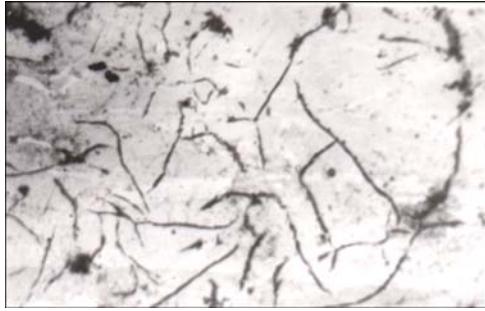
Fig. 4. Original sample, 150x magnification,

Based on the investigations made on the original sample, the structure of the metal was identified as soft cast iron with vermicular graphite at the limit of ferrite grain and interstitial graphite nests (see Figure 5). This alloy presents a high structural content of phosphorous eutectic (P between 0.9% - 1.2%) characteristic to the casting of thin pieces and decorations due to its high fluidity.
