# EXPERIMENTAL ANALYSIS AND CONTROL OF WHITISH INDUCEMENT AT CORNER OF BLUNT TRAILING EDGE OF FAN BLADE

*It is a difficult problem to study the cause of whitening of the corner of blunt trailing edge of fan blade after vacuum perfusion molding. The causality analysis method is used to summarize and analyze the causes of the whitening of the corner of blunt trailing edge of fan blade and determine the main factors affecting it. Through in-depth analysis and experimental demonstration of raw materials (pouring resin, core material, etc.) and layering structure design used in the process of making fan blades, the measures to effectively control the blanking at the corner of blunt trailing edge of fan blades are put forward. The results show that all the influencing factors can have certain influence on the corner whitening of the blunt trailing edge of the fan blade. This study can provide reliable basis and theoretical basis for the study of product quality and blunt trailing edge of fan blade.*

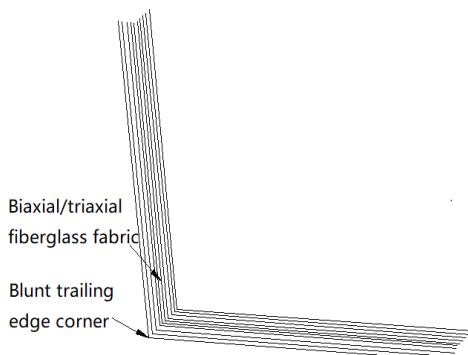
Fig. 6 Lay-up structure without core material

By comparing the structural designs of 76A(LZ) and 76(LZ) leaf shapes, it is found that the layering structure at the corner of blunt trailing edge of blade is different. For 76A(LZ), the layering at the corner of blunt trailing edge of blade is all made of glass fiber cloth without core material (as shown in Fig. 6), while for 76(LZ), the layering at the corner of blunt trailing edge of blade is made of internal and external glass fiber. There is a core material in the middle (as shown in Fig. 7). Therefore, the following ideas are proposed: Blunt trailing edge corner area layer structure because contain factors of core material in layer between cause in the process of glass fiber cloth and glass fiber cloth, glass fiber cloth and between the core material, core material with large space between the core material, clearance form resin gather location, resin reaction too quickly produce a lot of heat, heat is out in time led to the corner area temperature is too high, Which leads to explosive polymerization leading to whitening defects.

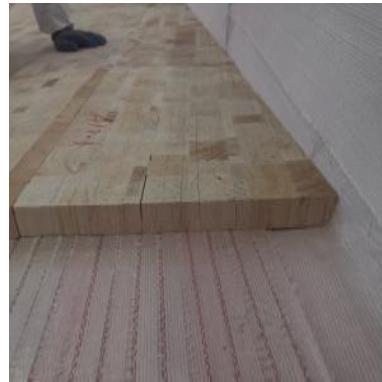
Fig 8. No clearance left in layering

Firstly, make 6 type 76 (LZ) blades on 1# and 2# molds respectively. When laying the middle layer of 1# mould, ensure that there is no gap between the cloth layer at the corner position of blunt trailing edge and the core material in the layering process (as shown in Fig. 8). When laying the middle layer of 2# mould, there is a certain amount of gap between the cloth layer and the core material at the corner position (as shown in Fig. 9).

c. As shown in Fig. 13: there is no gap in the corner area, and the highest curing temperature of the blade without cooling measures is between 84°C and 93°C, and the corner area is slightly white. After polishing the white area, it is found that there is no resin rich phenomenon.

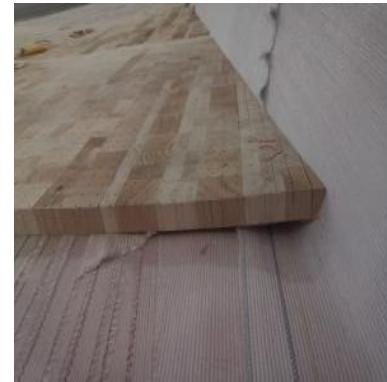
Fig. 9 Layering with gaps

a. As shown in Fig. 12, there is a gap in the corner area, and the highest curing temperature of the blade without cooling measures is between 99°C and 115°C, and the corner area is seriously white. After polishing the white area, it is found that there is a certain resin rich phenomenon.

b. As shown in Fig. 14, there is a gap in the corner area, and the highest curing temperature of the blades that take cooling measures during curing is between 75°C and 86°C, and the corner area is slightly white. After polishing the white area, it is found that there is a certain phenomenon of rich resin

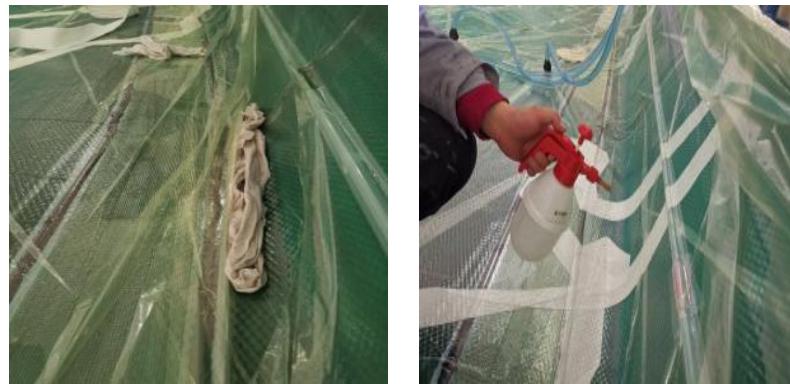
Fig. 10 Corner cooling operation

Secondly, during the period from the completion of vacuum infusion and the peak of resin exothermic heat, the corner position of the blunt tail edge of the first three blades made on mold 1# and 2# respectively was not treated, and only the highest temperature of the curing process in the corner area was recorded; The corner temperature of the blunt tail edge of the last three blades made on the 1# and 2# molds was monitored in real time, and when the temperature increased sharply, the corner position was cooled by spraying water from a watering can or wiping with a wet rag (as shown in Fig. 10), and the highest temperature in the curing process of the corner area was recorded (as shown in *Table 3*).

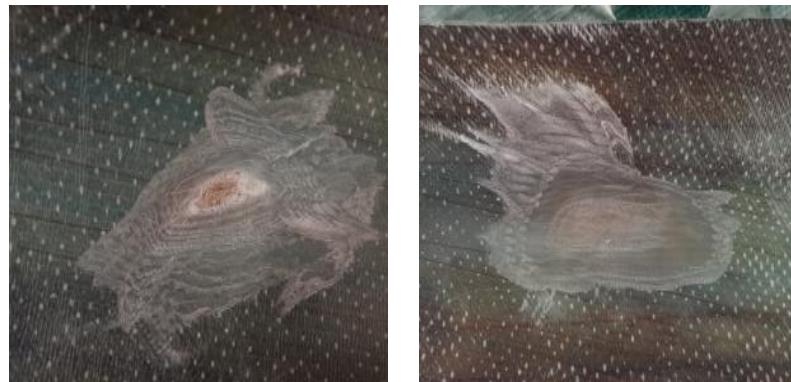
Fig. 11 Schematic diagram of defect grinding

Finally, after the curing, remove the auxiliary material on the corner surface of the blunt trailing edge, judge the defect in the corner position of the blunt trailing edge, and polish the corner position to observe the internal situation of the defect (as shown in Fig. 11).

- a. Severe whitening: refers to the incompletely infiltrated glass fiber cloth layer number of  $\geq 5$ ;
- b. Slight whiteness: refers to the number of layers of glass fiber cloth with incomplete infiltration  $\leq 5$  layers.
