RING TESTS ON CANDU FUEL ELEMENTS SHEATH SAMPLES

Silviu IONESCU¹, Octavian UTA², Marin MINCU³, Gabriel GHITA⁴,
Ilie PRISECARU⁵

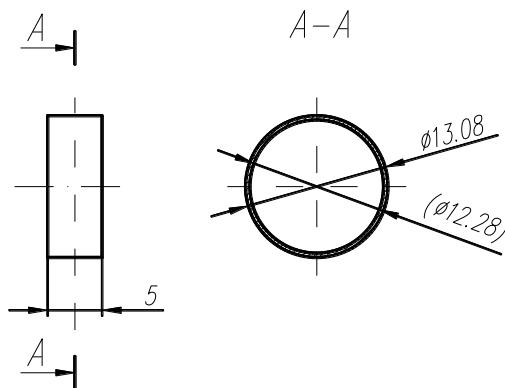
Fig. 9: Ring test sample

After the preliminary tests, three ring samples (5 mm long each) were cut from the fuel rod, for further tensile tests (Fig. 9). The samples were prepared according to the shapes and dimensions given in ref. [9], [10].

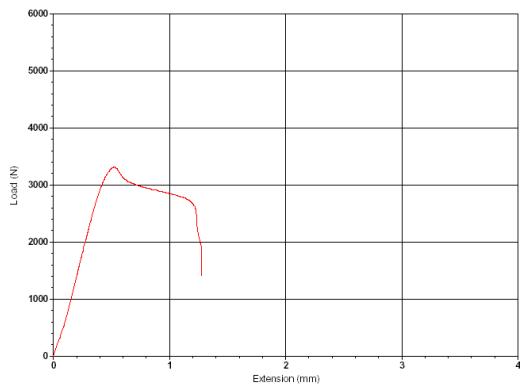
Fig. 10: Load-extension diagram

- the strain–stress diagrams and load extension (Fig. 10, 11);
- the yield strengths (offset method at 0.2%);
- the elastic limit;
- the ultimate tensile strength of the samples.

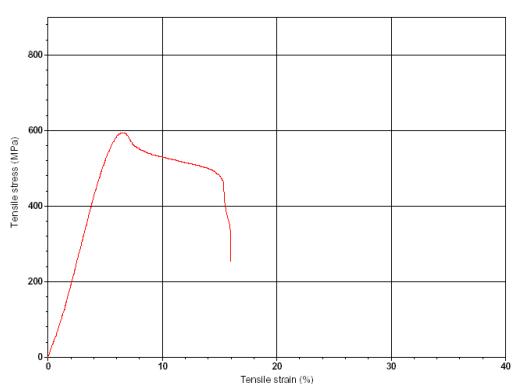
Fig. 11: Strain-stress diagram

The tests were done according to the procedures and standards are given in ref. [9], [10] and [11]. The aspect of the rupture and the relevant mechanical properties reveal the effect of irradiation on cladding material. It could be observed the increase of yield strengths and ultimate tensile strength with around 50% and the decrease of elasticity properties with the same value as effect of irradiation.

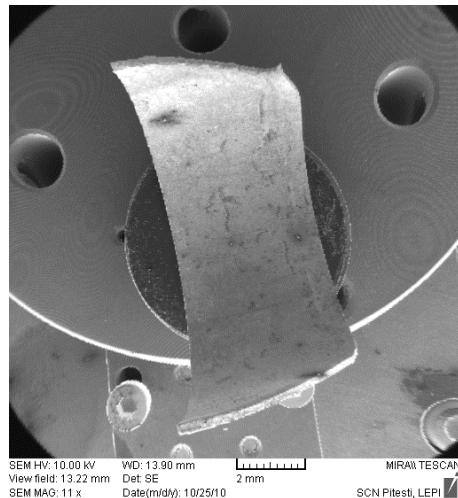
Fig. 13: Sample fixture on the electronic microscope table

Because of the ring shape of the sample, for rupture surface visualization, the sample was split into two parts, which were mounted in microscope chamber as in Fig. 13.
