## INFLUENCE OF AGEING TIME ON CAVITATION RESISTANCE OF 6082 ALUMINUM ALLOY

**Keywords:** aluminum alloys 6082, cavitation, ageing, micro and macrostructure

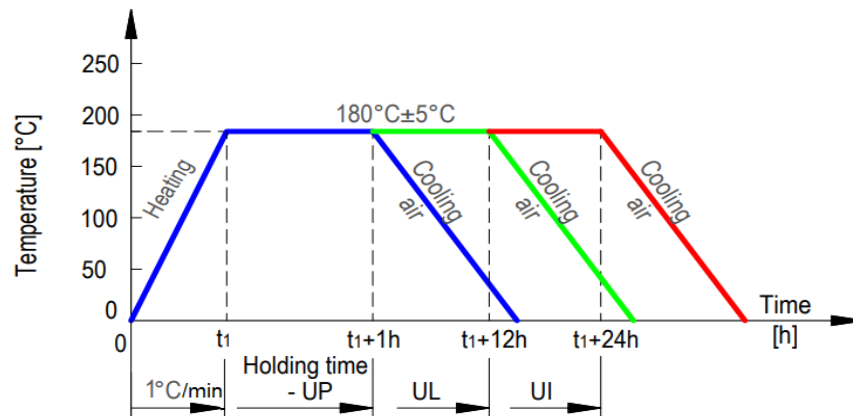
In the research carried out in this paper, were used the samples from the material in the delivery state, as well as samples subjected to heat treatments of ageing. The heat treatments of ageing were applied differently to three sets of three samples each and consisted of heating the samples to a temperature of 180 °C with maintenance for 1, 12 and 24 hours and cooling in air, according to the diagram in Fig. 1.

Fig. 1. Heat treatment cyclogram

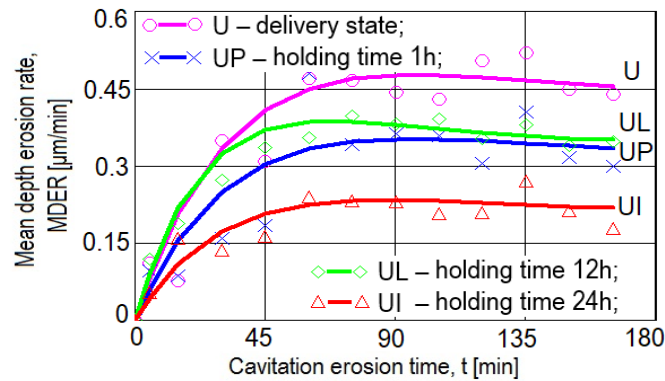
Fig. 13. Variation of mean depth erosion rate MDER with cavitation duration t

The material in the delivery state U presents the highest values of the cavitation parameters: cumulative average penetration depth of MDE erosion, MDER erosion rate. The appearance of the curve MDER (t) (Fig.13) is characteristic of materials with crystalline structure with high granulation and low cavitation resistance [1]. The behavior of UL samples, after ageing at 180°/1h, according to the shape of the curve MDER(t), is characteristic of materials with high plasticity, on the surface may appear the work hardened structures [12]. The UP samples, after ageing at 180°/12h have a similar behavior to those mentioned above. The UI samples, after ageing at 180°/24h show the best behavior at cavitation erosion, being in accordance with the superior mechanical characteristics of the material, obtained after the treatment.

$$MDER(t) = A \cdot (1 - e^{-B \cdot t}) + A \cdot B \cdot t \cdot e^{-B \cdot t} \quad (2)$$
