## A NOVEL APPROACH FOR THE STRUCTURAL INTEGRITY ASSESSMENT OF CANDU REACTOR PRESSURE TUBES

*The CANDU reactor pressure tubes are vulnerable to a detrimental event known as Delayed Hydride Cracking under normal operating conditions (DHC). The current work offers a novel method for assessing the structural integrity of the DHC initiation at the pressure tube's blunt defects. Based on the results of the experiments, the technique uses Failure Assessment Diagrams.*

**Keywords:** CANDU reactor, pressure tubes, hydride cracking, failure assessment diagram

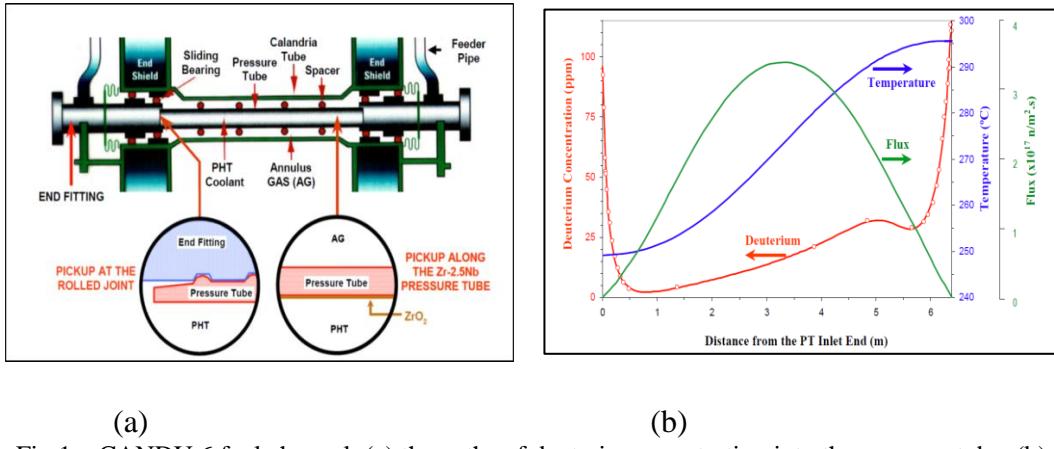
Fig.1 – CANDU 6 fuel channel: (a) the paths of deuterium penetration into the pressure tube, (b) deuterium concentration, temperature and neutron flux along the CANDU 6 pressure tube [1]

concentration of deuterium (equivalent hydrogen) at the ends of the pressure tube surpasses the solubility limit (30 ppm) in the solid state in the second part of the planned lifetime at temperatures in the range of 260°C to 310°C (Fig. 1(b)).

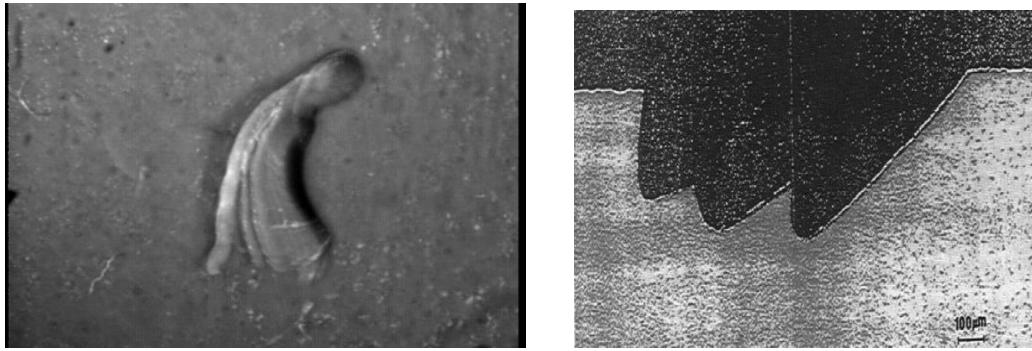
Fig. 2 – Examples of debris fret on the inner pressure tube surface: (a) (replica) [5], (b) transverse section [1]

Fretting of bearing pads, crevice corrosion at the locations of the fuel bundle bearing pads, fretting of debris, and fuel bundle scratching during refuelling are the most frequent flaws of the pressure tubes in CANDU reactors that have been discovered through periodic examination. In this context, debris fretting is a recognized in-service damage mechanism that results in pressure tube flaws deeper than the acceptability standard (0.15mm) of CSA Standard N285.4 [4]. As shown in Fig. 2, the bulk of debris fretting damage in CANDU pressure tubes has been confined, shallow, blunt notches with low-strain concentration.

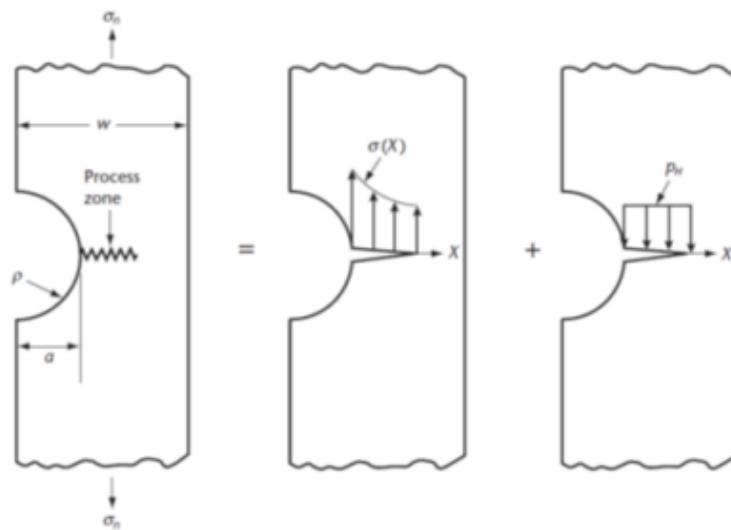
Fig. 3 – Blunt flaw geometry and characteristics in process-zone approach [4]

The process-zone concept can be used to model DHC initiation since the hydrided region is discrete in character [8]. The strip yield zone is the term given by the process zone methodology to the form of representation that describes relaxation brought on by plasticity at a stress concentration [4]. It is possible to think of a hydrided zone that escapes at a defect root and the nearby region that is fracturing as one unit (Fig. 3).

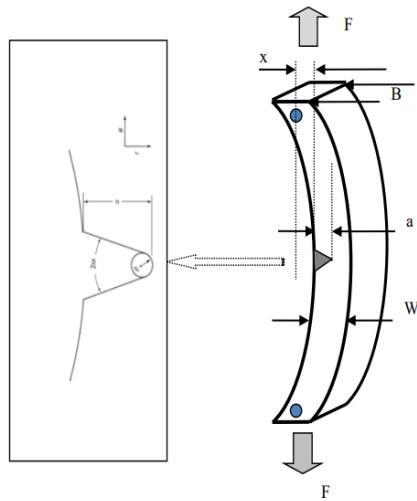
Fig. 4 – C-shape specimen, Zr-2.5%Nb, used in the experimental work

For the present study, the experimental works used a specimen having a “V-type” notch, on the inside surface, Fig. 4. The range of flaw depth was  $a = 0.2 \div 0.3 \text{ mm}$ , and the root radius  $\rho = 0.07 \div 0.1 \text{ mm}$ .

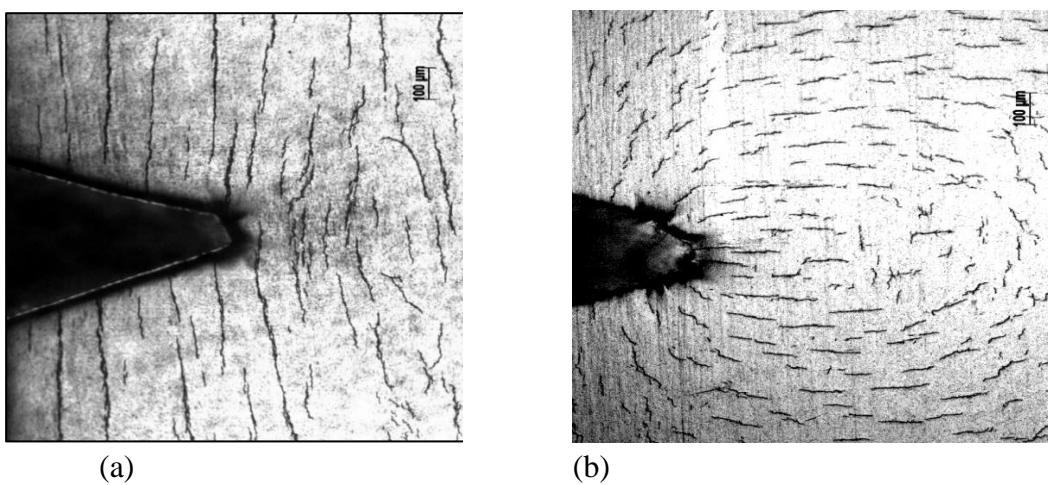
Fig. 5 – Metallographically aspects of hydride orientation: (a) original precipitation of the zirconium hydrides in Zr-2.5%Nb, (b) hydride reorientation at notch tip, (65 ppm of hydrogen)

The stress should be around 240 MPa at the flaw tip at a temperature of 270°C to initiate the reorientation hydrides phenomenon in Zr-2.5%Nb specimens from the circumferential direction in the radial direction of the pressure tube wall. Fig. 5(b) depicts a portion of hydride reorientation at the defect tip.

Examining the metallographic analyses in Fig. 5(b), it can be seen that the hydride platelets are reoriented in an approximately circular zone at the flaw tip. These zones are referred to as "zone with reoriented hydrides" (ZRH), and the degree of mechanical stress determines how big they are.

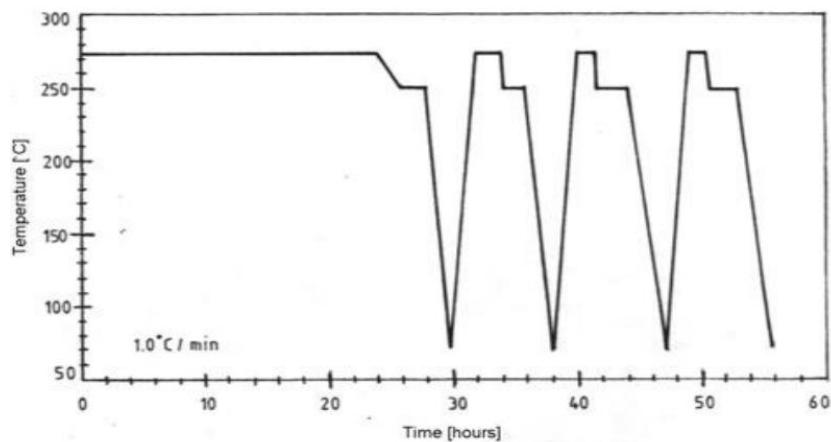
Fig. 6 – Thermal cycles for hydride reorientation

- Increase the tensile loading on the specimen up to a defined nominal stress;
- Maintaining the load at a constant level;
- Applying a thermal treatment, with thermal cycle sequences as in Fig. 6.

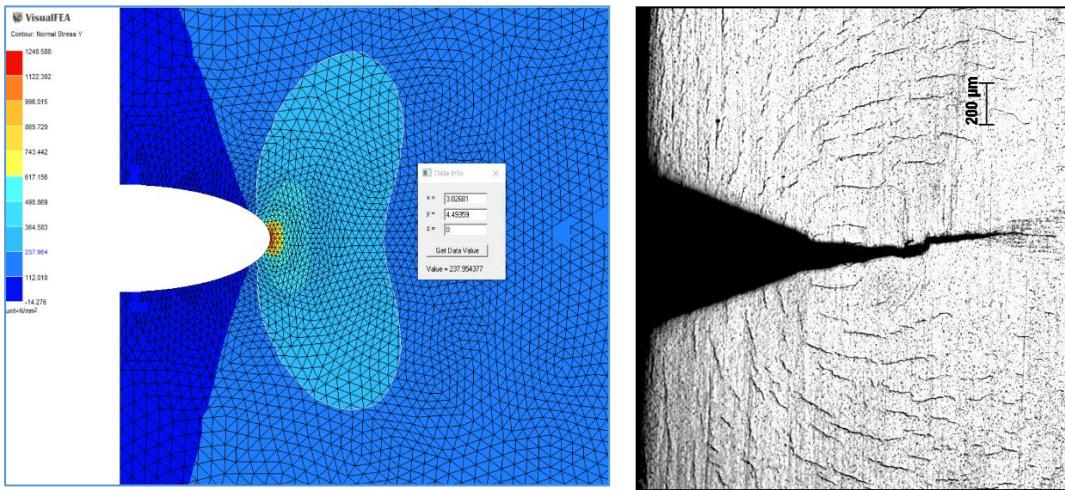
Fig. 7 – (a) Finite element analysis of flaw tip zone, (b) cracking of ZRH through hydrides

Using the same stress loading conditions as the experimental work, a finite element analysis was performed to estimate the magnitude of ZRH (Fig. 7 (a)).

Fig. 7(a) shows the size and form of the zone surrounding the flaw tip, which has a stress of at least 240 MPa and is of a similar magnitude to the ZRH found in metallographic analyses.

In comparison to the zirconium ductile matrix, the hydride **ZrH<sub>1.6</sub>** is extremely brittle, and the critical stress intensity factor has a value in the range  $K_{Ic}=1\text{--}3$  MPa. Fig. 7(b) illustrates what happens when the number of heat cycles is increased under a constant tensile load: fracture start and growth through the hydride reorientation zone. The stress intensity factor for a blunt flaw in this last image is  $K_I = 12.2 \text{ MPa}\sqrt{m}$  (estimated for a crack with the same two-dimensional dimensions), and N=17 thermal cycles are present. Zirconium hydrides that are broken off perpendicular to the surface tip of the notch cause the crack to spread through the DHC mechanism. The DHC crack is expanding in a radial direction to a depth of approximately 400  $\mu\text{m}$ . The brittle filaments of the reoriented hydrides were fractured to achieve crack penetration, and given the size of the DHC crack in Fig. 8(b) and the fact that it developed quickly during the most recent thermal cycles, the hypothesis of a limited number of brittle fracture sequences is put forth. A brittle crack generally progresses along a brittle line of connected hydride filaments in the area of localized hydride reorientation, with its front oriented perpendicular to the direction of mechanical force. As anticipated, at this level of  $K_I$  factor value, fracture propagation ceases only when the crack tip touches the ductile matrix of the Zr-2.5%Nb alloy. Based on these factors, we may construct an "effective blunt flaw" idea or even view the ZRH entity in front of the notch tip as "an extension" of the true flaw. Since real notch depth and ZRH depth are added together, we consider the depth of the effective blunt flaw to be equal.

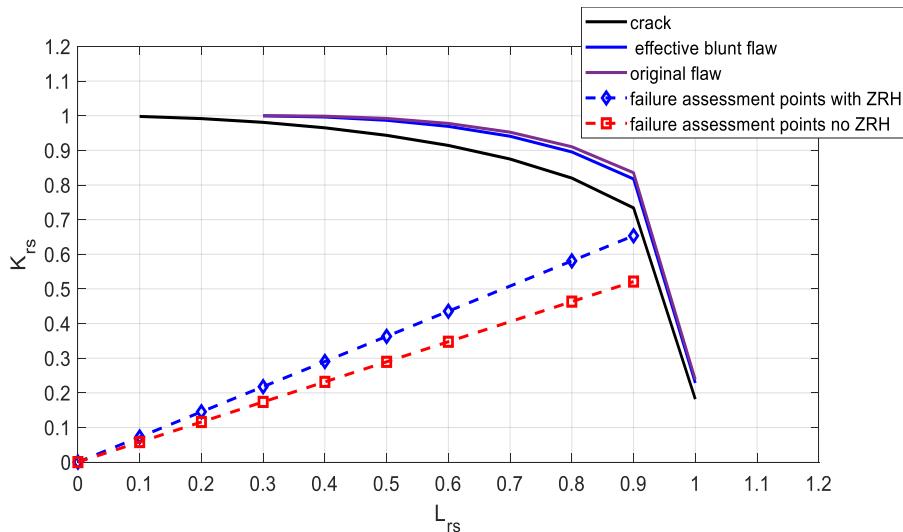
Fig. 8 – Evaluation with the Failure Assessment Diagram of a notch by considering the “effective blunt flaw” concept

Then, using the Failure Assessment Diagram (Equation (5)) and the assessment point (Equation (8)), we examine how this concept applies to the structural integrity assessment of the CANDU pressure tube. The following blunt flaw characteristics are selected: depth of real flaw;  $a = 0.3 \text{ mm}$ ; root radius of the flaw;  $\rho = 0.05 \text{ mm}$ ; depth of ZRH;  $a_{ZRH} = 0.2 \text{ mm}$ ; depth of the effective blunt flaw;  $a_{eff} = 0.3 + 0.2 = 0.5 \text{ mm}$ . Evaluation with the Failure Assessment Diagram of a blunt flaw with these characteristics by considering the “effective blunt flaw” concept is displayed in Fig. 8.

- By using the “effective blunt flaw” concept the FAD evaluation curve is a bit closer to the FAD representation for a crack;
- FAD evaluation curve with the “effective blunt flaw” concept becomes a little more conservative than the actual flaw when the structural integrity assessment is done;
- The assessment points line, given by Equation (8), by considering the “effective blunt flaw” concept, has a higher slope than for the real flaw; this increases the probability of DHC crack initiation and growth, at the point where this line intersects the failure assessment curve.
