HEAT TREATMENT PARAMETERS INFLUENCE ON THE CAVITATION RESISTANCE OF AN ALUMINUM ALLOY

Keywords: aging heat treatments, aluminum alloys, cavitation erosion

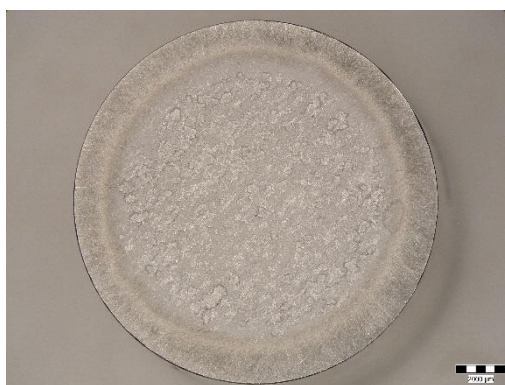
Fig. 5- Stereomacroscopic aspects (a,b,c) of cavitation surfaces for sample after ageing at 180°C/24h and microstructural aspect of eroded surfaces samples after ageing at 180°C/24h revealed by stereomicroscopic analysis (base image) and metallographic analysis (right top image)

The samples subjected to the aging treatment at 180 °C with maintenance for 24 hours (fig. 5) show the highest mass losses, extended both in surface and in depth. As a result of maintaining the samples for a long time at a high temperature, Si forms with Mg the Mg₂Si phase, which dissolves in aluminum and contributed to reduce the values of mechanical properties [1], [8], [9]. This fact contributes substantially to decrease the resistance to cavitation erosion.

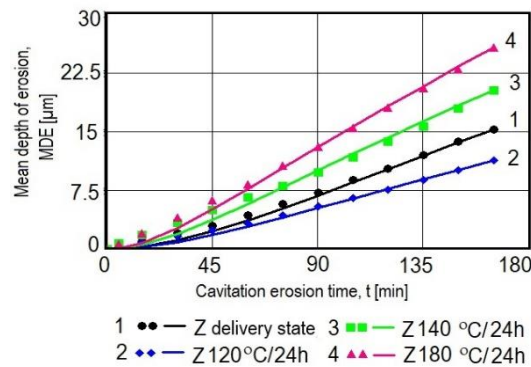
Fig. 8. Mean depth of erosion vs. cavitation erosion time of the experimental 2017A aluminum samples

The characteristic cavitation curves shown in Figs. 8 and 9 were prepared based on the analytical relationships established statistically in the Laboratory within the Polytechnic University of Timișoara [11-20], based on partial mass losses, the procedure being in accordance with the requirements of international standards in the field ASTM G32-2010.

Analyzing the curves of variation of the mean depth of erosion $MDE(t)$, after the 165 minutes of cavitation attack, compared to the delivery state, are observed decreases of the values of the average erosion depth only at the samples treated at 120°C with approx. 26%, the other samples registering increases of this parameter by 32.6% in the case of samples after ageing at $140^\circ\text{C}/24\text{h}$ and by 68.2% in the case of samples after ageing at $180^\circ\text{C}/24\text{h}$.
